# Monitoring of the Building Envelope of a Heritage House - A Case Study<sup>1</sup>

M.N.A. Saïd<sup>2</sup>, W.C. Brown<sup>2</sup>, C.J. Shirliffe<sup>3</sup> and A.H.P. Maurenbrecher<sup>2</sup>

## Abstract

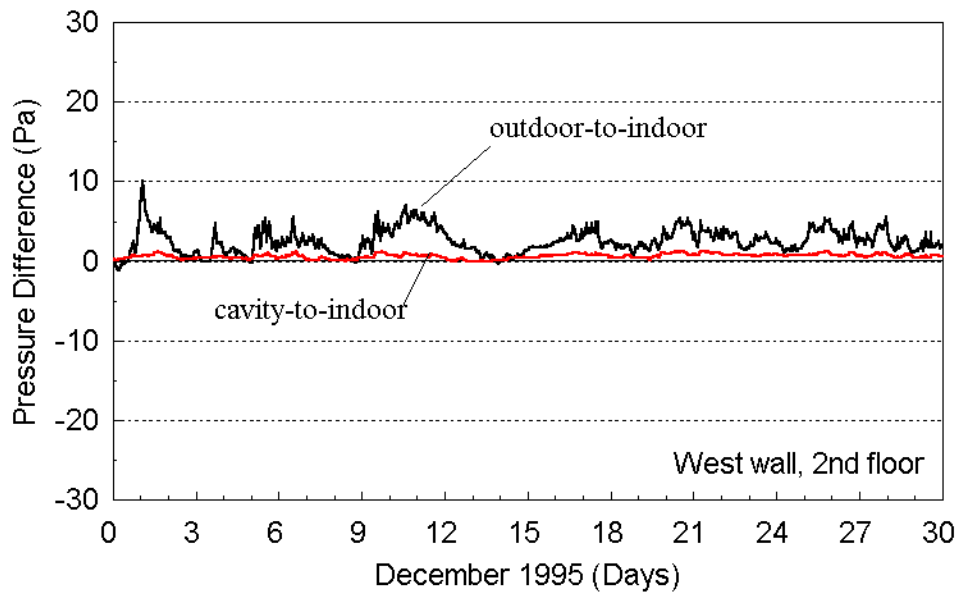
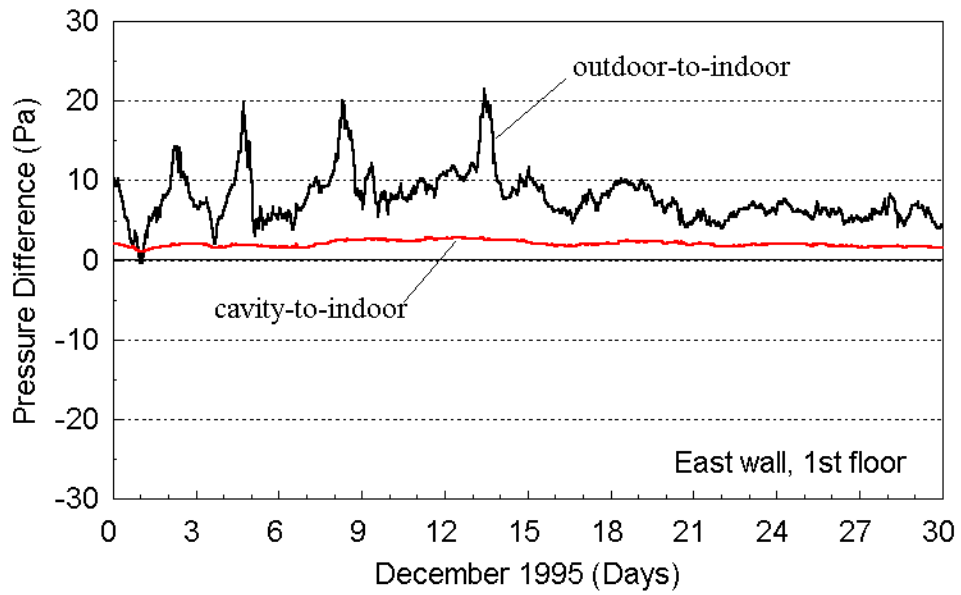
Figure 4. Pressure differential, outdoor-to-indoor and wall cavity-to-indoor, December 1995.

The indoor air pressures (hourly averages) were below the outdoor air pressure at the locations monitored (for example, during December 1995, the outdoor pressures were 7.7 Pa & 2.5 Pa higher for the first and second floors respectively, Fig. 4). The air pressure in the wall cavity was also higher than indoor air pressure (during December 1995, the mean cavity pressures were 2 Pa & 0.6 Pa higher for the first & second floors respectively). The negative indoor air pressures essentially eliminated the

leakage of the humid indoor air into the wall cavities and thus eliminated the potential for condensation on colder cavity surfaces. On the other hand, cold exterior air travelled through wall spaces, ceiling spaces and openings in the interior surfaces. This caused localized cold spots and ice formation on interior surfaces in several areas including walls and ceilings that have connection to the outdoors. This led to condensation and crack development. The latter was probably caused by dimensional changes due to changes in moisture content and temperature of the wall and ceiling materials.

The results also indicated that the brick walls are unlikely to experience internal condensation problems as long as the walls are subjected to a negative air pressure. However, because the building is quite leaky, the negative pressure created other surface condensation problems. Negative pressures are not a solution unless the size of the leakage paths are reduced (between the roof, ceiling spaces and walls). Air leakage at roof and dormer levels must be addressed.

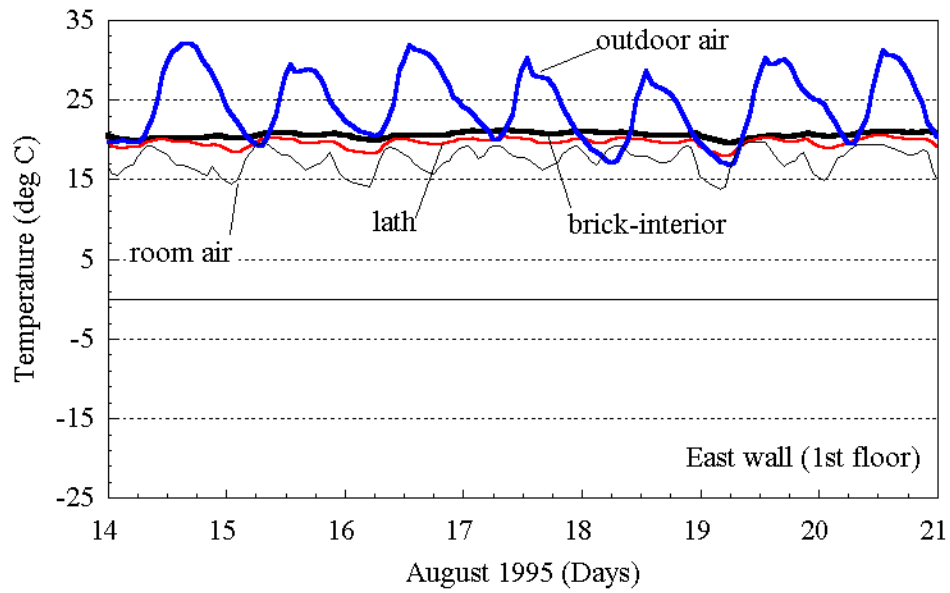
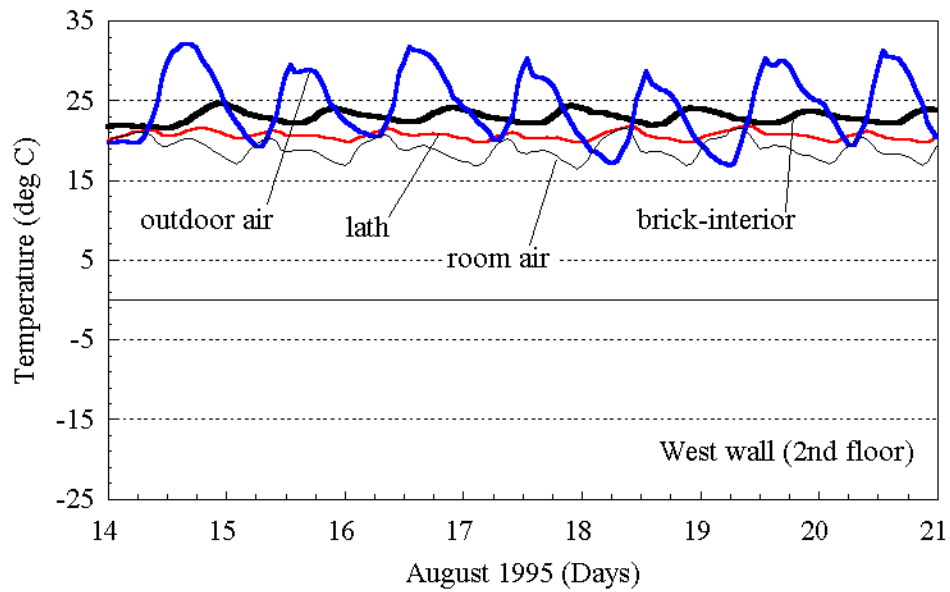
Figure 5. Temperatures of brick interior surface and intermediate lath within wall cavities and indoor and outdoor air, for selected periods in August 1995.

**Indoor temperatures:** During the summer, indoor air temperatures varied between 13°C and 22°C. Figure 5 shows that indoor air temperatures frequently dropped to 13°C during the night and rose to over 20°C the following morning. The figure also shows that indoor air temperatures tend to follow the diurnal variations in outdoor air temperature with a lag of about 12 h. This suggests that the HVAC system, which operated continuously, had limited control of indoor air temperatures especially during the summer. During the winter the variation was small (typically 20 to 23°C; Fig. 6) because the radiators had individual thermostats.

**Wall-cavity:** The variation in the surface temperatures of the brick and the lath within the wall cavities (air spaces in the walls) generally followed the daily average of the outdoor air temperature partly due to the damping effect of the thermal mass of the masonry wall (Figs. 5 & 6). The variations of surface temperatures in the east wall-cavity were less than those for the west wall-cavity surfaces. This is because the east wall is shaded by a neighbouring highrise building and a large tree. In addition, a west wall normally receives more sun than an east wall.

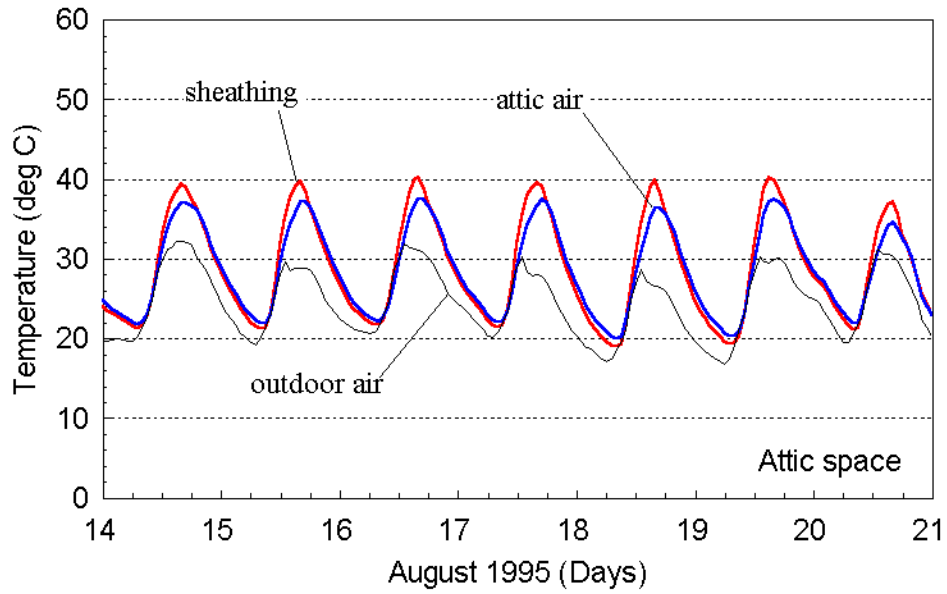
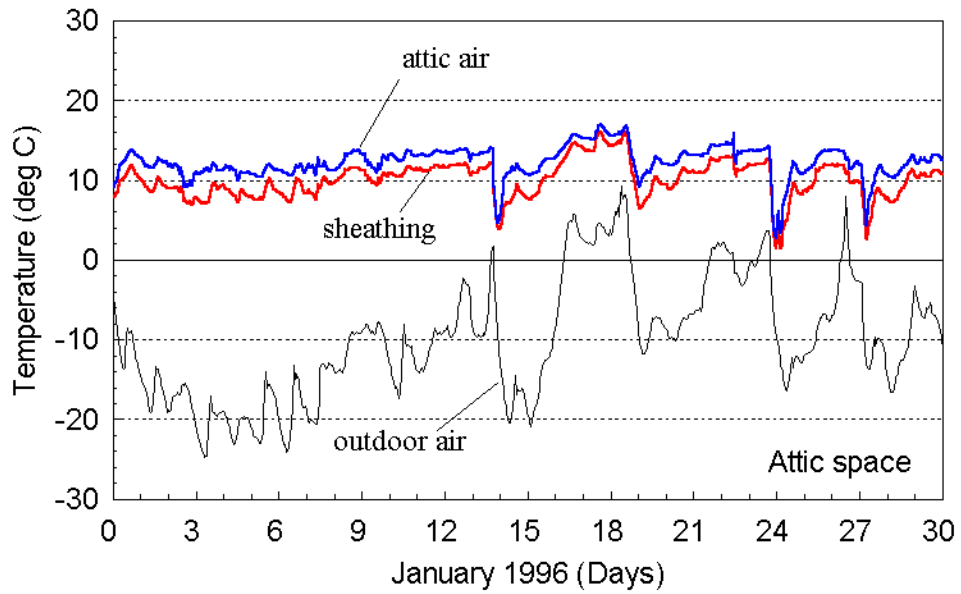
Figure 7. Temperatures of roof sheathing, attic air and outdoor air, for selected periods in August 1995 and in January 1996.

**Attic space:** Figure 7 shows the variation of temperature in the attic space above the third floor mechanical room during winter and summer. Solar heat caused a large increase in the roof sheathing and attic air temperature in the summer. In winter the roof sheathing and air temperature were more stable and were usually much higher than the outdoor air temperature (15-20°C higher; the temperature only approached the exterior temperature on windy days). This indicates a large heat loss into the attic space with the major part probably caused by air leakage. This also explains the ice-damming which is a problem on this building.

The temperature of the wood sheathing of the attic roof was usually higher than the dew-point of the attic air. However, on one occasion, in January 1996, the ceramic moisture sensor indicated surface wetting of the roof sheathing because of condensation. The temperature of the roof sheathing in the attic dropped about 1°C below the dew-point at about 6 a.m. The ceramic sensor dried out about 11 hours later. The moisture pins, inserted in the sheathing, indicated that moisture from the condensation was insufficient to affect the sensor at a depth greater than 6 mm.

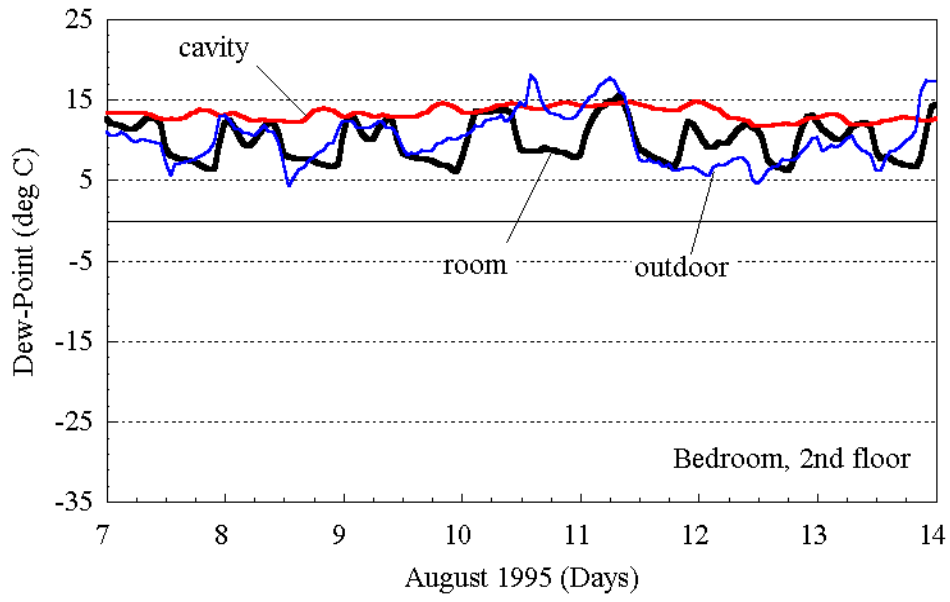
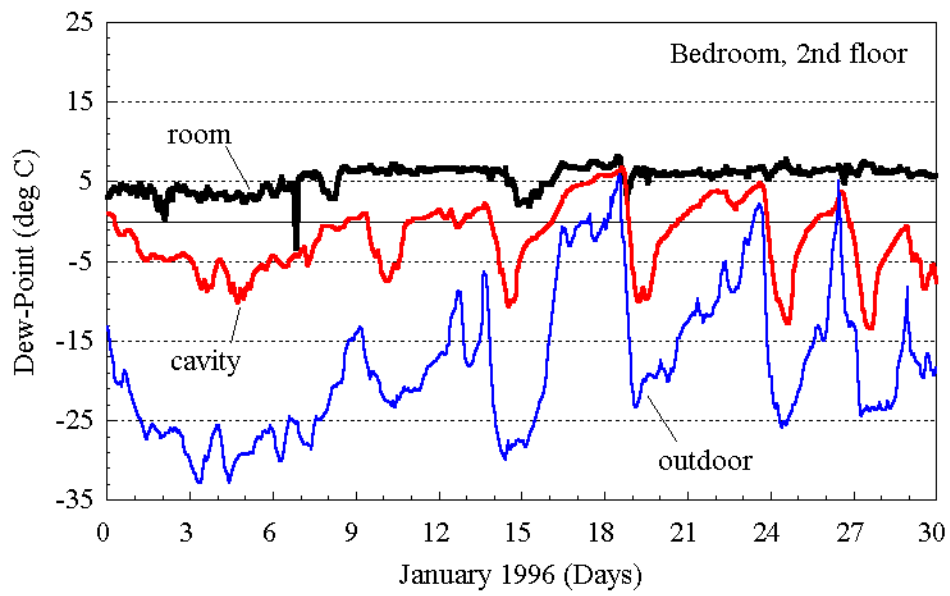
Figure 8. Dew-point of room air, wall cavity air and outdoor air, Mr. King's Bedroom (west wall, 2nd floor), for selected periods in August 1995 and in January 1996.

**Indoor air:** The RH of the indoor air varied from room to room and also from month to month (Table 1). It far exceeded specified indoor conditions. The variation in RH during August was partially due to the large variation in indoor air temperatures. Figure 8 shows that variation in indoor air dew-point during August had a diurnal variation similar to the outdoor air dew-point (the dew-point is representative of the moisture in the air). Measured RH during the summer shows that the HVAC system did not adequately control the relative humidity. Possible causes may include improper operation, location, or type of the humidistat; faulty controller operation; or insufficient dehumidification capacity of the HVAC system.

**Wall cavity:** The RH in the wall-cavity exceeded 60%. Figure 8 shows little variation in the cavity air dew-point during the summer while in winter it followed the variation in outdoor air dew-point. The results also indicate that, during summer, the brick is drying into the cavity air which led to higher dew-point in the cavity than in the indoor air.

The relative humidity of the indoor air varied considerably from room to room and also from month to month. It reached up to 80%. This large variation in humidity is not desirable for the preservation of the historical artifacts. A complete review of the HVAC system is required. Factors to consider include the location of the RH control sensor, ensuring it controls the dew-point, and checking its calibration and operation. Also check the de-humidification capacity of the HVAC system. After the HVAC is modified and air leakage at roof and dormers is addressed, it will be necessary to monitor the building envelope again. The HVAC system should also be monitored.

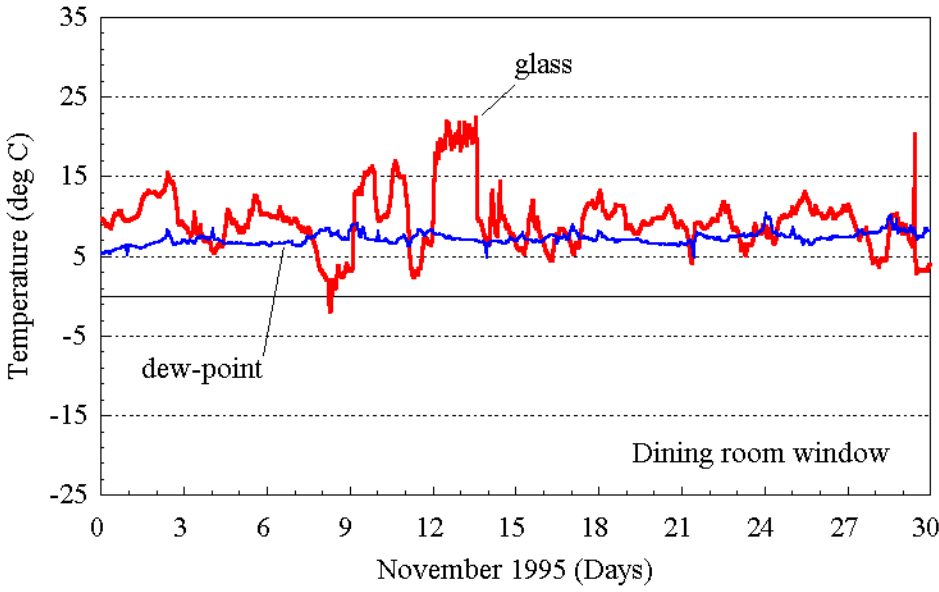
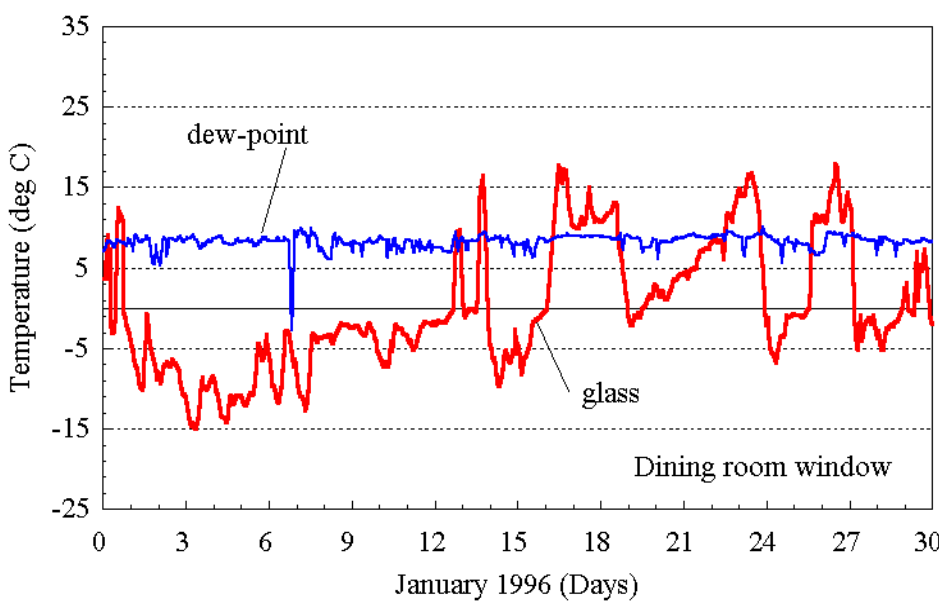
Figure 9. Temperatures of dining room window glass (single-glazed) and dew-point of indoor air, November 1995 and January 1996.

**Windows:** Extensive condensation and ice buildup was observed on the single-glazed window during the winter months. The surface temperature of the single-glazed window in the dining room dropped below the dew-point for several days during November and for most of January (Fig. 9). Water stains and wood swelling were evident on the sill of the dining room window.

The windows require immediate attention. The high indoor humidity has caused excessive condensation on the windows. To reduce the adverse effect of condensation on the durability of the windows, the thermal performance and air tightness of the windows should be improved. Thermal performance could be improved by using double glazed storm windows. In this way the historic value of the windows would be least affected. The original storm windows can be kept in storage.

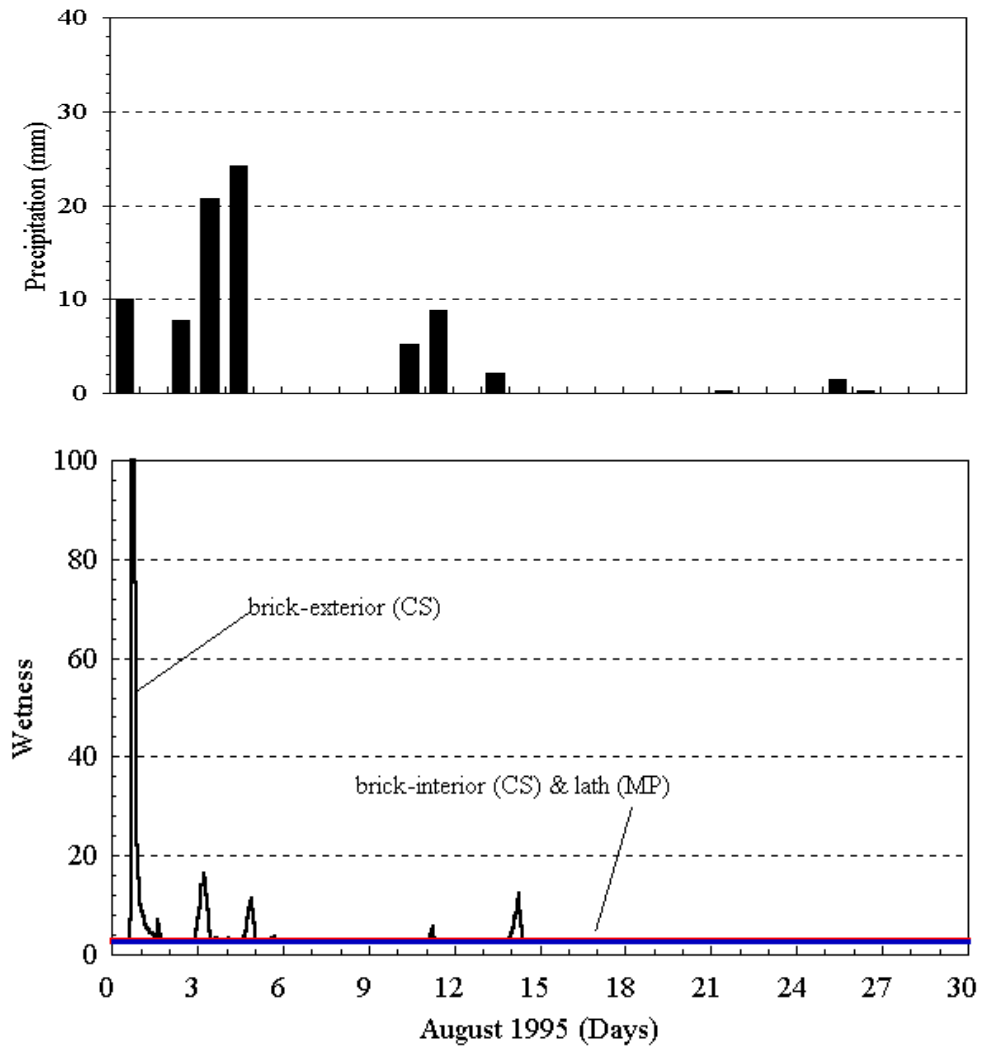
**Exterior surface:** The data from ceramic moisture sensors mounted on the exterior surfaces showed periods of wetting during precipitation (Figs. 10 and 11). They dried out within 6 to 36 hours from the onset of precipitation.

**Wall cavity and attic space:** No condensation was detected within the air spaces of the walls at the locations monitored. The surface temperature of the brick and the lath within the wall-cavities was always higher than the dew-point of the cavity air. The ceramic and moisture pin sensors within the wall cavity indicated that no wetting occurred on the masonry interior surface or the lath (Figs. 10 and 11).

Figure 10 Wetting-drying cycles during August 1995 on the west wall of Mr. King’s bedroom, 2nd floor. Wetness detected on exterior only. The scale for wetness is arbitrary. The top graph shows precipitation measured at Ottawa airport (source: Environment Canada). CS = ceramic sensor; MP = moisture pins.

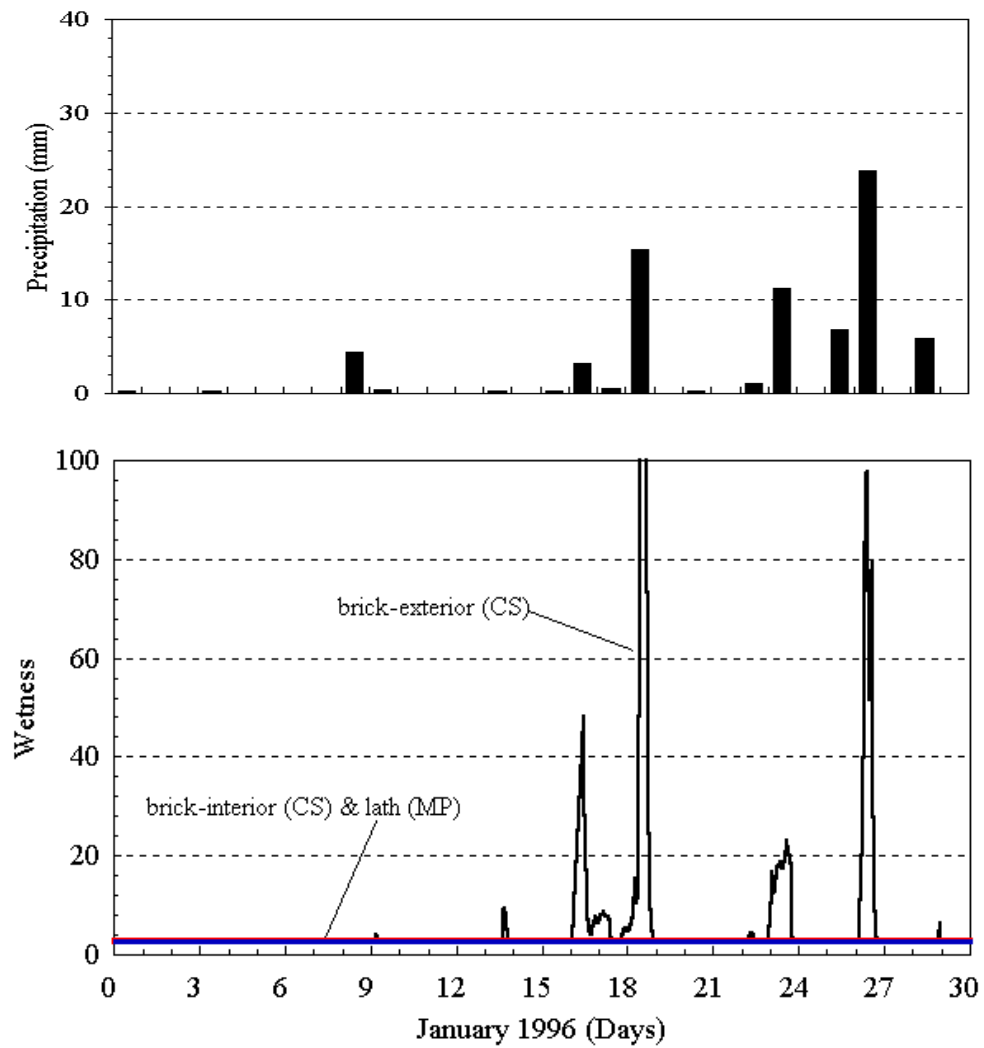
Figure 11 Wetting-drying cycles during January 1996 on the west wall of Mr. King's bedroom, 2nd floor. Wetness detected on the exterior only. The scale for wetness is arbitrary. The top graph shows precipitation measured at Ottawa airport (source: Environment Canada). CS = ceramic sensor; MP = moisture pins.
