Kysor On/Off Diagnostic Guide

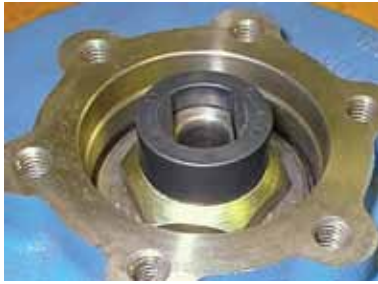
Figure 1 Pulley hub with coupler in place on shaft (Figure 1)

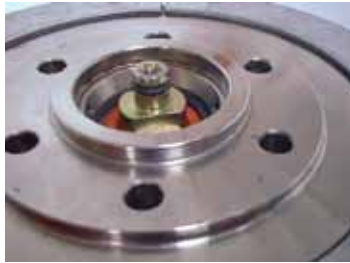
Figure 2 Clutch with rear O-ring on piston rod

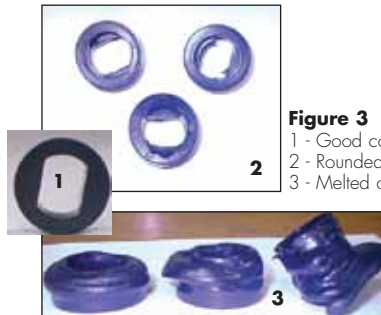
Rounded out damage to the coupler and rear O-ring failure can occur when the clutch piston rod is forced to rotate. (Figure 3-2)

Figure 3
1 - Good coupler
2 - Rounded out coupler
3 - Melted couplers

This can be caused by a clutch bearing failure or improper clutch servicing. The clutch cylinder cap must be held stationary by hand when removing the front retainer nut.

If the coupler is rounded out, the clutch ball bearings

need to be inspected carefully. The clutch should be replaced if bearings are damaged or worn.

Always replace the coupler and rear O-ring when servicing the clutch or hub.

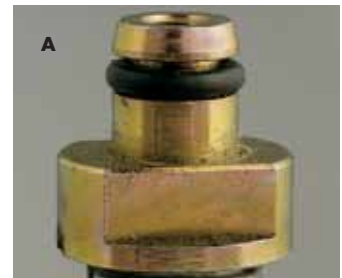
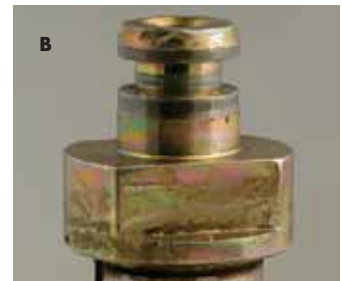
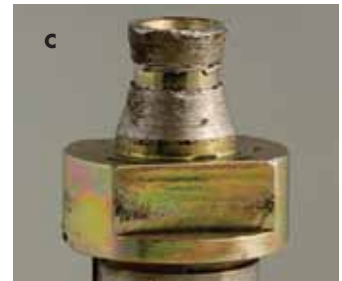
Damage to the rear of the piston rod (center shaft) and rear O-ring is usually caused by worn or damaged pulley hub bearings. This may first be noticed as an air leak at the rear of the clutch.

The rear portion of the piston rod enters into the front of the pulley hub shaft. Bearing wear or damage in the pulley hub may cause the pulley to not run true on the shaft. Bearing wear can cause damage to the rear O-ring and eventually the piston rod. (Figure 6) There should be no play in the pulley hub bearings. Check for scuffed plating on the piston rod around the O-ring area. Check for worn metal at the rear of the piston rod. If the metal is not damaged, the clutch can be reused.

Figure 6 Oring area of new piston rod (Figure A), minor damage at rear of piston rod showing scuffed plating serviceable with repair kit (Figure B), and severe damage to rear of piston rod showing worn-away metal, not serviceable. (Figure C)

Always determine and correct the cause of failure. Inspect and make any pulley hub repairs or replace the pulley hub as required if worn or damaged. Pulley hub bearing kits are available for service.
