Manual TP-0445

# Parts Failure Analysis

# Service Notes

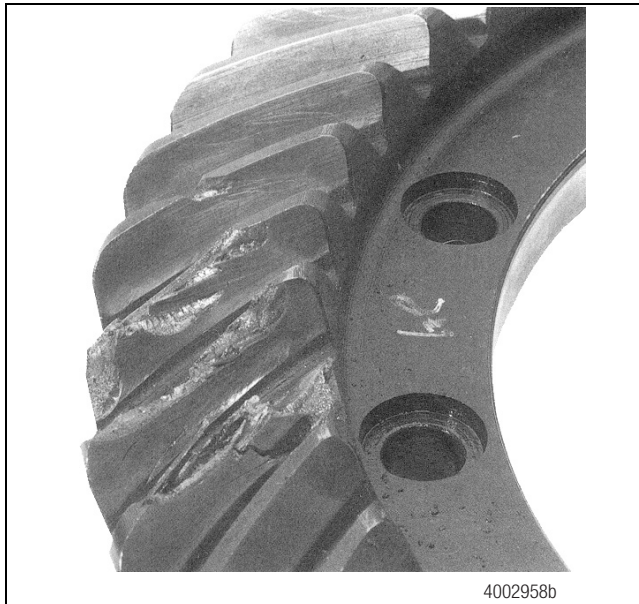
Figure 1.1

This publication provides a parts analysis process to help you determine why parts failed during operation, what to look for when you inspect parts, and how to help prevent failures from occurring again. Figure 1.1, Figure 1.2 and Figure 1.3 are examples of failed parts.

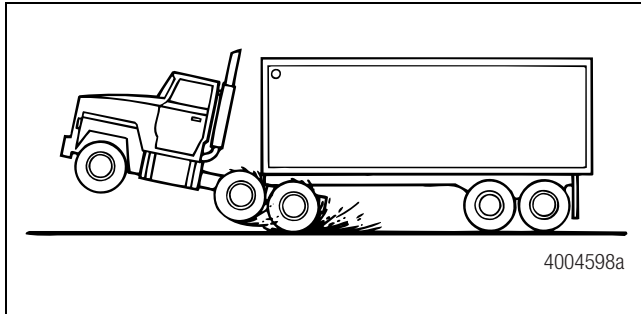
**Figure 1.4**

For example, when a driver speeds up the engine and rapidly releases the clutch (“popping the clutch”), or allows a vehicle’s spinning wheel to hit dry pavement, it causes an immediate load, or force, to the driveline. Component failure can occur immediately, or at a later time. Figure 1.4 and Figure 1.5.

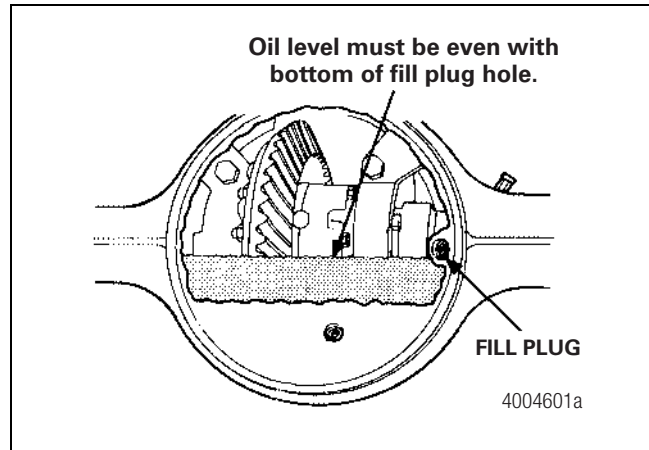
**Figure 1.6**

For example, lubricant contaminated with water, dirt or wear particles will damage the mating surfaces of components, particularly bearing surfaces. Other areas of concern are seals and breathers. Figure 1.6.

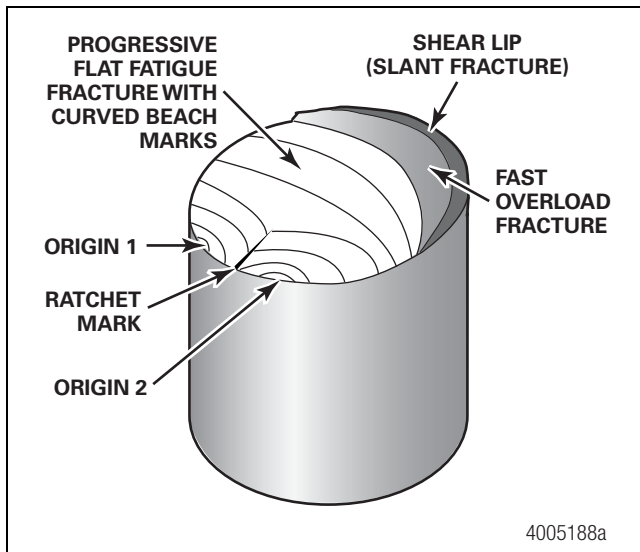
Figure 3.1

Beach marks represent fatigue cycles that occurred before the component failed completely. Visually, beach marks are often compared to the rippling effect of a stone thrown into calm water. Figure 3.1.

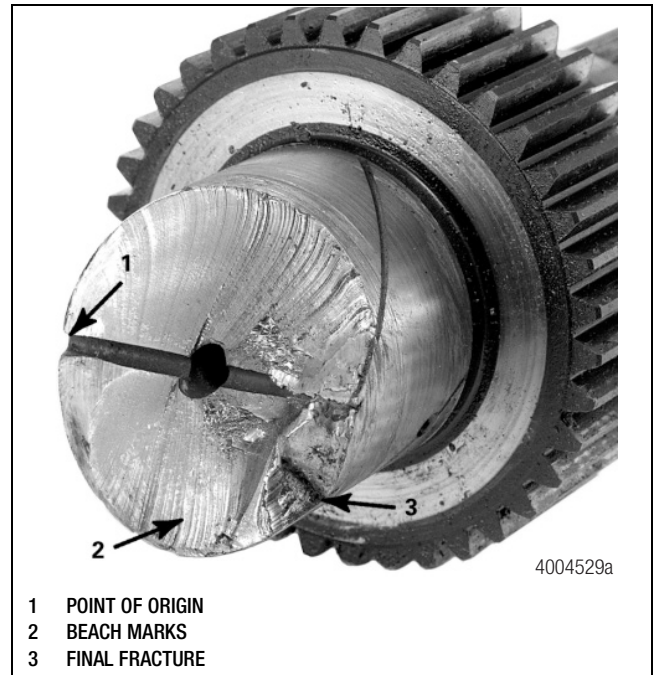
Bending is a type of fatigue fracture that occurs when a shaft is subjected to both torsional and bending fatigue at the same time. Beach marks form and usually point toward the origin of the fracture, which represents fatigue fracture cycles that occurred before the component failed completely. Figure 3.2 shows beach marks on an axle shaft that indicate it fractured as a result of bending fatigue.

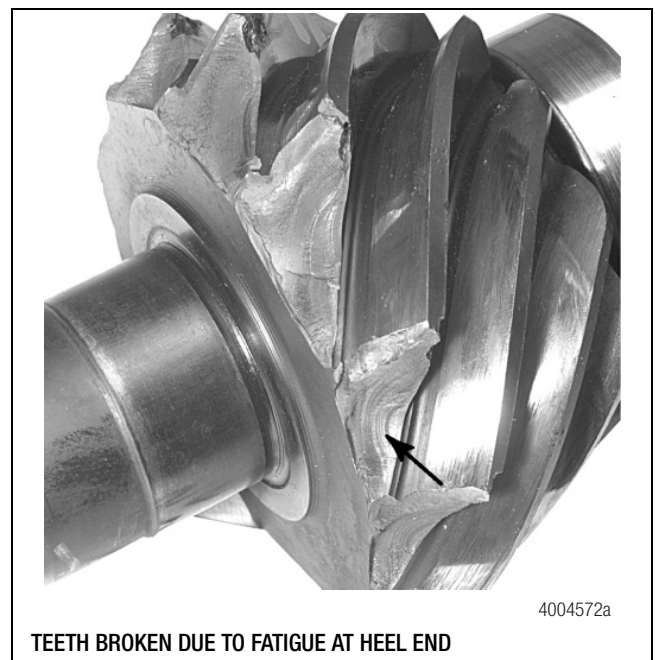
Bending fatigue also causes gears to change position, which affects tooth contact patterns. Figure 3.3 shows concentrated loading at gear teeth corners instead of over the entire surface. Figure 3.4 shows two tooth patterns on the ring gear, because bending fatigue caused the gear to change position.

TEETH BROKEN DUE TO FATIGUE AT HEEL END

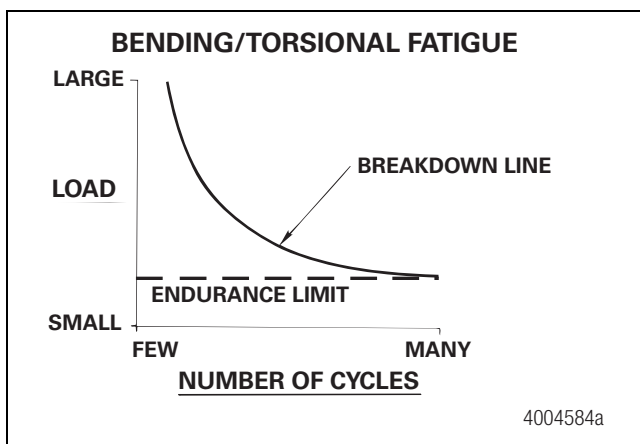
Figure 3.5 shows what happens when parts are under bending fatigue. When the load is large, failure can occur within a few load cycles. As the load becomes smaller, more load cycles are required before failure will occur. When the load becomes even smaller, the part can withstand load cycles without damage. Also refer to **Reverse Bending Fatigue** in this section.

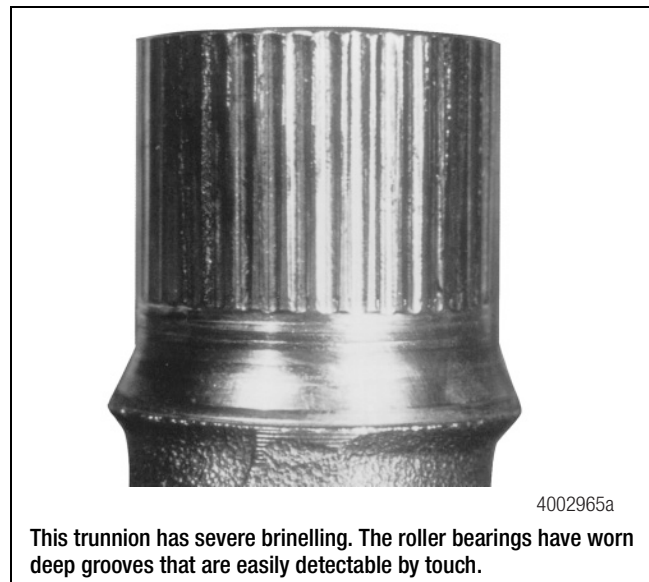
Figure 3.6

Brinelling is a type of surface fatigue that causes bearing rollers to wear deep grooves into the mating surface. Figure 3.6. Brinelling of a u-joint usually occurs when load applications exceed the vehicle's rating, which can also cause parts to spall from uneven load application.

Brinelling can also be caused by overloads on undersized u-joints and by a breakdown of lubricant between the needle rollers and trunnion. To determine if the condition you see is brinelling, check the trunnions with your fingertips. Do you feel deep grooves? If so, brinelling has occurred.

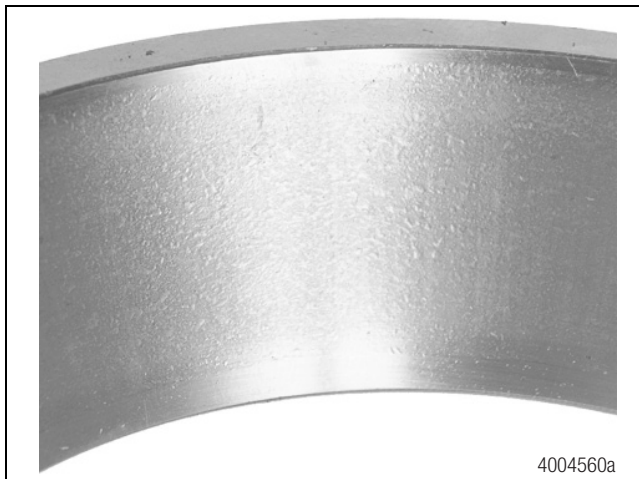
Figure 3.7

Bruising is a type of surface fatigue that's similar to brinelling, which causes dents in a metal surface. Metal chips or large particles of dirt circulate in the lubricant and become trapped between the bearing cone, cup and rollers. Figure 3.7.

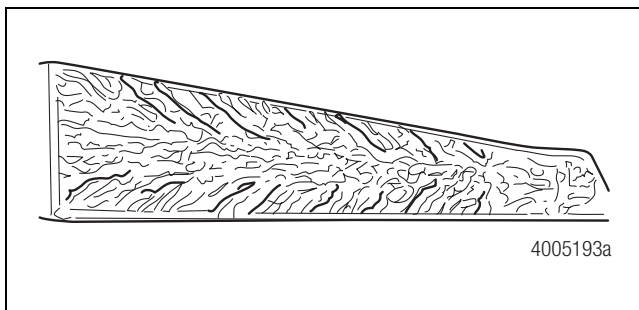
Figure 3.8

A chevron pattern contains V-shaped radial marks on a brittle fracture surface, usually on parts whose widths are considerably greater than their thickness. Also called a herringbone pattern, the points of the chevrons identify a fracture's path by pointing toward its origin. A chevron pattern is easily visible as a result of an instantaneous failure, but you can see them on some fatigue failures as well. Figure 3.8.

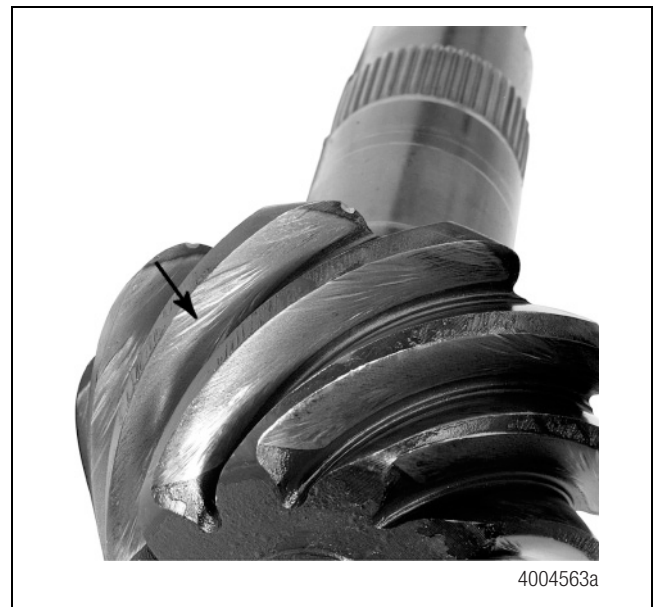
Metal-to-metal contact occurs, which causes friction to damage parts. Figure 3.9 and Figure 3.10.

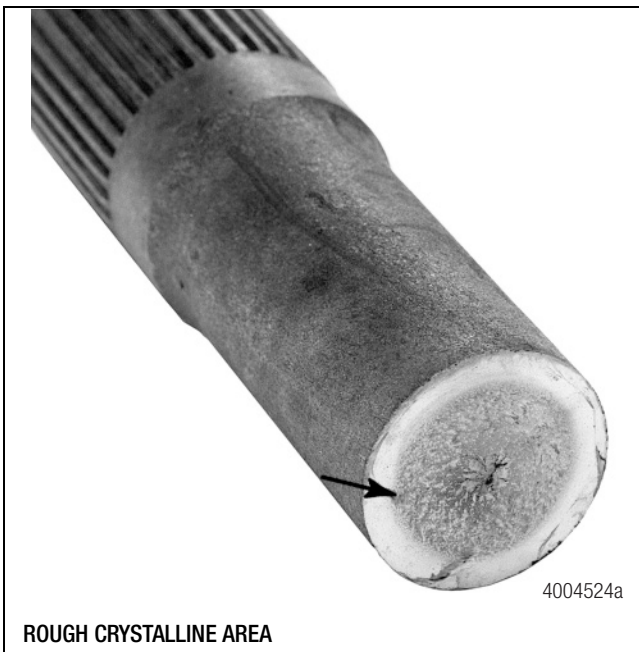
Figure 3.11

When a sudden, severe impact load occurs, the wear pattern that forms on the surface of the part resembles crystal facets. Figure 3.11.

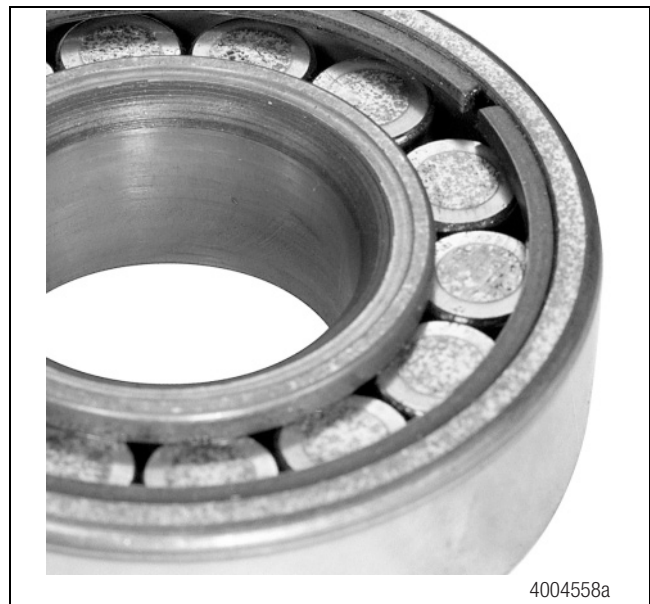
Water in lubricant damages bearing races and cups, and causes the hypoid gear set to wear prematurely. Figure 3.12 shows corrosion on the spigot bearing roller ends. Figure 3.13 shows etching damage on the bearing rollers, non-contact surfaces and bearing cage windows.

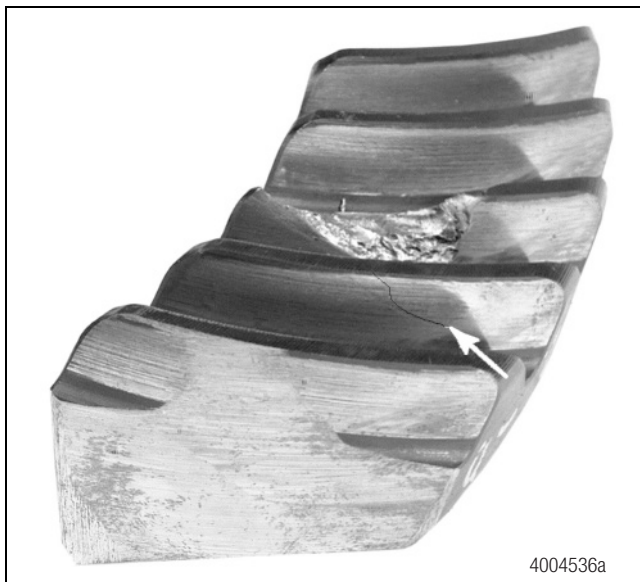
Figure 3.14

Flank cracking is a type of surface fatigue that's similar to spalling, because it causes metal to break into chips or fragments. When flank cracking occurs, initially cracks form along the length of the gear tooth. Once flank cracking appears, the tooth begins to crumble, and failure rapidly occurs. Figure 3.14.

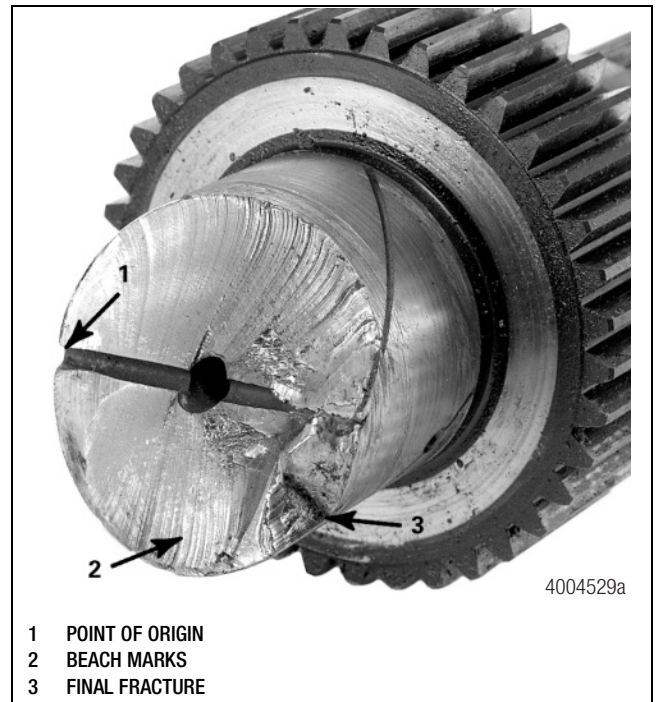
Figure 3.15

A fatigue fracture can be caused by cyclic torque overloads on a component, torsional vibration, and twisting and bending. A fracture begins at one or more points, which you can identify by the ratchet marks and subsequent beach marks that develop on the part.

In an axle assembly, a fatigue fracture is a common failure type. A typical fracture begins when a load cycle is large, and failure will occur after only a few load applications. Reducing torque load will postpone imminent failure; however, repeated load cycles will gradually weaken a component, and it will fail.

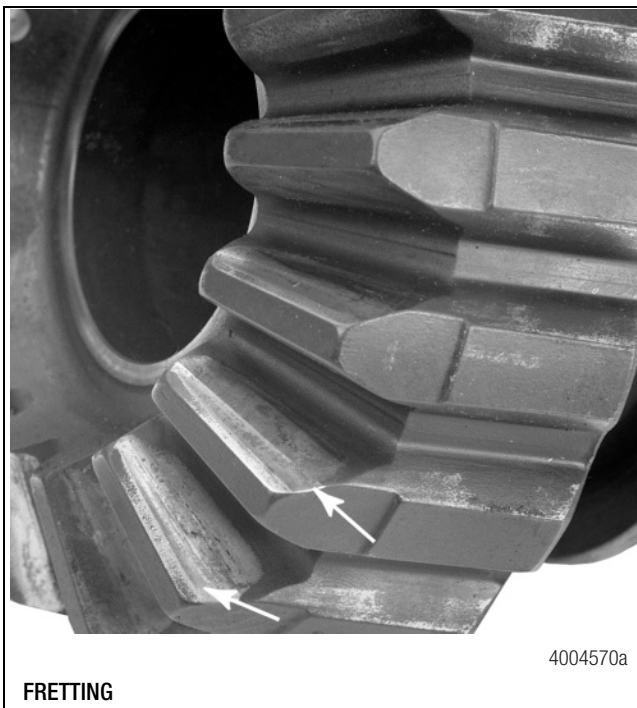
**Figure 3.16**

Inspect the back of the gear teeth on the forward drive axle carrier. If you find a contact line on the rear side of the gear teeth on the forward drive axle carrier, fretting has occurred. Figure 3.16.

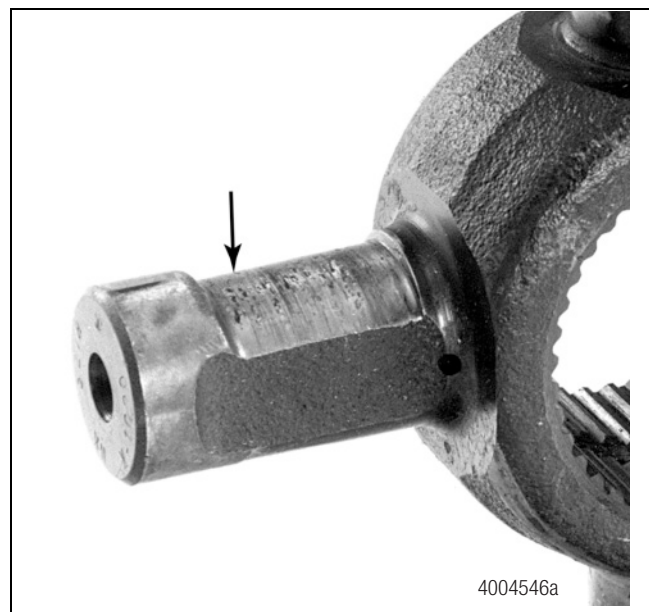
**Figure 3.17**

Galling, a type of surface fatigue that occurs when two unlubricated metal surfaces rub against each other. Galling is also called "metal transfer." Figure 3.17.

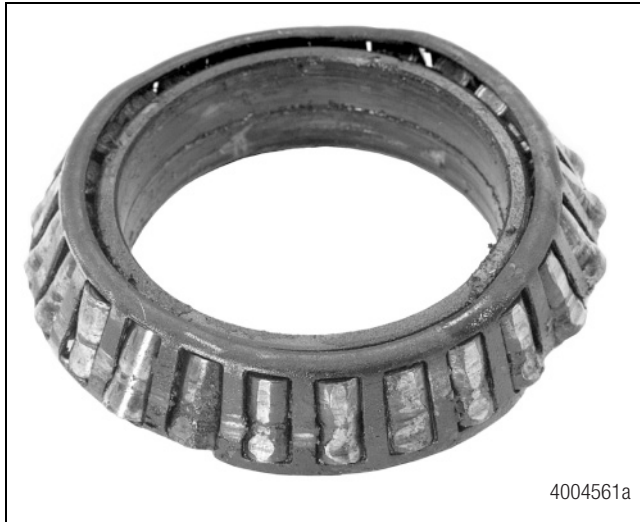
A similar type of galling is called "scuffing." Scuffing causes a bearing to wear prematurely and eventually fail. Figure 3.18 shows flat spots on the rollers and scoring on the rest of the assembly, which indicate the scuffing damage.

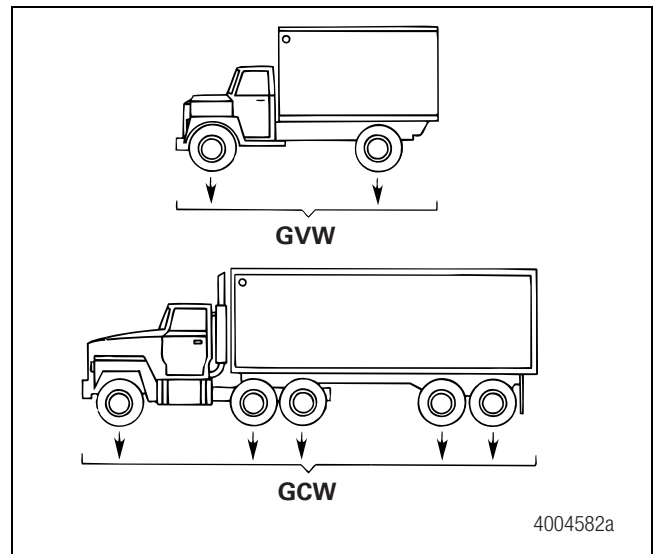
Figure 3.19

The gross vehicle weight rating (GVWR) is a vehicle's maximum allowable weight rating, which includes a vehicle's total weight, fuel, fluids and full payload. Figure 3.19.

The gross vehicle weight (GVW) is the vehicle's total weight, fuel, fluids and full payload. Figure 3.19.

The gross combined weight rating (GCWR) is a vehicle's maximum allowable load rating. GCWR includes a vehicle's total weight, fuel, driver, trailer and payload. Figure 3.19. A vehicle's GCWR typically will be higher than its GVWR, because gross vehicle weight ratings are determined by axle ratings, and a trailer has its own axles.

The gross combined weight (GCW) is a vehicle's total weight plus fuel, driver, trailer and payload. Figure 3.19.

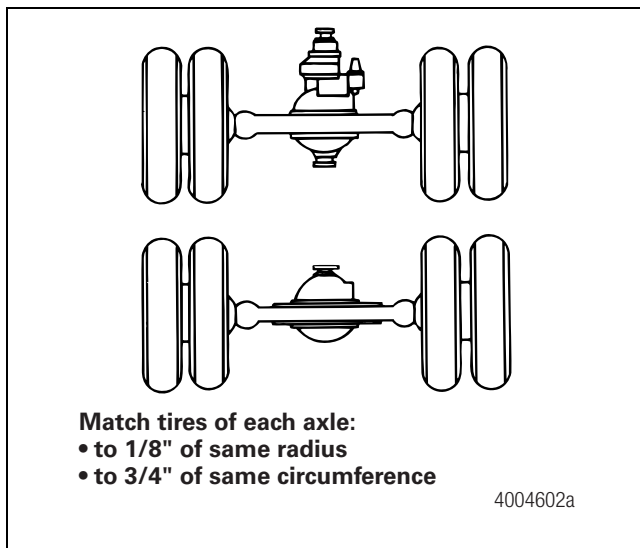
Figure 3.20

Mismatched tires can cause excessive differential component wear. Meritor recommends matching tires to within 1/8-inch (3.175 mm) of the same rolling radius and 3/4-inch (19.05 mm) of the same rolling circumference. In addition, the total tire circumference of both driving axles should be matched to each other as closely as possible. Figure 3.20.

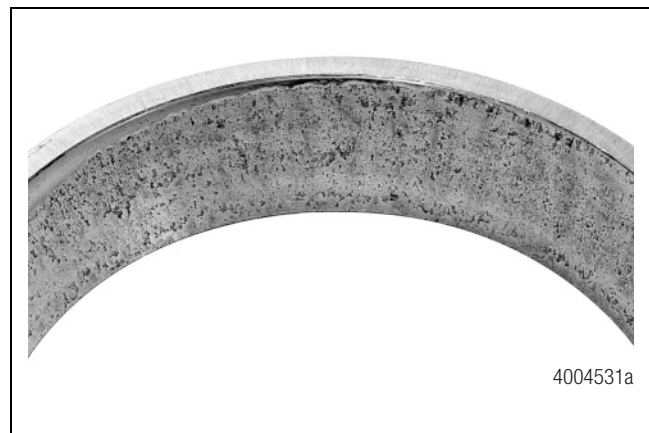
Figure 3.21

Cyclic overloading and contaminated lubricant can damage bearing cups and rollers, and hypoid gearing. Localized pitting on drive pinion teeth can sometimes indicate that another axle component is operating out-of-position. Figure 3.21.

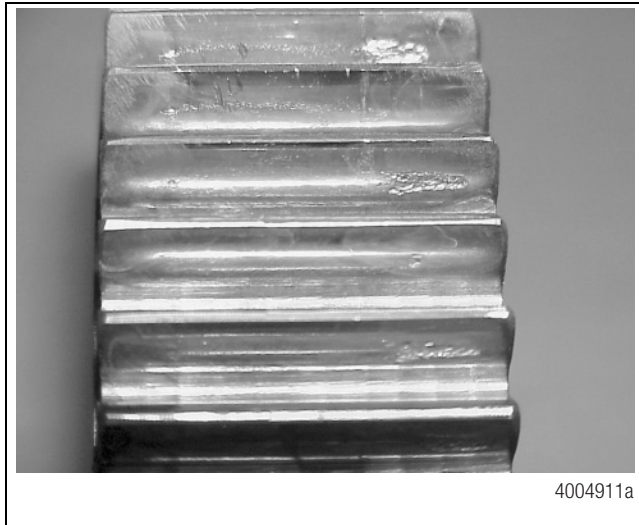
Figure 3.22

Light or moderate pitting is a normal wear condition on transmission spur gear teeth that doesn't affect performance or gear life. As the gear continues to operate, sliding friction eventually removes pitting. However, heavy or deep pitting requires gear set replacement. Figure 3.22.

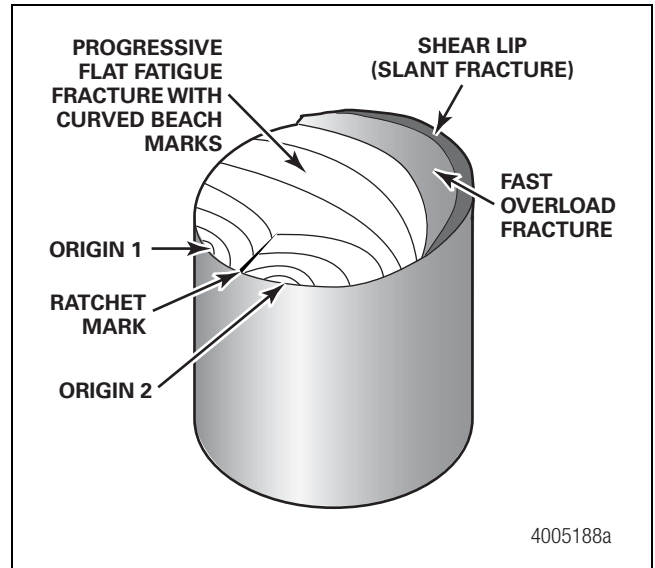
Figure 3.23

When more than one fatigue fracture occurs, beach marks form and create a raised, rough "ridge" between the origins of the fractures. This ridge is called a "ratchet mark." In this figure, you can see the ratchet mark between the first fracture, (Origin 1), and the second fracture, (Origin 2). Figure 3.23.

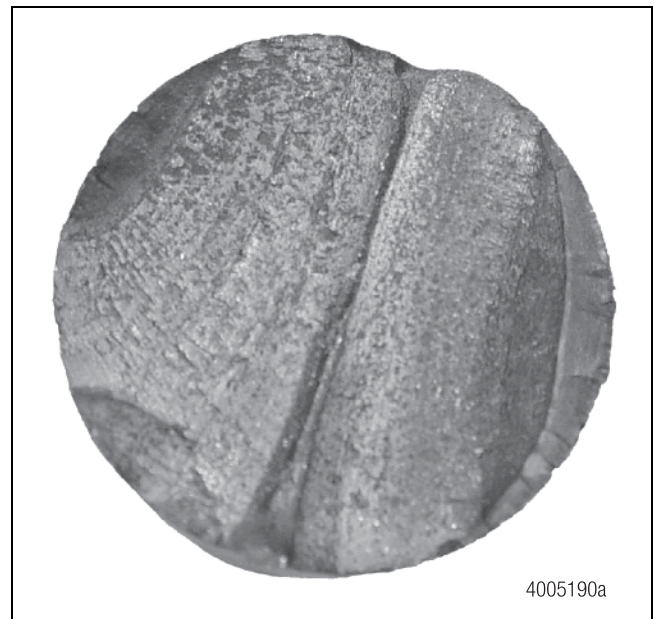
Figure 3.24

Reverse bending is a type of fatigue that breaks a component in two directions, 180 degrees apart. Beach marks occur on each side of the fractured area and move toward the center of the component. Figure 3.24.

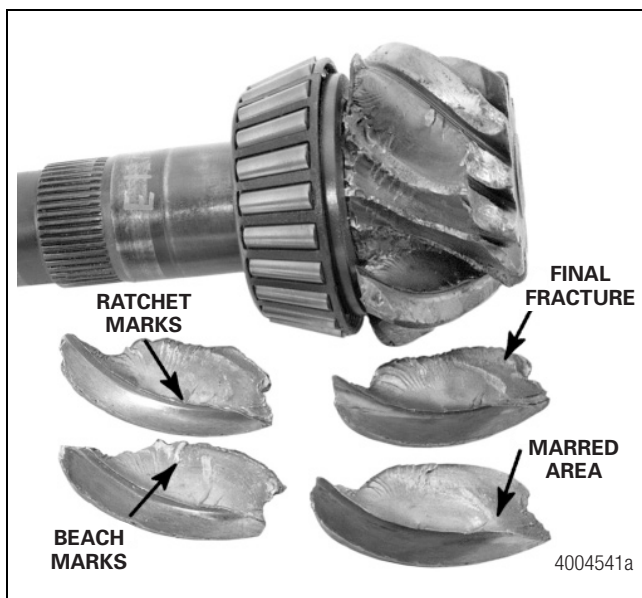
Figure 3.25 shows a less common root beam fatigue fracture that occurred when shock load was strong enough to crack the tooth, but not to break the entire tooth.

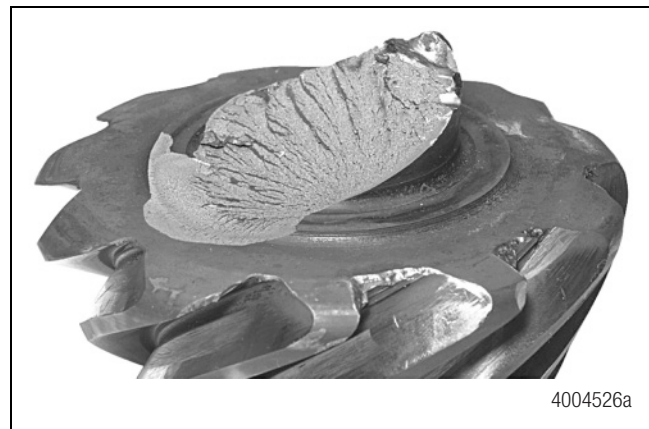
Figure 3.26 shows a pinion gear damaged by shock load. The fracture has a rough, crystalline appearance and is broken at a 45-degree angle.

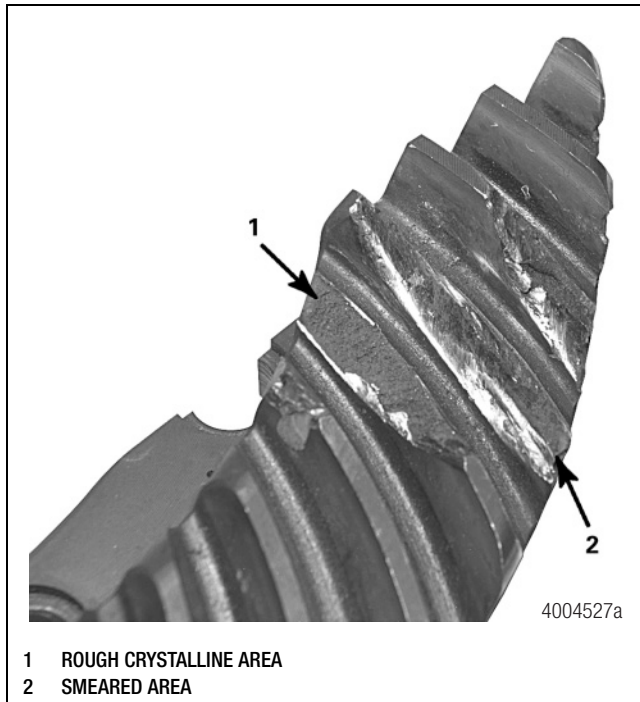
Figure 3.27 shows a hypoid gear seat damaged by shock load. Typically, the first tooth breaks at the heel, the second tooth breaks completely, and the third tooth breaks at the toe. The figure shows how two of the teeth were damaged by the pinion rubbing against the area where the teeth broke.

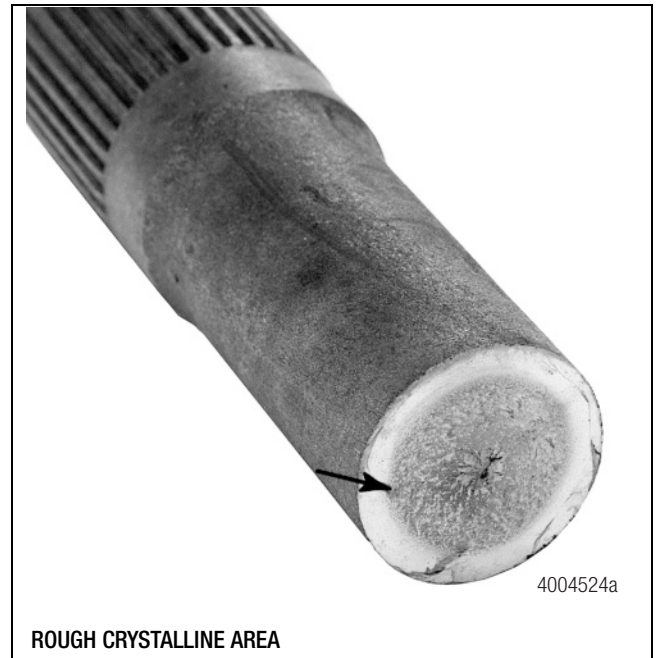
Figure 3.28 and Figure 3.29 show an axle shaft damaged by shock load that fractured perpendicular to its centerline, which caused a rough, crystalline surface to form on the shaft. This type of failure is also called "torsional shear." If the fracture is at a 45-degree angle to the centerline, the damage is called "torsional tensile" failure.

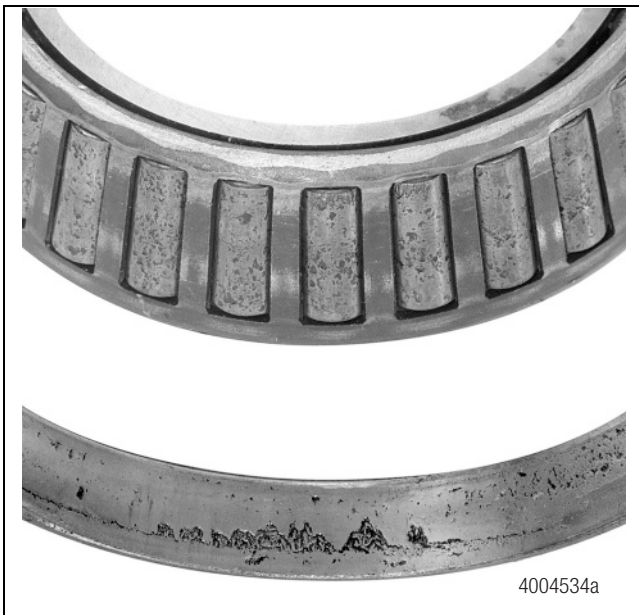
Some causes of spalling are prolonged stress from excessive load applications; or the components operate with no lubricant or a lubricant that doesn't meet the correct specification. Spalling can also occur when components are operated beyond the maximum mileage range. Figure 3.30 and Figure 3.31.

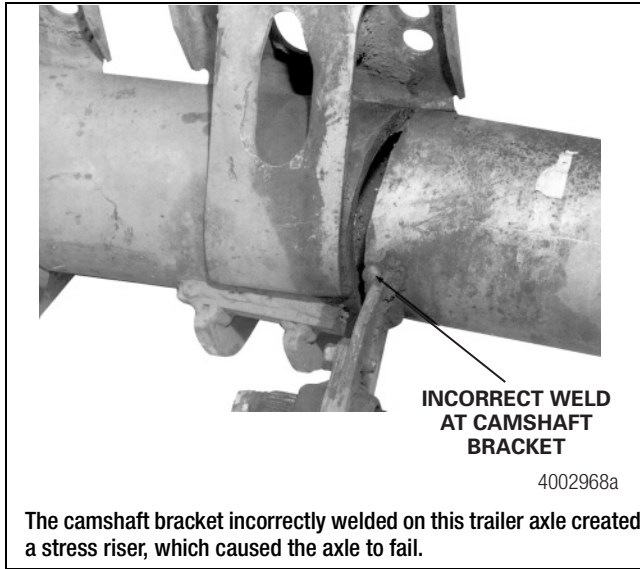
Figure 3.32

A stress riser is a condition caused by fatigue that deforms metal on a component's surface. For example, welding on an axle creates intense heat that changes the characteristics of the metal that surrounds the weld, and an incorrect weld caused fatigue to occur. In Figure 3.32, you can see that fatigue had created a stress riser, which caused the axle to fail.

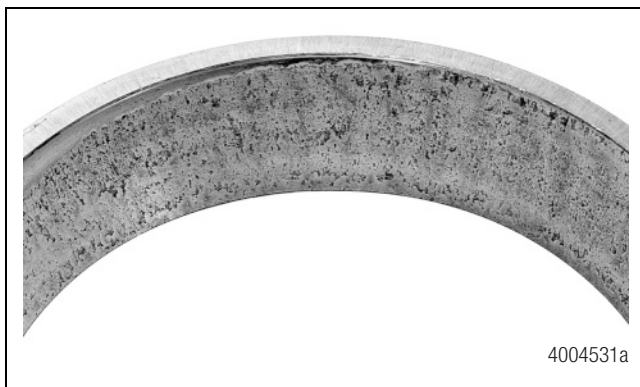
Surface fatigue is usually caused by cyclic overloading on bearings or gear teeth, and contaminated lubricant can accelerate surface fatigue. Figure 3.33 and Figure 3.34.

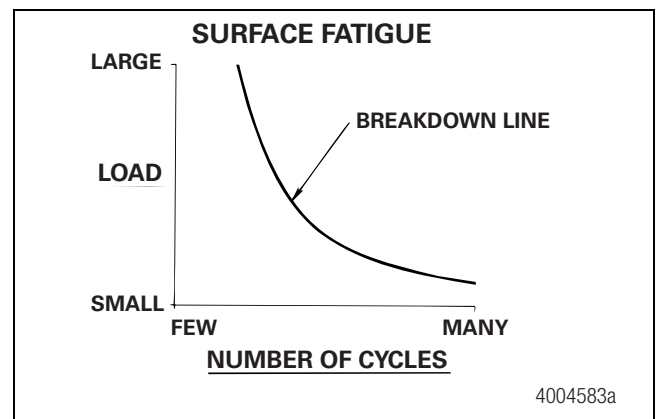
Figure 3.35

When the surface (contact) fatigue load is large, failure can occur within only a few load cycles, as shown by the breakdown line in Figure 3.35. As the load becomes smaller, the number of cycles required for the part to fail increases. However, even smaller load cycles eventually will result in a surface fatigue failure. The fatigue characteristics of bearings subject to surface loads also follow the breakdown line.

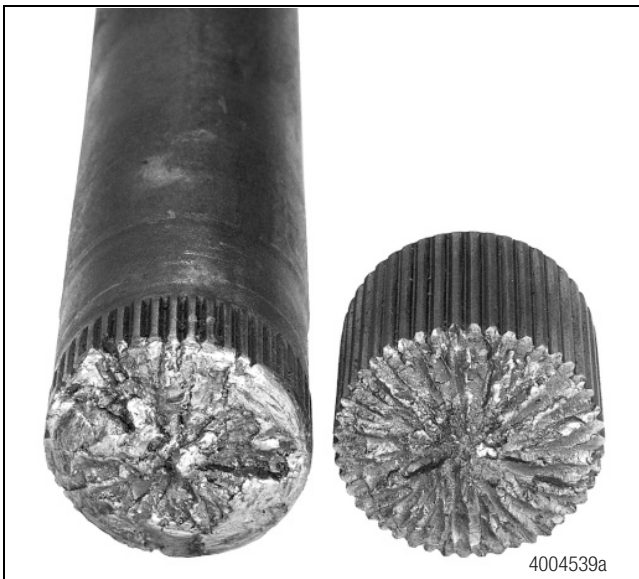
**Figure 3.36**

Unlike bending fatigue, torsional fatigue causes excessive twisting that weakens components. Usually, you'll see beach marks and ratchet marks at the fracture's origin point. However, if torsional fatigue occurs on a splined shaft, you'll see that the fracture started at the base of each spline. Figure 3.36 shows a drive shaft damaged by torsional fatigue. As the splines continued to weaken, the metal formed a star-shaped radial pattern, eventually breaking the shaft at the center.

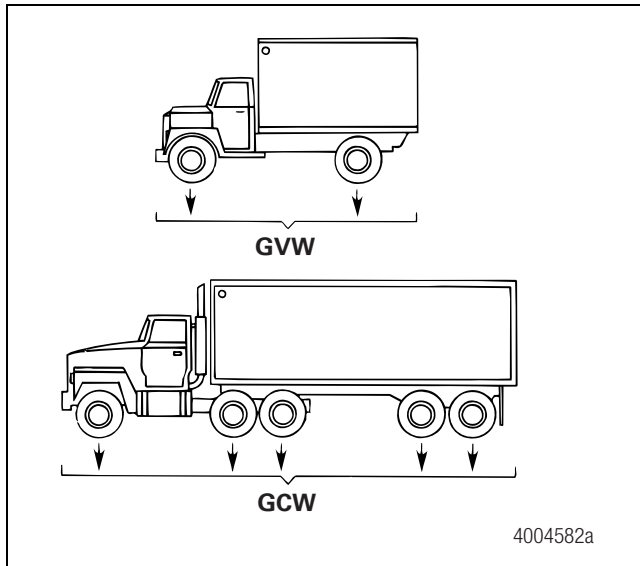
Figure 4.1

Axles operated under conditions that exceed their design capacity can wear prematurely. Fatigue, which can result from load cycles that exceed a carrier's gross vehicle weight rating (GVWR) or gross combined weight rating (GCWR), can cause an axle to fail.

Figure 4.1.

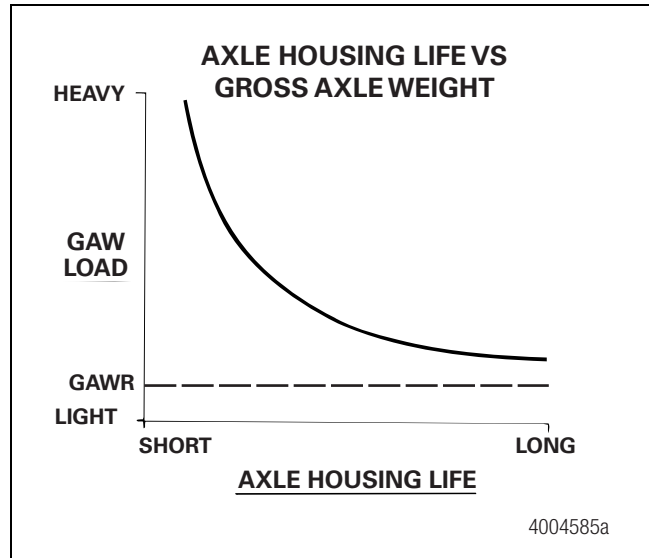
Figure 4.2

Operating a vehicle at a weight that exceeds a carrier's gross axle weight rating (GAWR) will damage components, because a carrier is rated for a specific application. For example, if a vehicle is operated on an unapproved road surface for the application, rolling resistance increases, and more torque is required to move the vehicle forward. Over a period of time, torque overload occurs and damages components. Figure 4.2.

Operational overload is a main cause of axle housing damage, which occurs when the vehicle is loaded in excess of its GAWR. When GAW increases, axle housing life decreases.

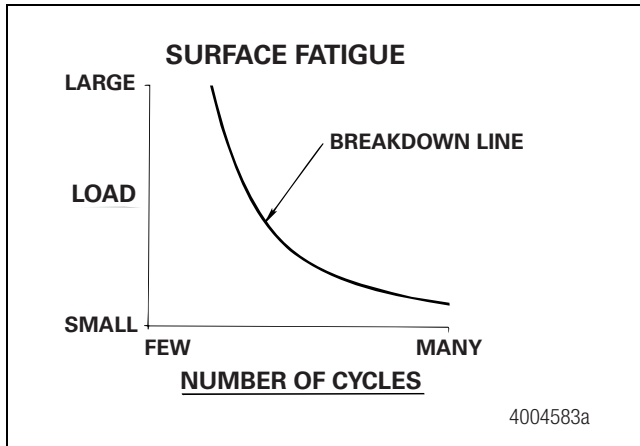
Figure 4.3

When the surface (contact) fatigue load is large, failure can occur within only a few load cycles, as shown by the breakdown line in Figure 4.3. As the load becomes smaller, the number of cycles required to destroy the part increases.

However, smaller load cycles will eventually result in a surface fatigue failure. The fatigue characteristics of bearings subject to surface loads also follow the breakdown line. Figure 4.3.

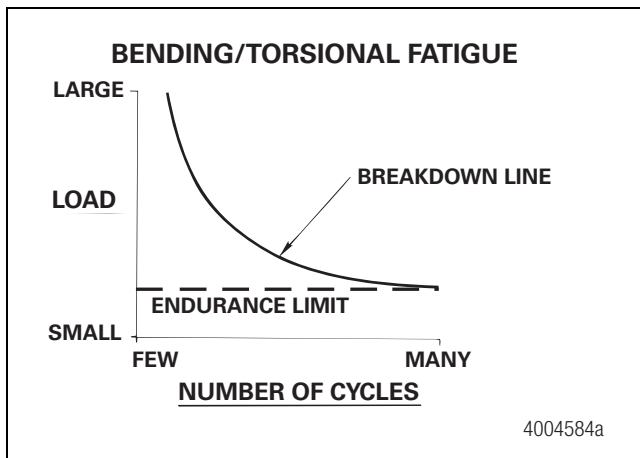
Figure 4.4 shows what happens when parts are under bending or torsional fatigue. When the load is large, failure can occur within a few load cycles. When the load becomes even smaller, the part can withstand load cycles without damage.

Gears are subjected to both bending and surface loads. Surface fatigue affects lightly loaded gears. As the load increases, damage is caused by bending fatigue.

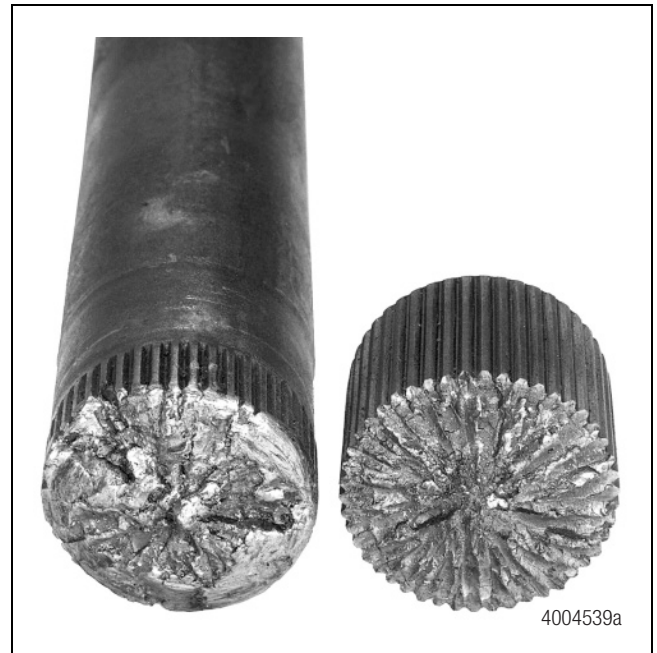
Figure 4.5 shows a shaft damaged by torsional fatigue. As the splines continued to weaken, the metal formed a star-shaped radial pattern, eventually breaking the shaft at the center.

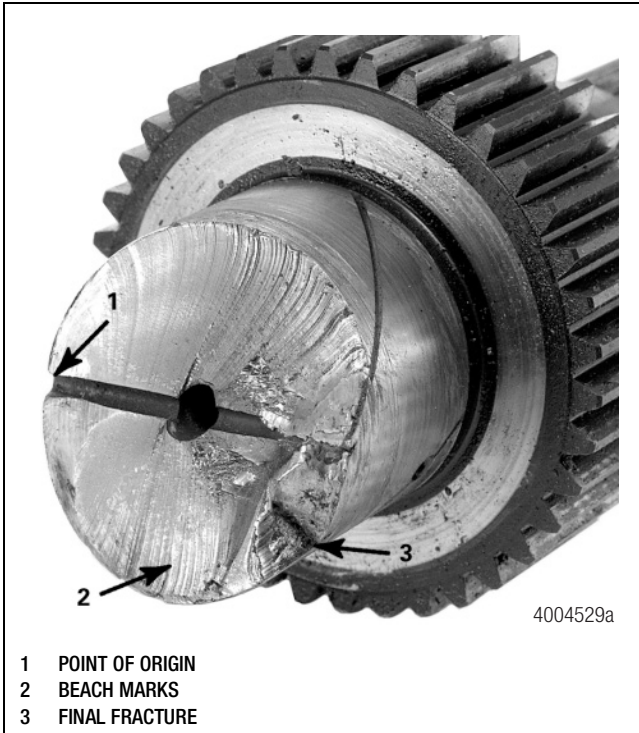
Bending is a type of fatigue fracture that occurs when a shaft is subjected to both torsional and bending fatigue at the same time. Beach marks form and usually point toward the origin of the fracture, which represents fatigue fracture cycles that occurred before the component failed completely. Figure 4.6 shows beach marks on an axle shaft that indicate bending fatigue caused the fracture.

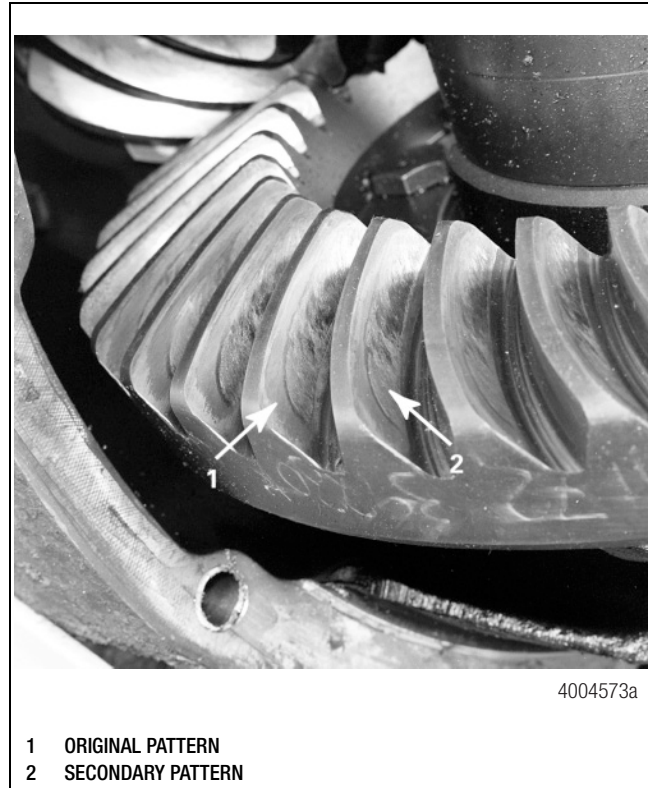
Bending fatigue also causes gears to change position, which affects tooth contact patterns. Figure 4.7 shows concentrated loading at gear teeth corners instead of over the entire surface. Figure 4.8 shows two tooth patterns on the ring gear, because bending fatigue caused the gear to change position.

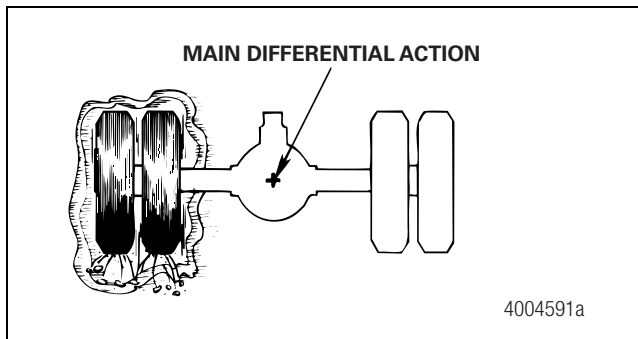
During spinout, the differential pinions turn at almost twice the speed of the drive shaft, which causes the pinions to be insufficiently lubricated. Heat created from friction between the differential pinion gears and cross legs can damage the axle. Figure 4.10 and Figure 4.11.

In axles without an oil pump, centrifugal force displaces all of the oil between the cross and pinions, and heat created by friction causes these parts to seize. Sometimes differential pinions become so hot, they weld to the mating surfaces of the differential assembly.

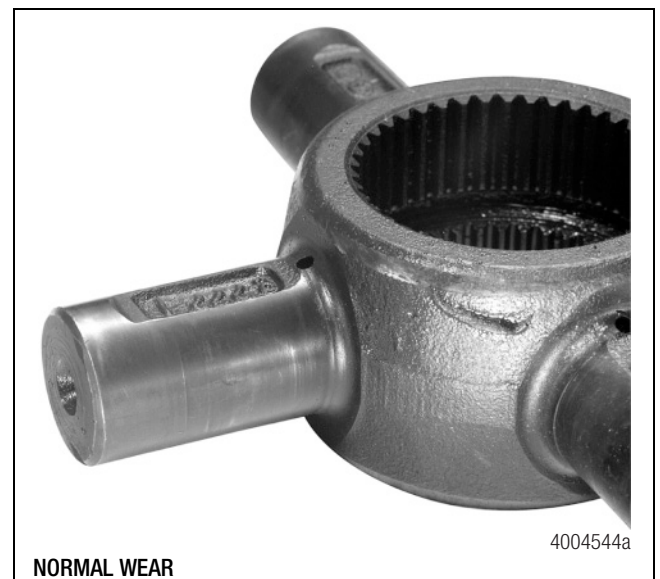
Figure 4.12

Figure 4.12, Figure 4.13, Figure 4.14, Figure 4.15 and Figure 4.16 show how spinout caused a pinion cross to fail. Damage progresses from normal wear, to moderate premature wear, and then to heavy wear; and finally, the pinion cross fails.

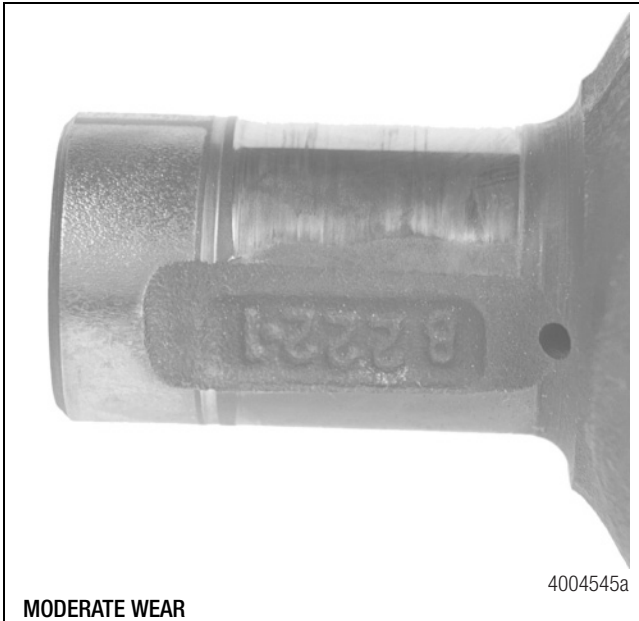
Figure 4.13

MODERATE WEAR

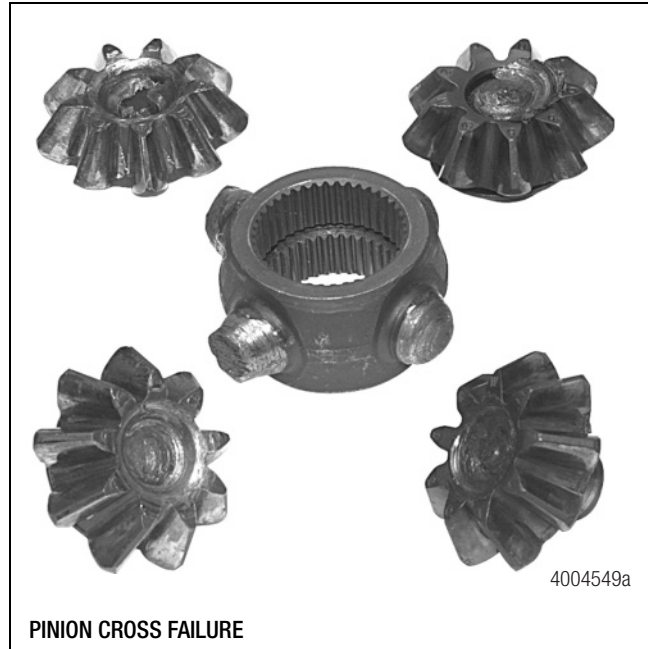
Figure 4.15

PINION CROSS FAILURE

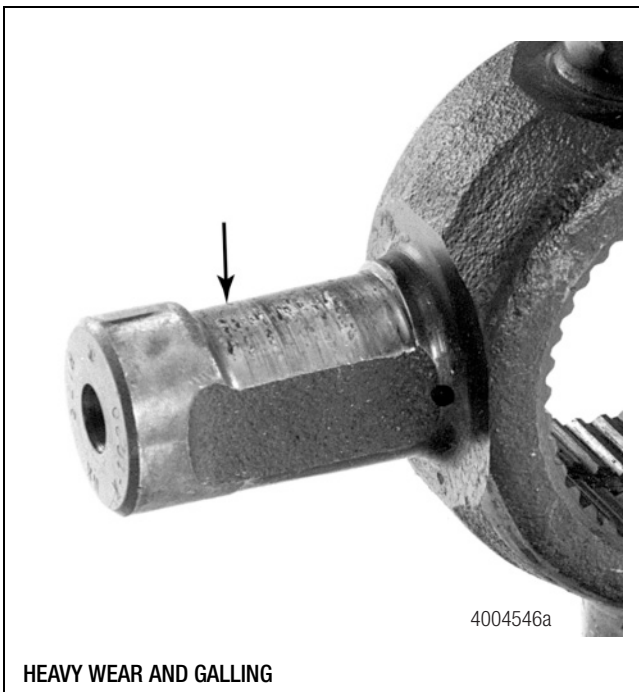
HEAVY WEAR AND GALLING

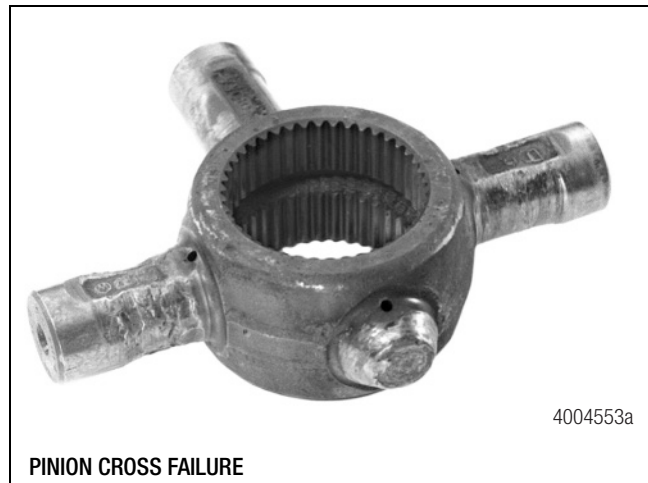
Figure 4.16

PINION CROSS FAILURE

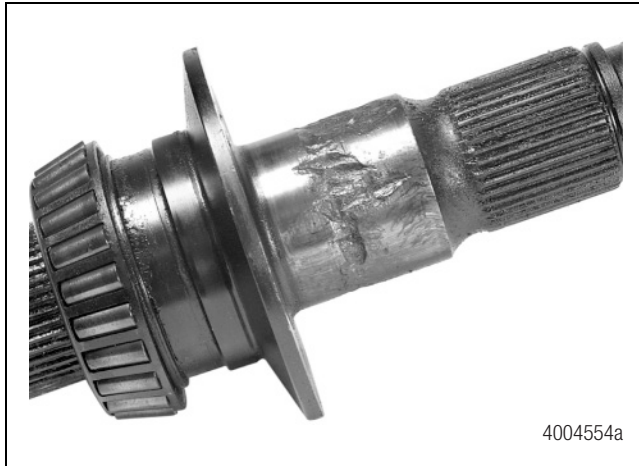
Figure 4.17

Friction from spinout can cause galling at the helical gear journal and the rear side gear journal. Figure 4.17. If spinout damaged the rear side gear, perform this inspection.

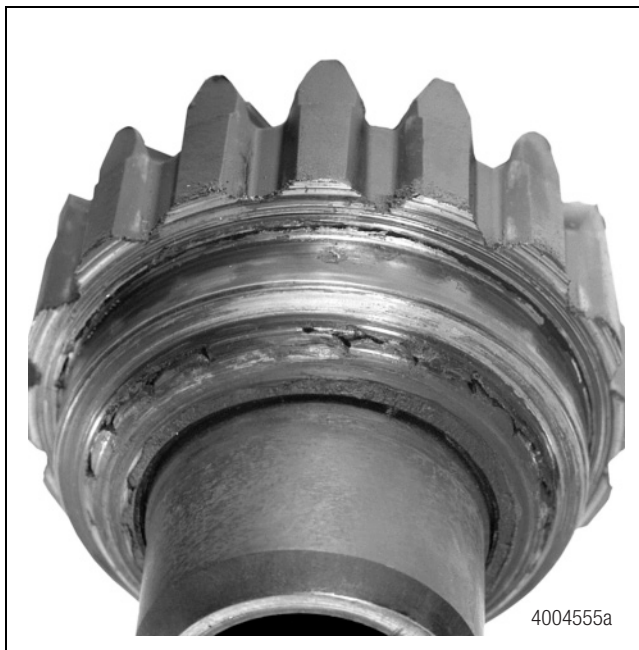
Figure 4.18 shows a rear side gear that's been damaged by spinout. If the rear side gear bearing fails, you'll find signs of overheating on the outside of the carrier.

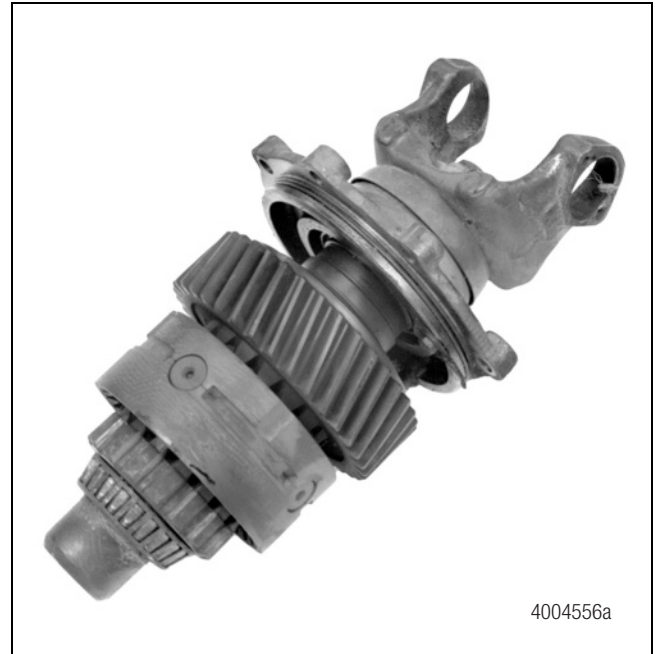
Figure 4.19

Spinout also caused the rear side gear to weld to the input shaft, and the bearing is scored. This damage resulted from a spinning rear wheel and a stationary forward axle, which prevented the forward gear set from lubricating the rear side gear. Look for localized heat damage and burned lubricant. Figure 4.19.

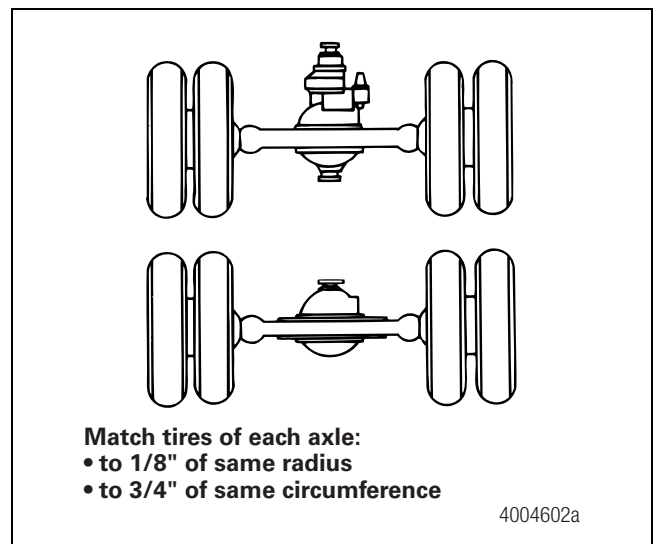
Figure 4.20

Mismatched tire ratios can cause spinout to occur. Meritor recommends matching tires to within 1/8-inch (3.175 mm) of the same rolling radius and 3/4-inch (19.05 mm) of the same rolling circumference. In addition, the total tire circumference of both driving axes should be matched to each other as closely as possible. Figure 4.20.

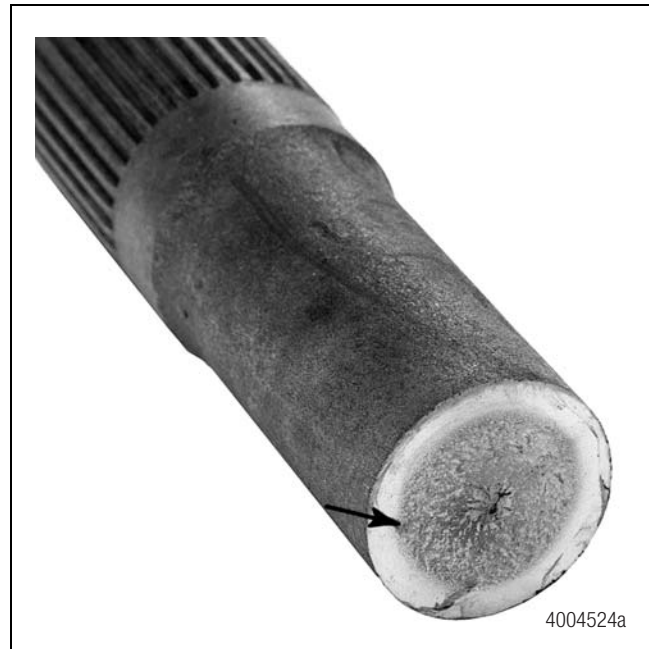
**Figure 4.21**

Shock load is a sudden and powerful force applied against a component. Shock load can destroy or damage a component immediately. Often, however, a component damaged by shock load will continue to operate, but it will wear prematurely or fail soon after the initial shock load occurred. Shock load causes components to crack and separate from each other. Look for a rough, crystalline finish on the separated parts. Figure 4.21 shows an axle shaft damaged by shock load.
