Manual TP-0445

# Parts Failure Analysis

# Service Notes

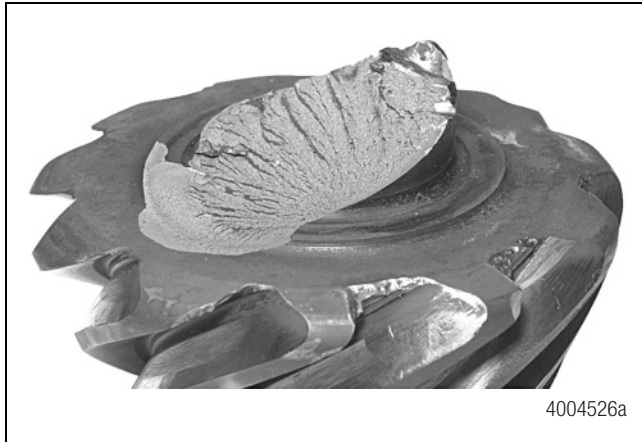
Figure 4.22 shows a pinion gear damaged by shock load. The fracture has a rough, crystalline appearance and is broken at a 45-degree angle.

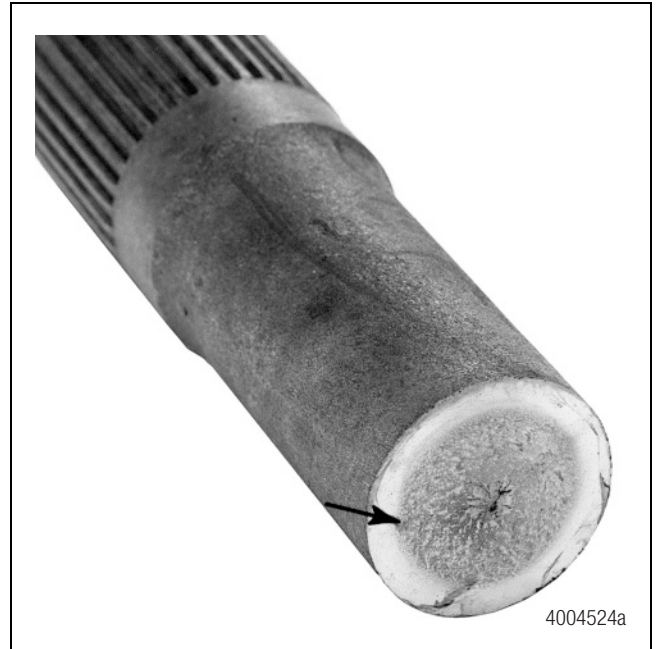
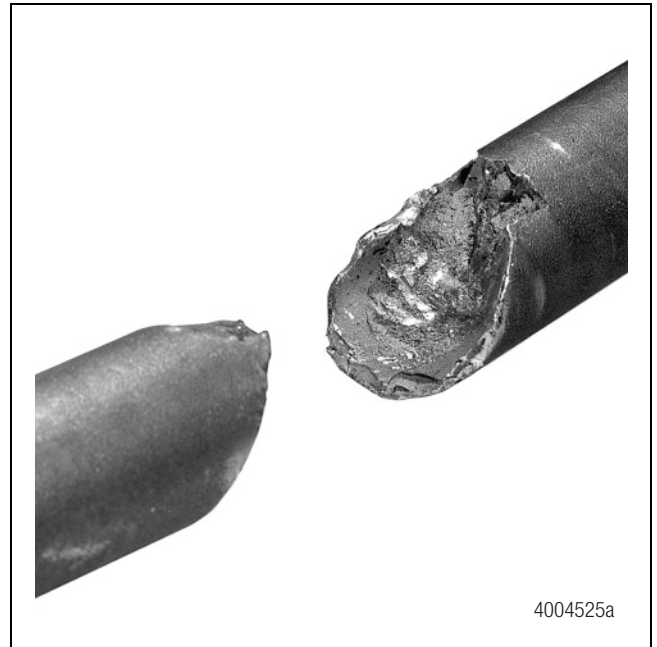
Figure 4.24 and Figure 4.25 show an axle shaft damaged by shock load that fractured perpendicular to its centerline, which caused a rough, crystalline surface to form on the shaft. This type of failure is also called "torsional shear." If the fracture is at a 45-degree angle to the centerline, the damage is called "torsional tensile" failure.

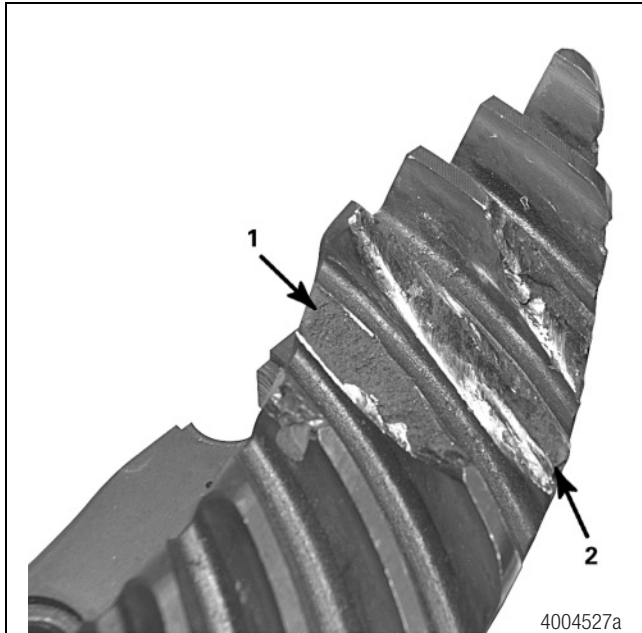
Figure 4.23 shows a hypoid gear set damaged by shock load. Typically, the first tooth breaks at the heel, the second tooth breaks completely, and the third tooth breaks at the toe. The figure shows how two of the teeth were damaged by the pinion rubbing against the area where the teeth broke.

- 1 ROUGH CRYSTALLINE AREA
- 2 SMEARED AREA

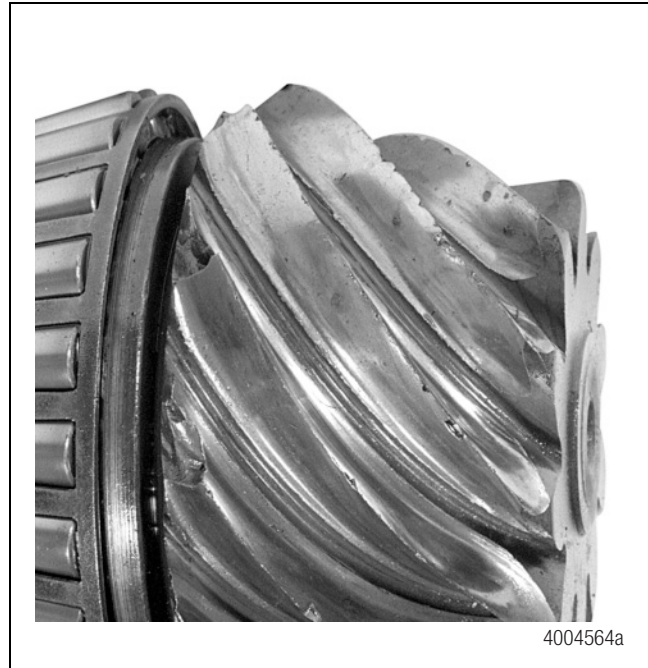
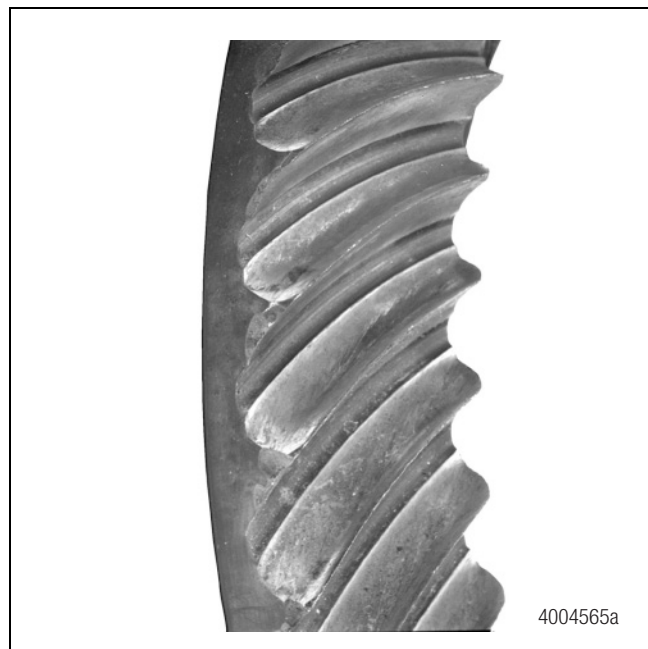
Installing a lubricant without EP additives causes hypoid gear teeth to wear to a thin edge. If detected early, you'll see that a crow's footing pattern formed on the gear teeth. Figure 4.26 and Figure 4.27.

Also, EP additives will deplete when a carrier overheats. For example, the EP additive in drive axle lubricant begins to deplete when the carrier's temperature is consistently above 250°F (121°C). The higher the temperature, the faster the additive depletes. Crow's footing, a result of overheating, causes lines and ridges to appear lengthwise on hypoid and amboid bevel gear teeth.

A lubricant that doesn't meet Meritor's specifications will cause components to wear prematurely. Meritor axles require lubricants to contain a GL-5 level of EP additives, which protect heavily-loaded parts to help prevent surface fatigue, scoring, galling and welding of moving parts.

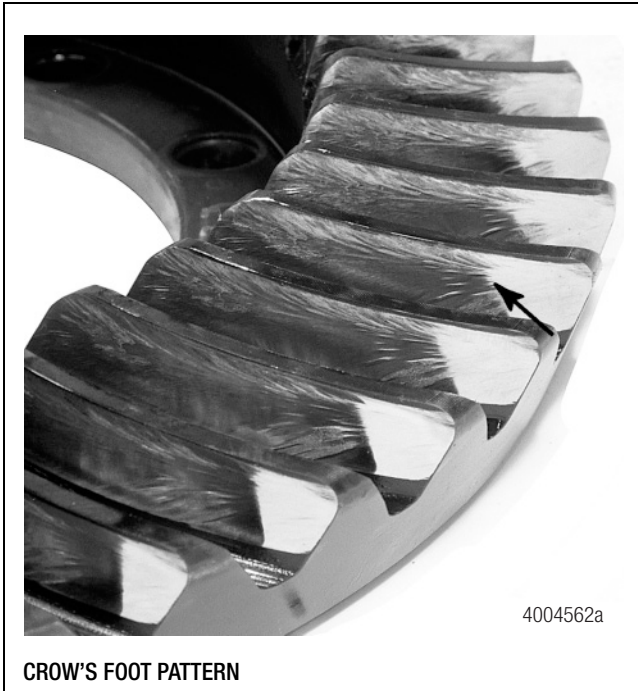
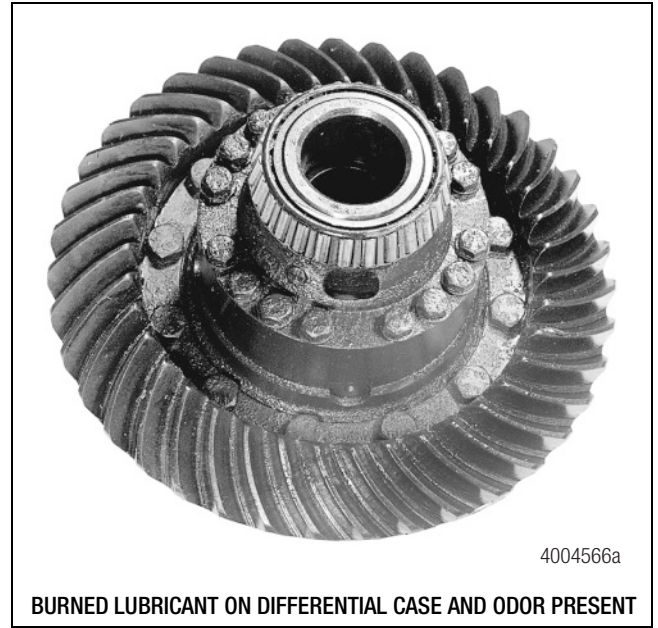
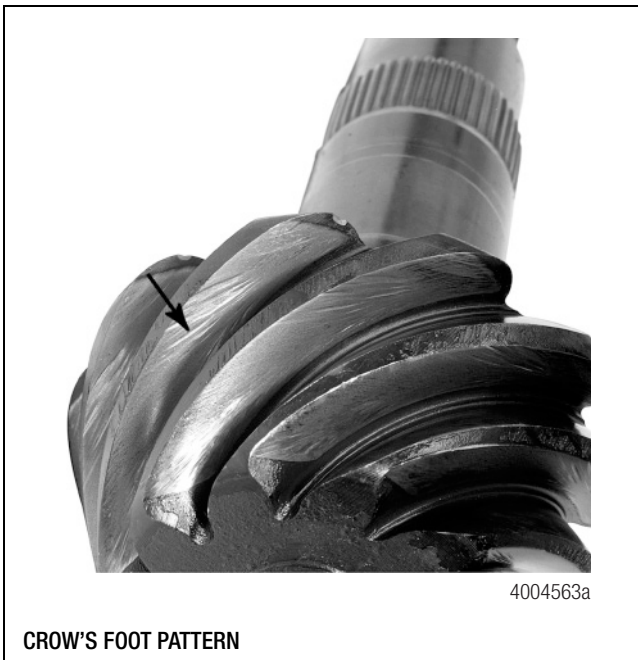
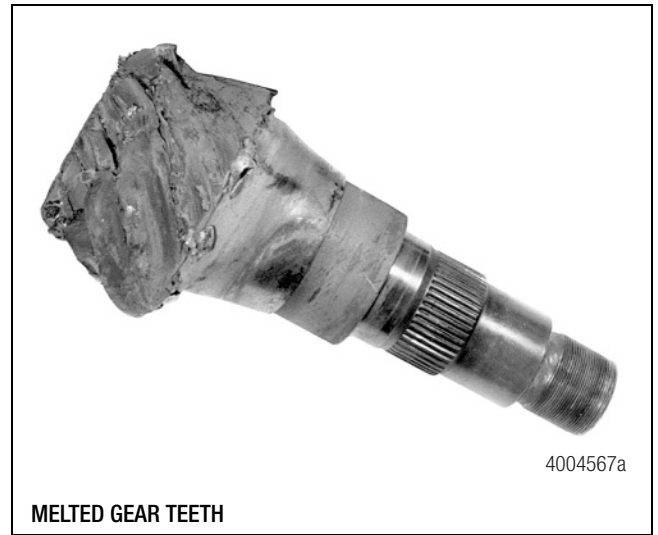
Figure 4.28, Figure 4.29, Figure 4.30 and Figure 4.31 show drive axle components damaged by burned lubricant and melted gear teeth.

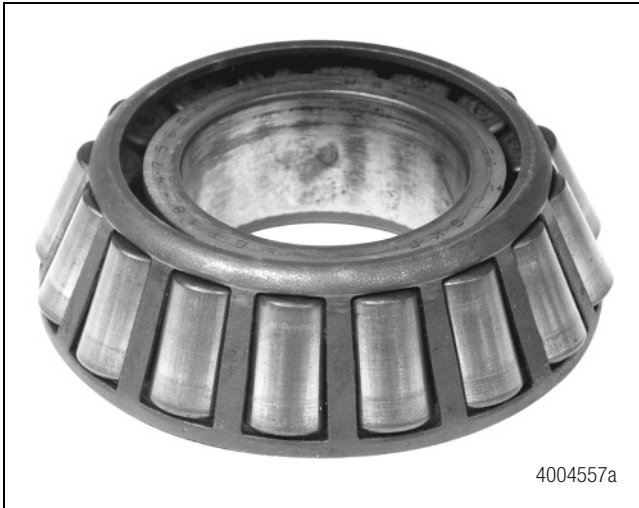
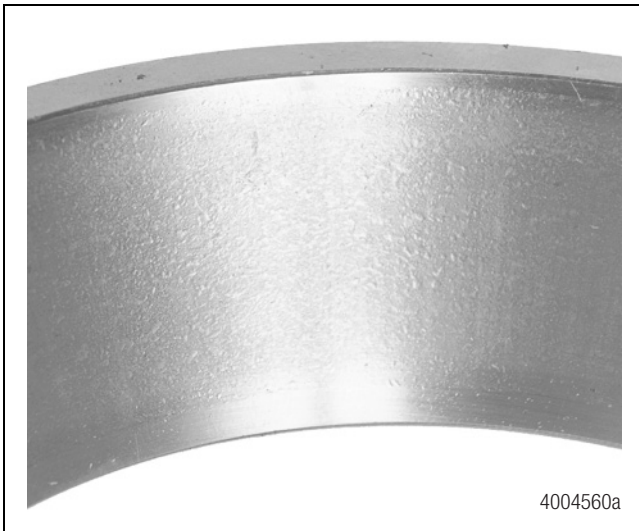
Lubricant contaminated with water, dirt or wear particles will damage the mating surfaces of components, particularly bearing surfaces. Figure 4.32 and Figure 4.33. Other areas of concern are seals and breathers.

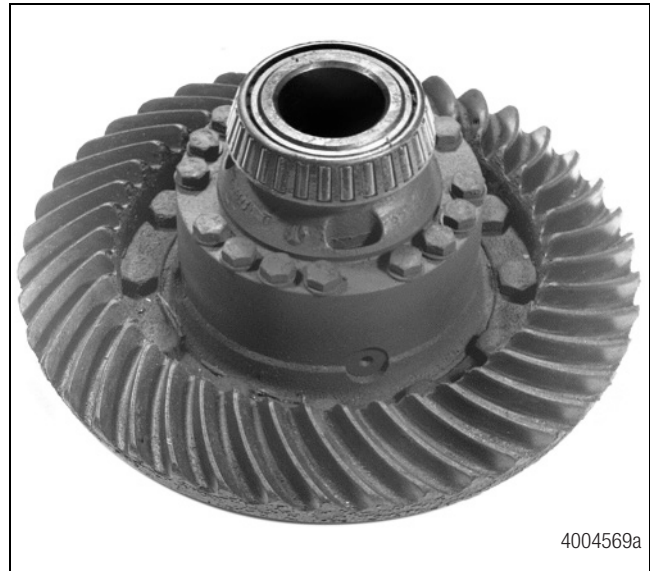
Figure 4.34

If a vehicle was insufficiently lubricated, damage can occur shortly afterward. Friction from parts generates heat and causes temperatures to increase considerably. If a vehicle was operated with no lubricant in the system, you'll find damaged gear teeth, as well as blueing on parts, which resulted from high operating temperatures due to friction. Figure 4.34.

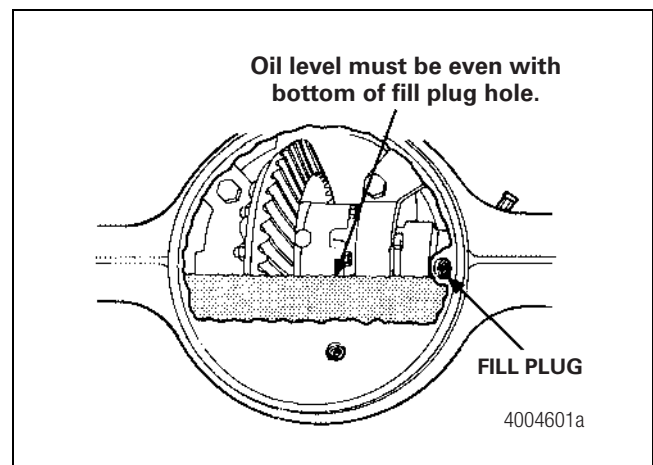
Figure 4.35

Low lubricant levels can result from leaking seals, which can be caused by a clogged axle housing breather. Figure 4.35.

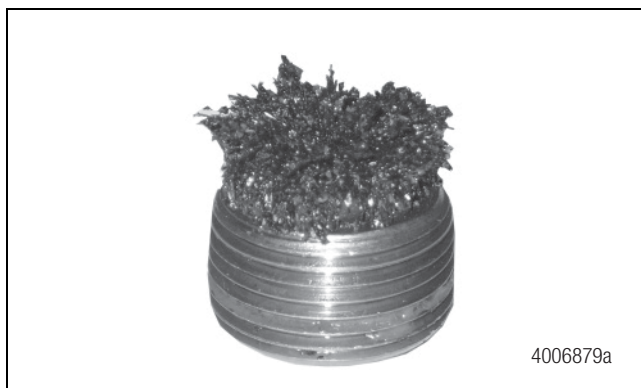
The fine metal particles attached to the magnetic plug in Figure 4.36 are normal. Internal components can shed fine metal wear particles at a steady rate, especially during the break-in period. In addition to the magnetic plugs, Meritor axles are also equipped with four to six magnets in the housing to capture debris generated during extended maintenance intervals used today.

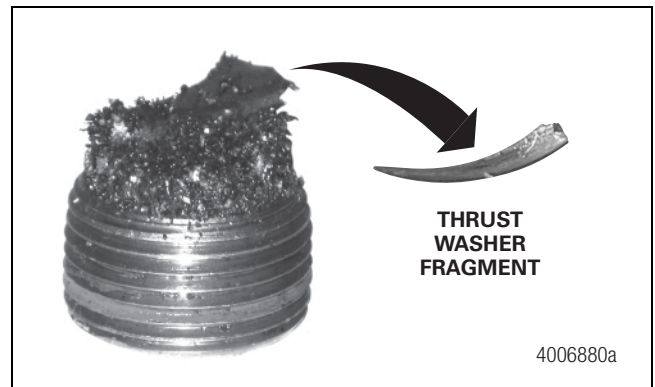
Figure 4.37 shows a main differential side gear thrust washer fragment. The loss of a fragment from the thrust washer is not detrimental to the operation of the axle and does not require disassembly, inspection and replacement of the axle.

If you are concerned about additional fragments or component damage, perform an oil sample analysis. If the iron content of the sample is above 1000 parts per million (ppm), inspect and repair the carrier as necessary.

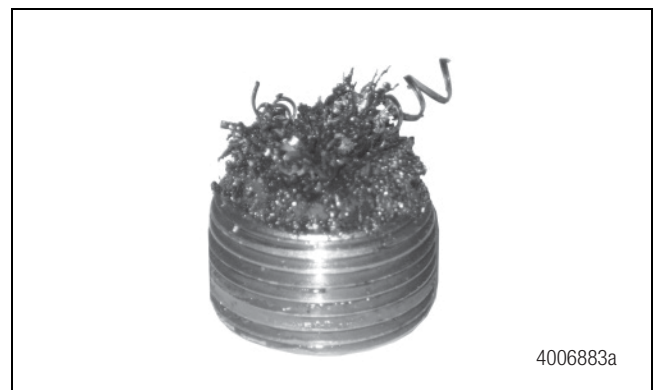
Figure 4.38 shows metal shavings which are remnants from the housing machining process. Metal shavings adhere to the magnets and are not detrimental to the operation of the axle. It is not necessary to perform further inspections or remove the carrier for cleaning.

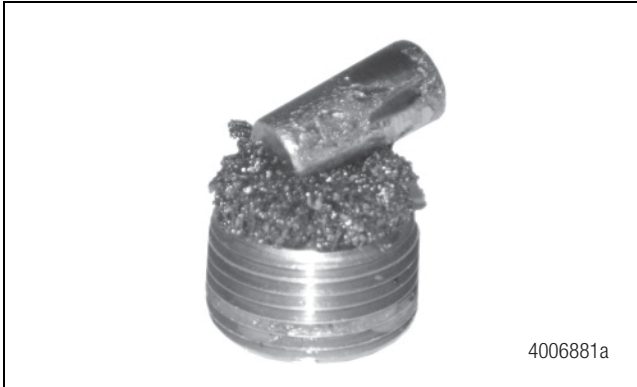
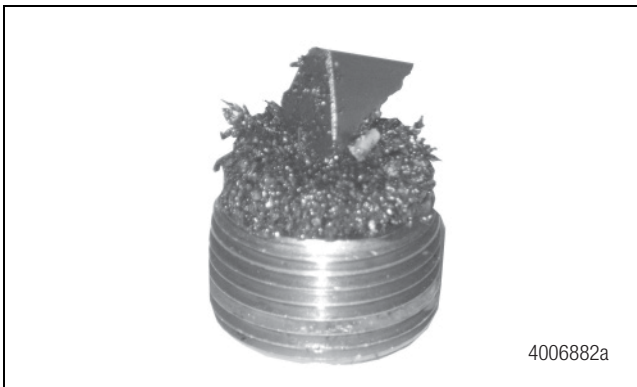
Figure 4.39 and Figure 4.40 show bearing and gear tooth fragments. Both indicate a significant issue that can result in component damage. Immediately remove the carrier, inspect it, and perform required repairs.

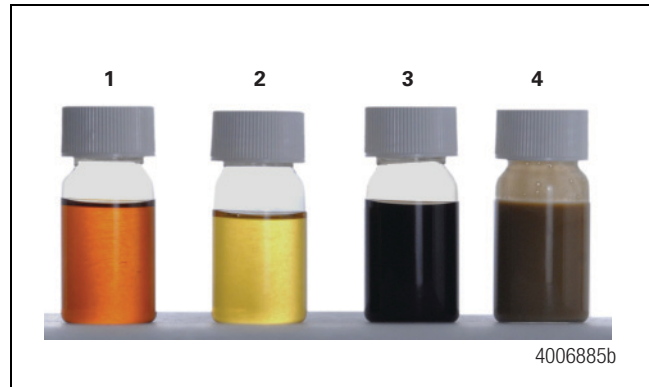
Most drive axle oils are either golden brown or deep red in color. If the oil looks “milky brown” or has a “copper” color, the oil is contaminated.

The oil samples in Figure 4.41 show how the lubricant may appear during inspection. Refer to Oil Conditions for guidelines.

Both the red and golden brown samples show the typical appearance of new GL5 EP oils that meet the SAE J2360 specification. They usually are golden brown, but also can be red in color. Figure 4.41.

This black sample is used-oil with significant time and mileage. The color change from red or golden brown to black is the result of a normal chemical process that occurs as the additive package in the oil degrades. The black color does not necessarily indicate that the oil's useful life has been exhausted. Perform a lubrication analysis to verify that the oil can still be used in the carrier. Figure 4.41.

This “milky” brown sample indicates the oil is contaminated with significant moisture well above the allowable change specification of >0.3%. Change the oil immediately. Also try to determine how the moisture entered the assembly and consider extending the breathers on applications where this occurs. Figure 4.41.

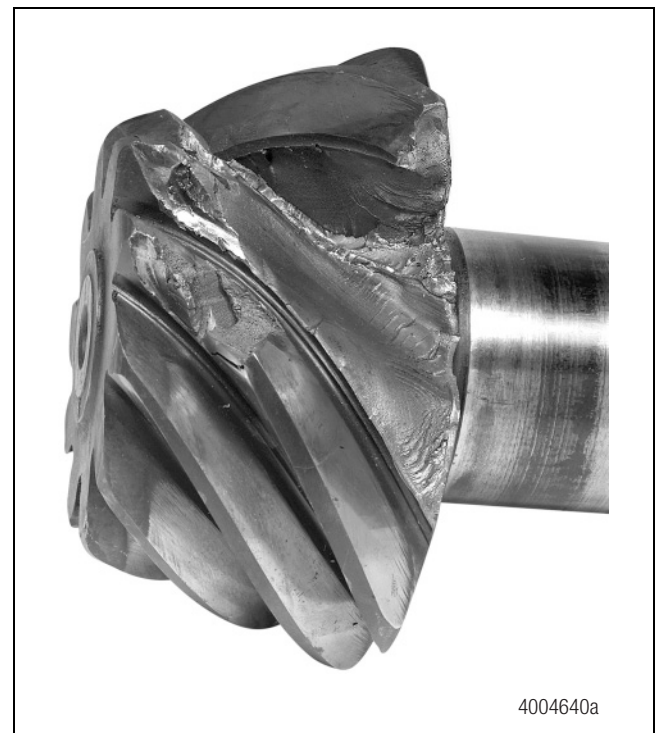
**Figure 4.42**

Root beam fatigue damaged the drive pinion.

**Primary Damage:** Root beam fatigue caused the drive pinion teeth to fracture and penetrate the gear teeth. Figure 4.42.

Operate the vehicle within its approved application and weight limits.

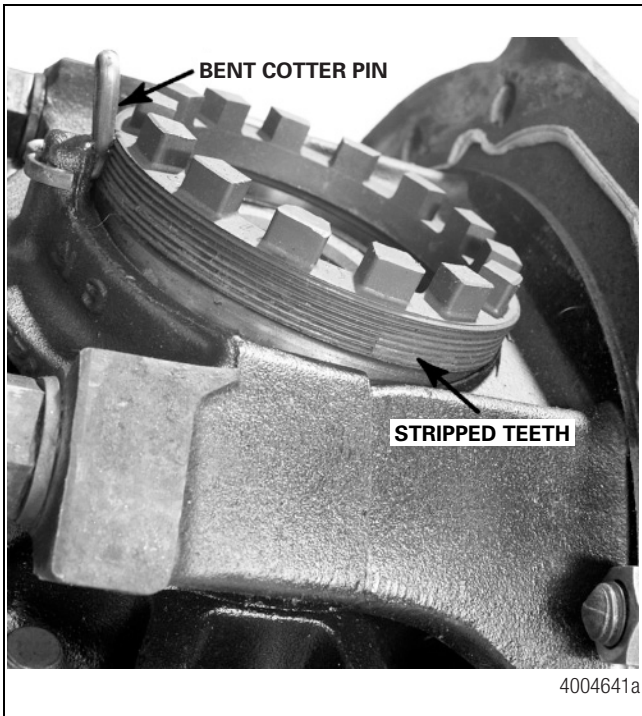
Figure 4.43

The adjusting ring on the flange side of the carrier pushed outward at the cap-to-case area and bent the main differential bearing cap cotter pin. Figure 4.43.

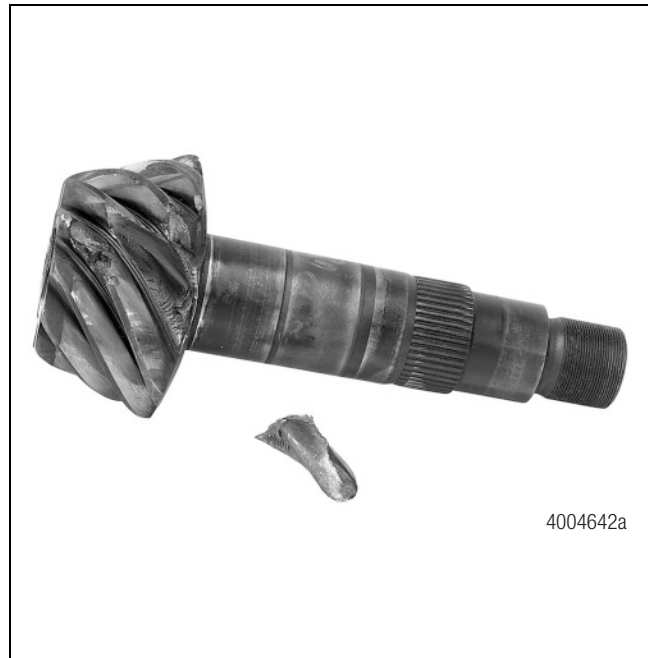
Figure 4.44

Shock load damaged the ring gear.

**Primary Damage:** Shock load fractured three adjacent teeth, causing them to penetrate the gear mesh. Figure 4.44.

Operate the vehicle within its approved application and weight limits. Teach drivers how to correctly operate a vehicle.

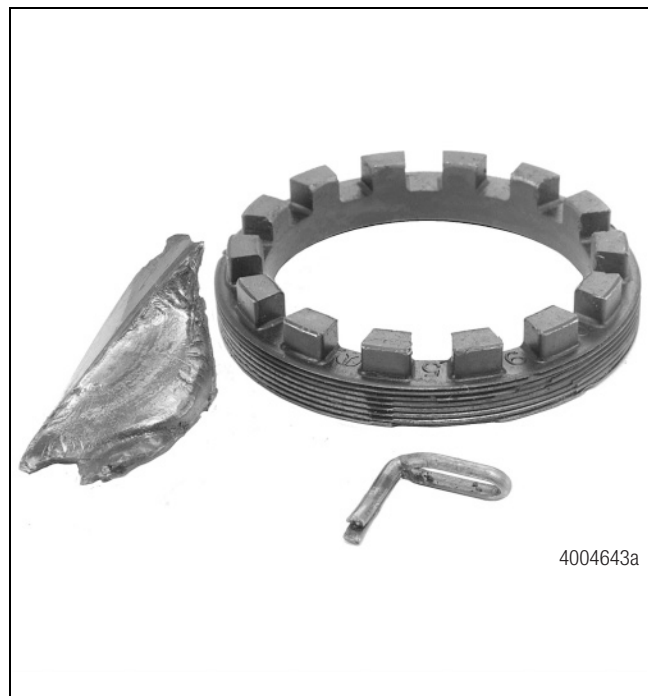
Figure 4.45

The adjusting ring pushed out of the carrier cap assembly and bent the cotter pin 90 degrees. Figure 4.45.

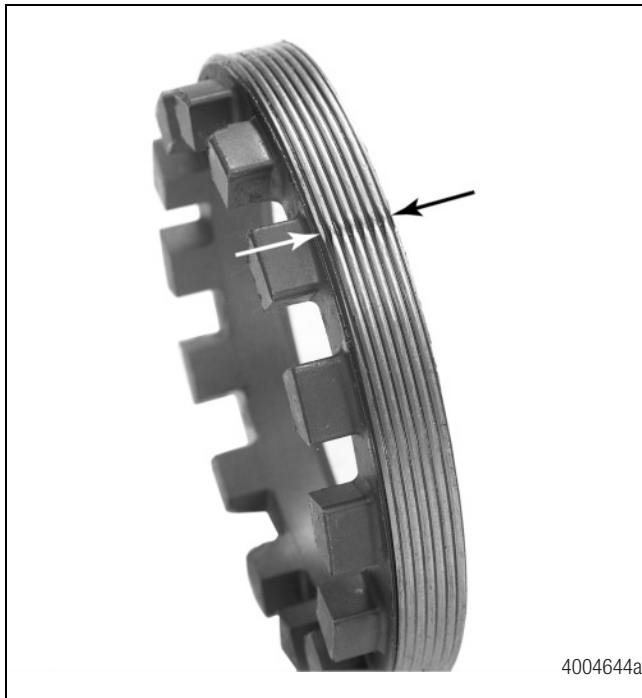
Figure 4.46

You can see marks on the adjusting ring where it was clamped between the main differential bearing cap and carrier case. Figure 4.46.

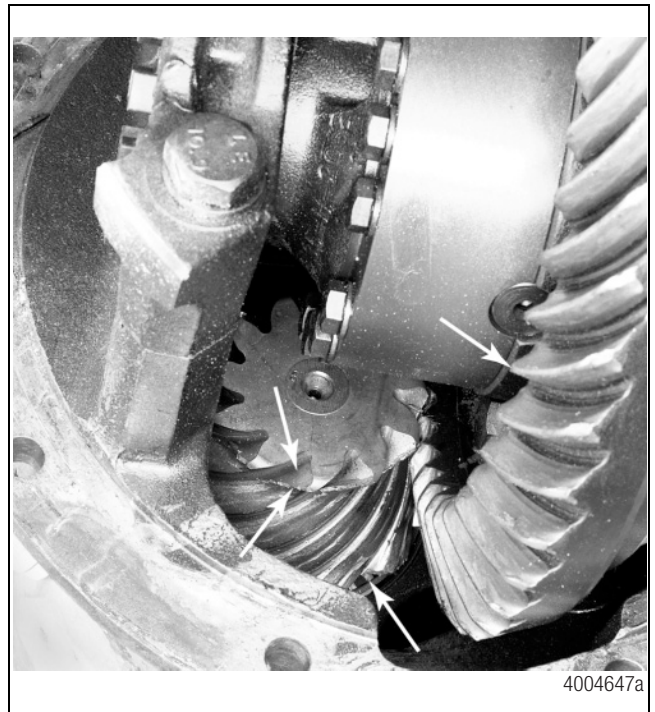
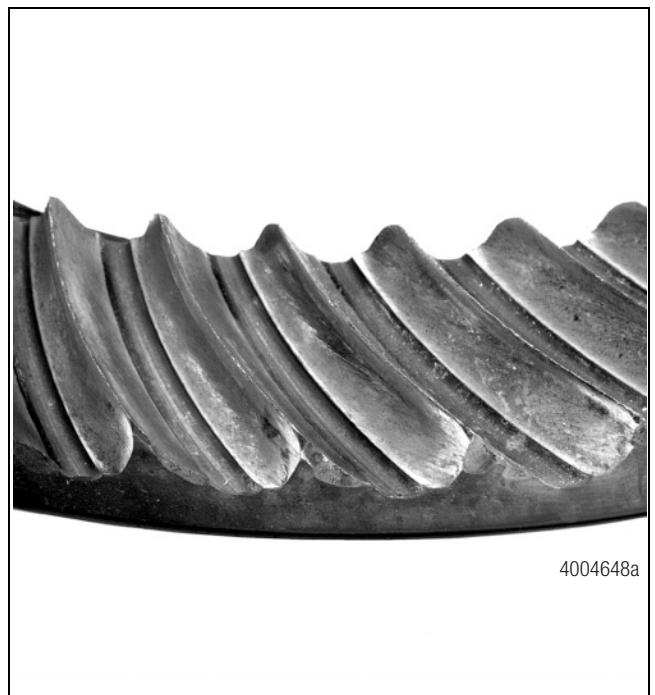
**Primary Damage:** Ring gear edges are worn thin and knife-like, and the hardened tooth surfaces no longer mesh with the pinion gear. Most likely, the lubricant installed did not meet GL-5 specifications, or high operating temperatures during operation depleted extreme pressure (EP) additives. Figure 4.47 and Figure 4.48.

Indications that the correct amount of incorrect lubricant was installed: the gear set is fairly clean with little evidence of heat, you don't see any burned lube, and the lubricant contains metal particles.

Follow Meritor's recommended maintenance practices and service procedures.

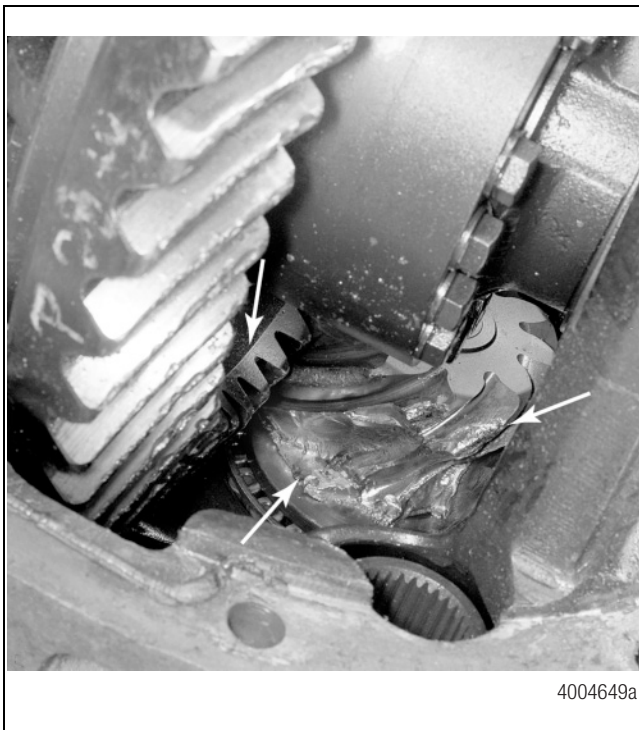
Figure 4.49

Ring gear teeth are damaged. Figure 4.49.

Operate the vehicle within its approved application and weight limits. Teach drivers how to correctly operate a vehicle.

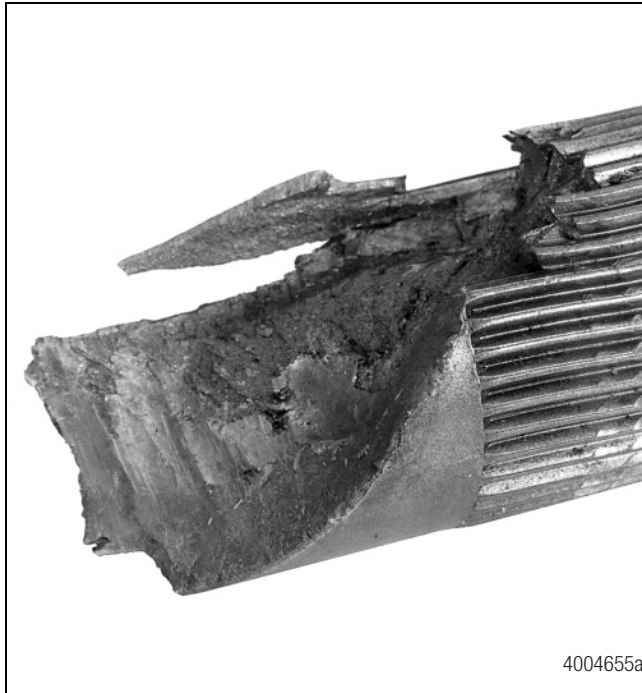
Figure 4.51

**Primary Damage:** Axle shaft splines are twisted and distorted. Figure 4.51.

Teach drivers how to correctly operate a vehicle.

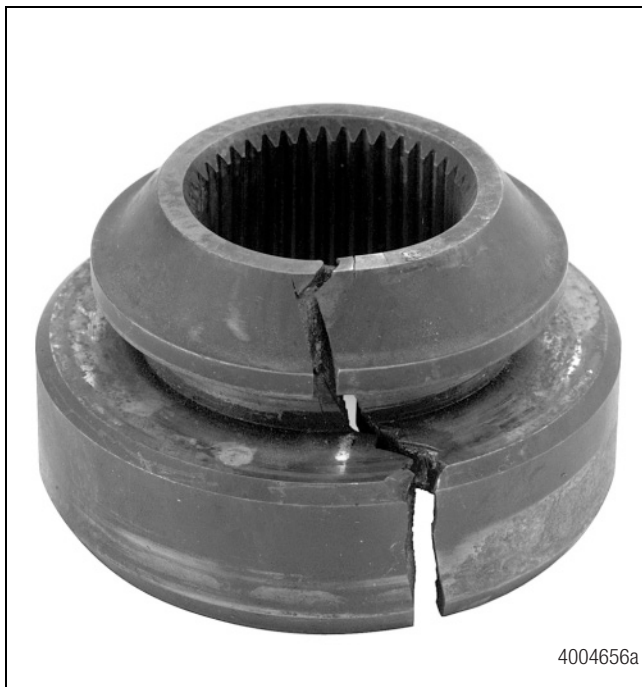
Figure 4.52

The DCDL collar is broken. Figure 4.52.

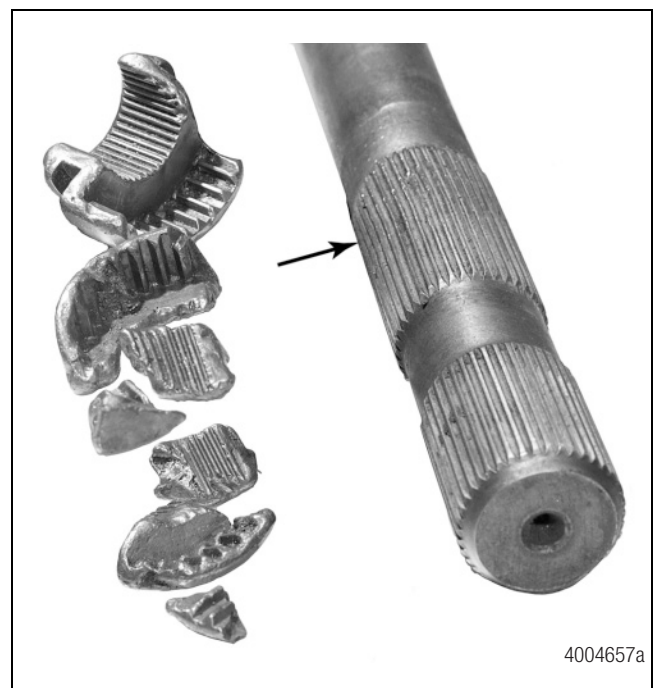
Figure 4.53

**Primary Damage:** The DCDL collar is broken into many pieces. Figure 4.53.

Teach drivers how to correctly operate a vehicle.

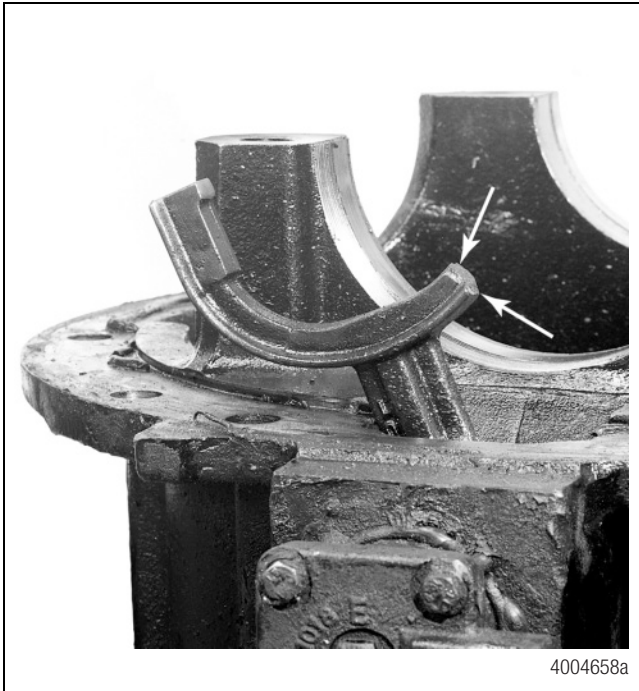
Figure 4.54

The shift fork leg is broken, and a rough, crystalline surface formed on the fracture. Figure 4.54.

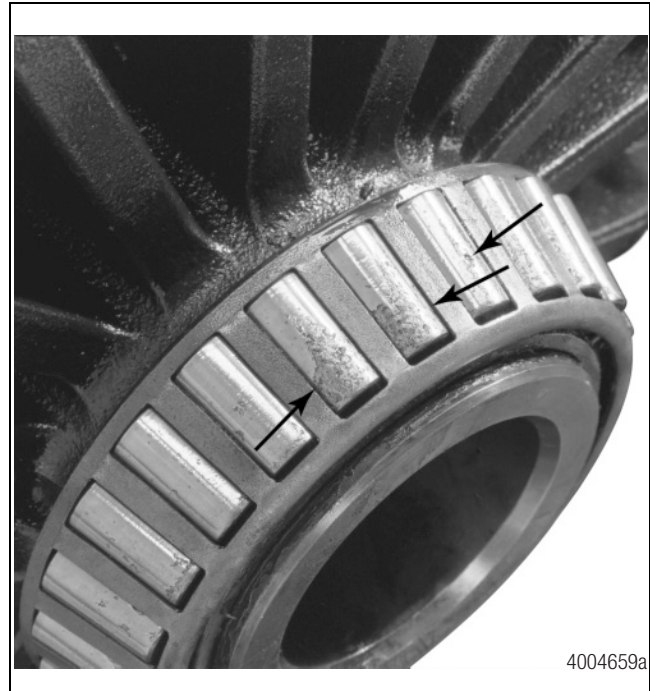
Figure 4.55

**Primary Damage:** You find spalling on the main differential bearing rollers and race on the outer side of the rollers. Figure 4.55.

Operate a vehicle within its approved application and weight limits. Follow Meritor's recommended maintenance practices and service procedures.

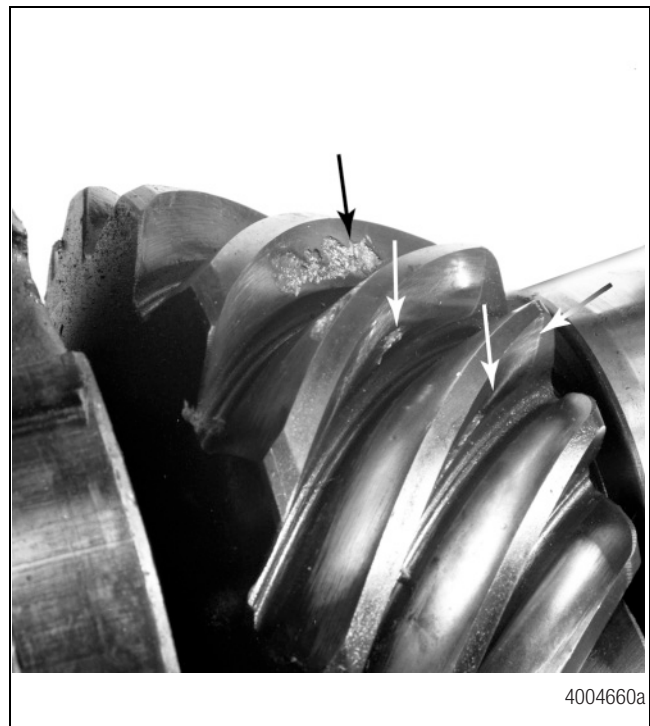
Figure 4.56

You find severe spalling on the undersurface of the drive pinion teeth. Figure 4.56.

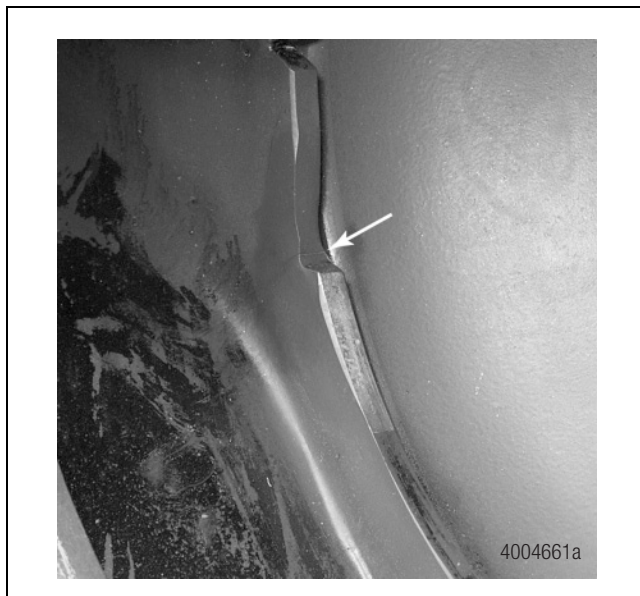
**Figure 4.57**

**Primary Damage:** The axle housings are fractured at the 10 o'clock position of the differential lock clearance notch. Figure 4.57.

Operate a vehicle within its approved application and weight limits.

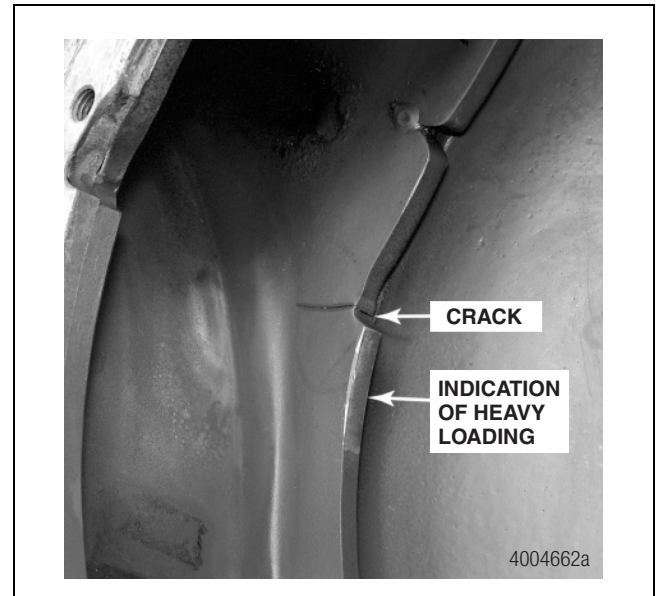
**Figure 4.58**

The fractures originate at the inner rib flange, and run through the bowl weld and into the axle housing cover. Figure 4.58.

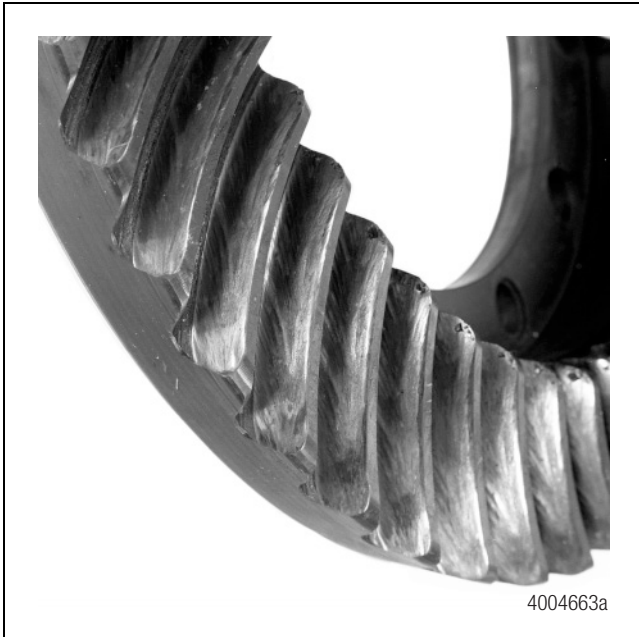
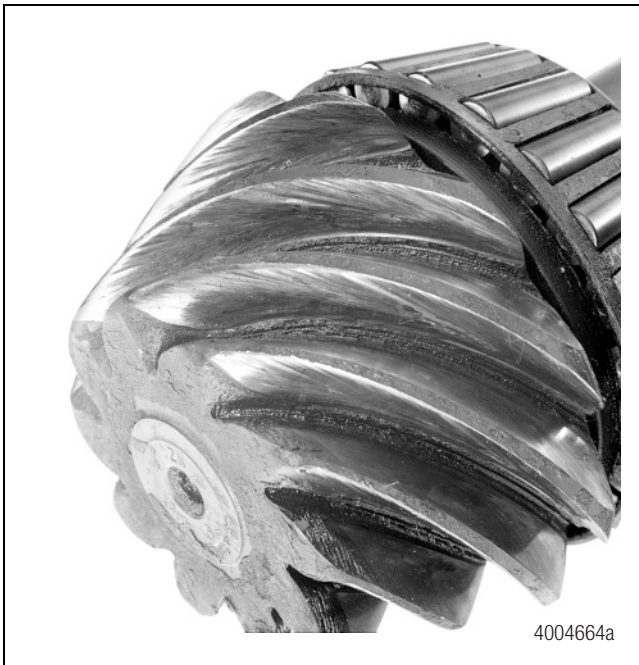
**Primary Damage:** You find crow's footing on both the ring and drive pinion gears, which indicates a low lubricant level or lubricant with depleted extreme pressure (EP) additives. The lubricant is black and has a burned odor. Figure 4.59 and Figure 4.60.

Follow Meritor's recommended maintenance practices and service procedures.

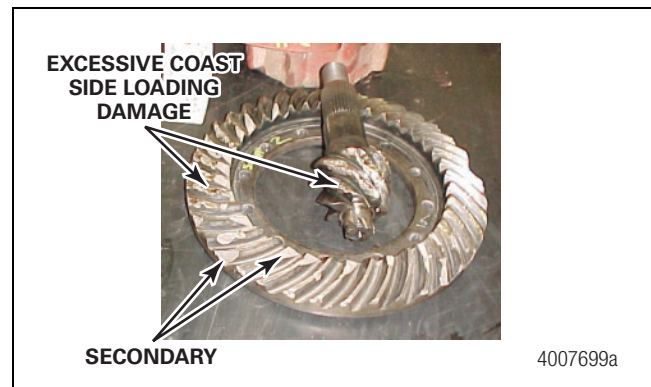
Figure 4.61

**Primary Damage:** Gear teeth on the pinion and ring gear are cracked or broken at the root with damage originating from the coast side of the gearing. Secondary damage such as broken gear teeth is present from loose parts entering the gearing. Figure 4.61.

Operate the vehicle within its approved application and weight limits according to Technical Publication TP-9441, Meritor Axle Application Guidelines. Also, refer to Meritor Technical Bulletin TP-0938, Part-Time 4x4 or 6x6 Severe-Duty Operating Guidelines for Meritor Medium-Duty Front Drive Steer Axles.

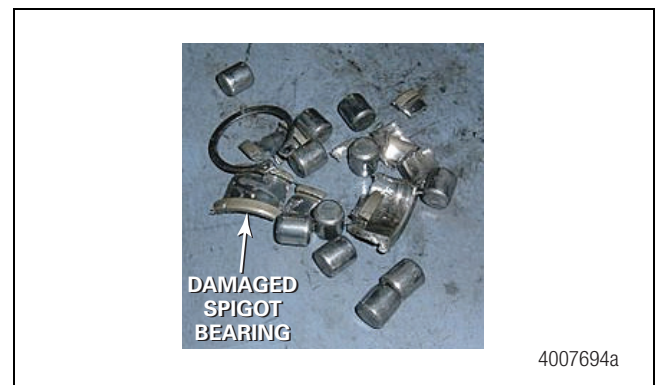
Figure 4.65

**Primary Damage:** The spigot bearing is damaged or broken in pieces. The bearing rollers are deformed or dislodged. Figure 4.65. Closer examination reveals spalling present on the bearing surfaces. The differential case also shows secondary damage from contact with loose parts. Figure 4.66.

Operate the vehicle within its approved application and weight limits according to Technical Publication TP-9441, Meritor Axle Application Guidelines. Also, refer to Meritor Technical Bulletin TP-0938, Part-Time 4x4 or 6x6 Severe-Duty Operating Guidelines for Meritor Medium-Duty Front Drive Steer Axles.

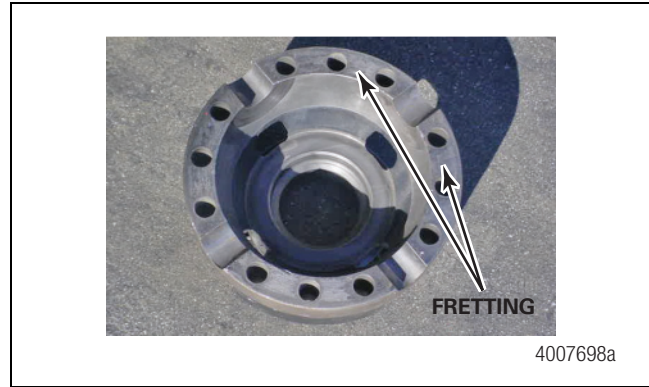
Figure 4.69

The thrust screw, if equipped, is excessively worn, cracked or broken. Figure 4.67. The back face of the ring gear shows excessive contact wear from the thrust screw. Figure 4.68. Fretting is found between the differential case-to-case bolt holes. Figure 4.69. Secondary gear damage such as broken gear teeth is present from loose parts entering the gearing. Figure 4.70.

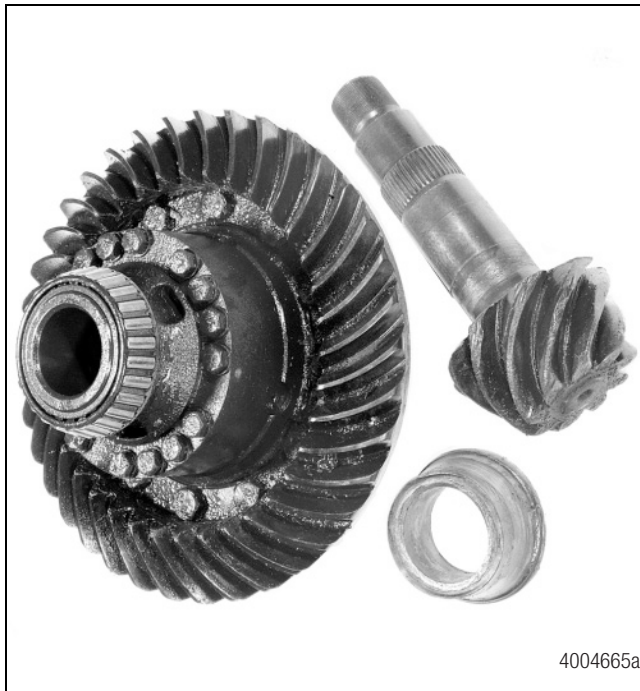
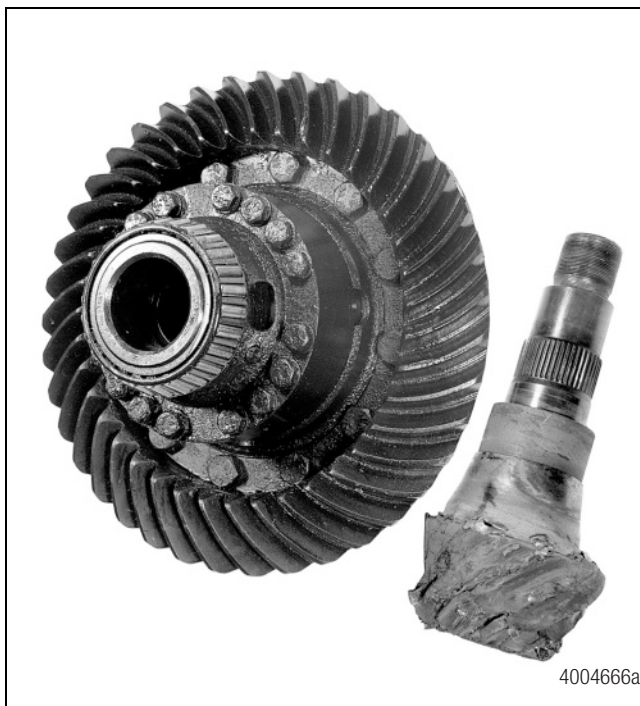
**Primary Damage:** The inner pinion cage and rollers are destroyed. Insufficient lubricant or a low lubricant level caused friction and heat buildup, which depleted EP additives. Figure 4.71 and Figure 4.72.

Lubricant on the ring gears is black with a burned odor. Figure 4.71 and Figure 4.72.

You find crow's footing on both hypoid sets, and the drive pinion gear is severely distorted. Figure 4.71 and Figure 4.72.

Follow Meritor's recommended maintenance practices and service procedures.

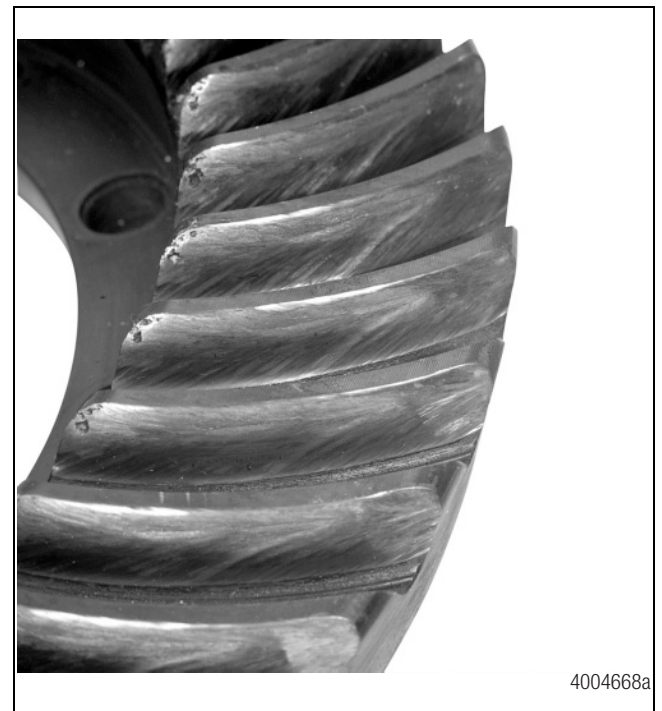
Figure 4.73

**Primary Damage:** The inner pinion bearing cup and cone are friction-welded together. You find severe crow's footing on the hypoid set. Figure 4.73.

Follow Meritor's recommended maintenance practices and service procedures.

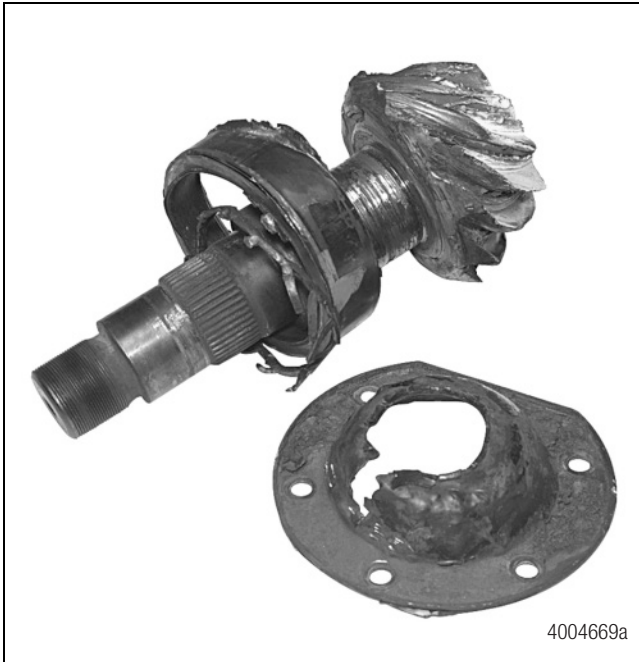
Figure 4.74

The drive pinion stem contacts the pinion cover and wears a hole into it. Figure 4.74.

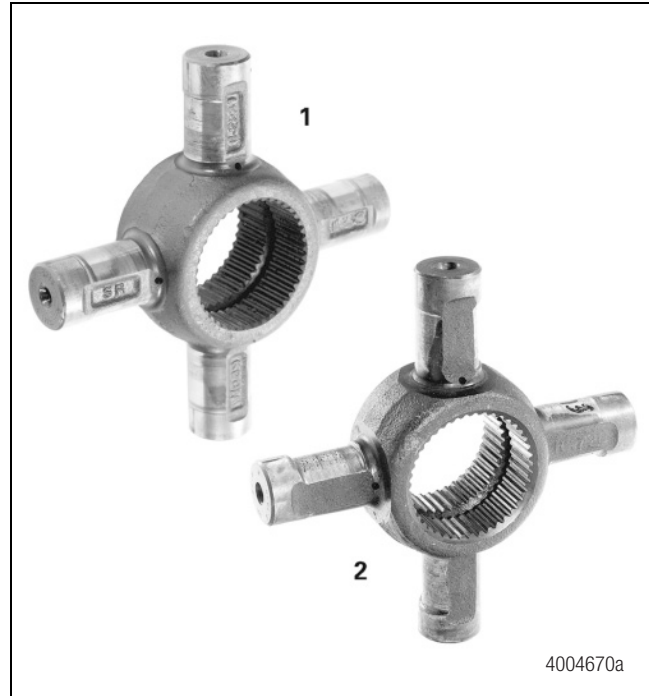
Figure 4.75

Spinout damaged the IAD.

**Primary Damage:** In Figure 4.75, you find galling on the first IAD. On the second, you find excessive spinout damage possibly caused by mismatched tires or axle ratios.

Teach drivers how to correctly operate a vehicle. Check for mismatched tires or axle ratios.

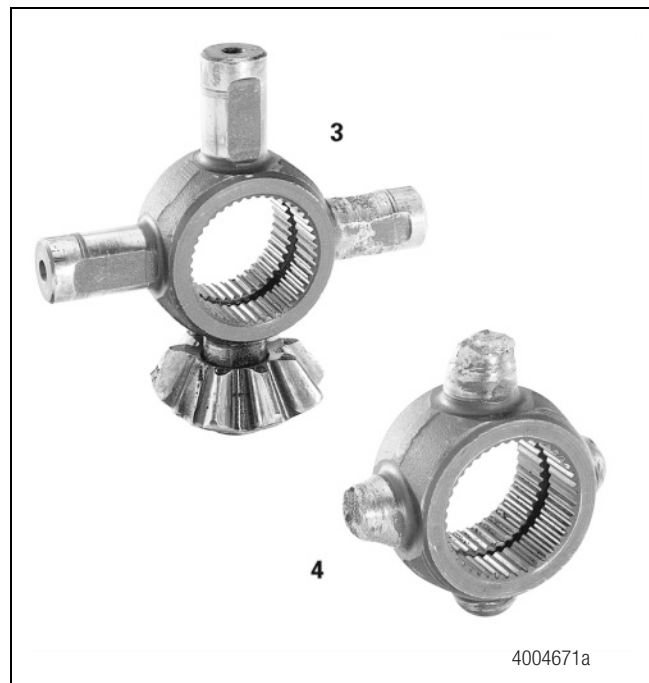
Figure 4.76

**Primary Damage:** In Figure 4.76, the third IAD shows a bent spider leg, and a gear seized to another spider leg. The fourth IAD shows that the spider legs have broken from the spline collar.

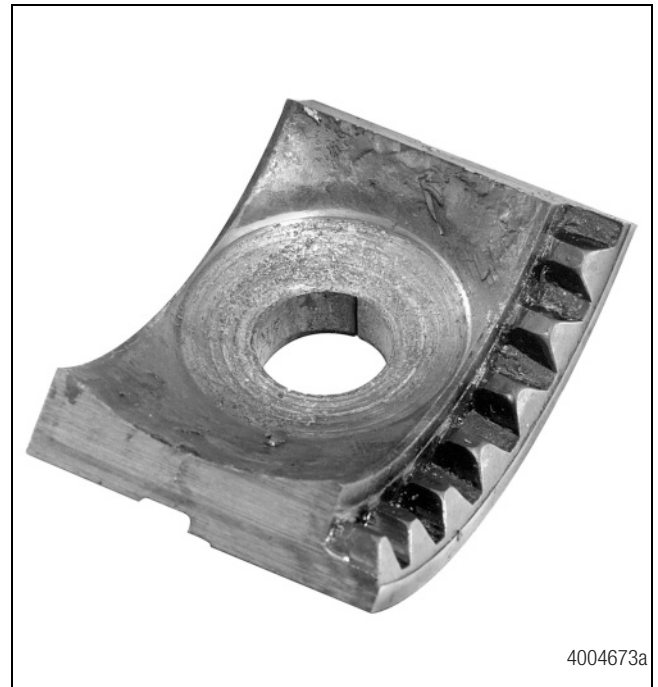
Figure 4.78

Fatigue fractured the pinion washers. Figure 4.78. Abrasive particles from spinout have caused one pinion washer to become very thin.

Teach drivers how to correctly operate a vehicle. Check for mismatched tires or axle ratios.

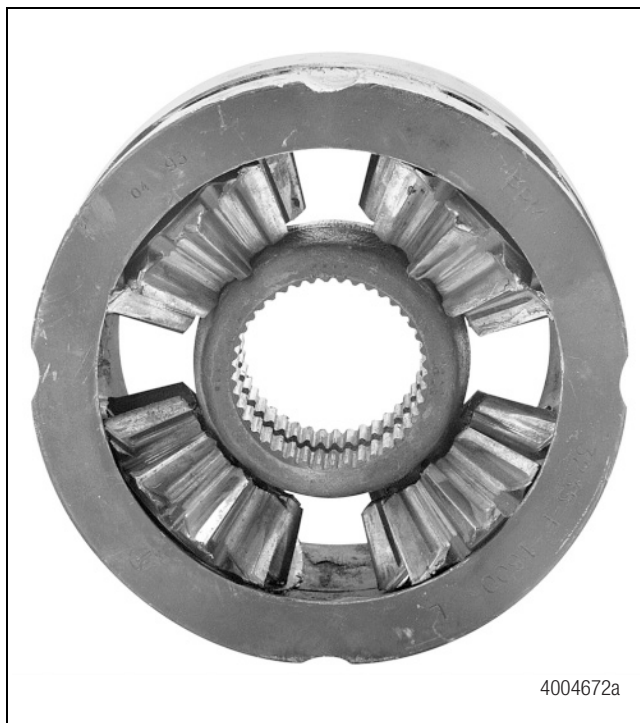
Figure 4.77

**Primary Damage:** The drive pinions are excessively loose on the spider legs. The pinions have worn into the IAD case. Figure 4.77.

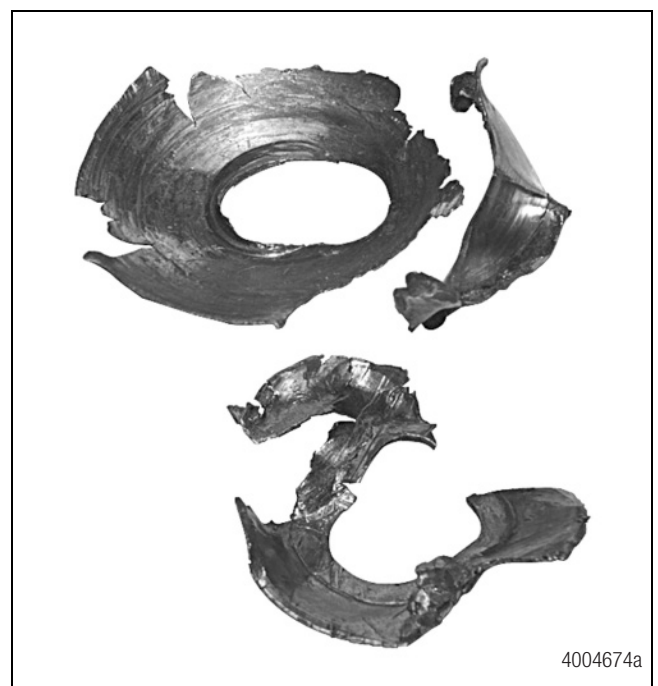
Figure 4.79

Fatigue caused the thrust washers to fail. Figure 4.79.
