Manual TP-0445

# Parts Failure Analysis

# Service Notes

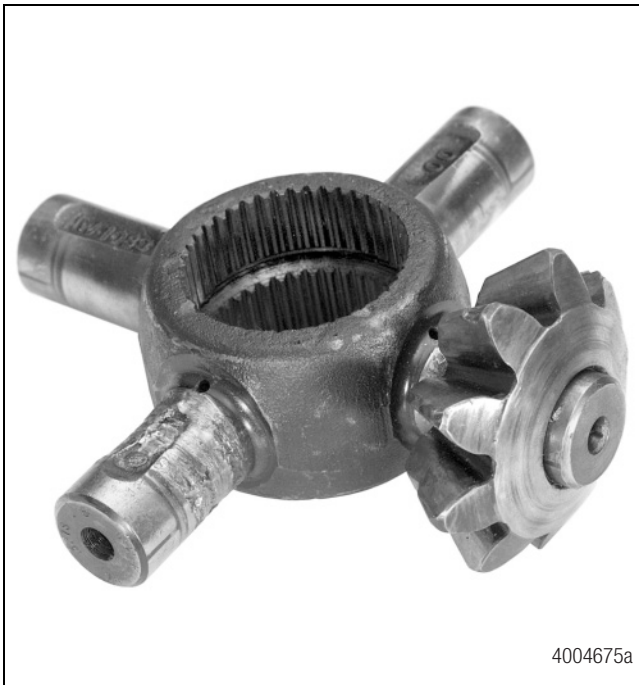
Figure 4.80

Spinout, and possibly shock load, occurred that damaged the IAD.

**Primary Damage:** You find galling on the spider legs. Figure 4.80.

Teach drivers how to correctly operate a vehicle. Check for mismatched tires or axle ratios.

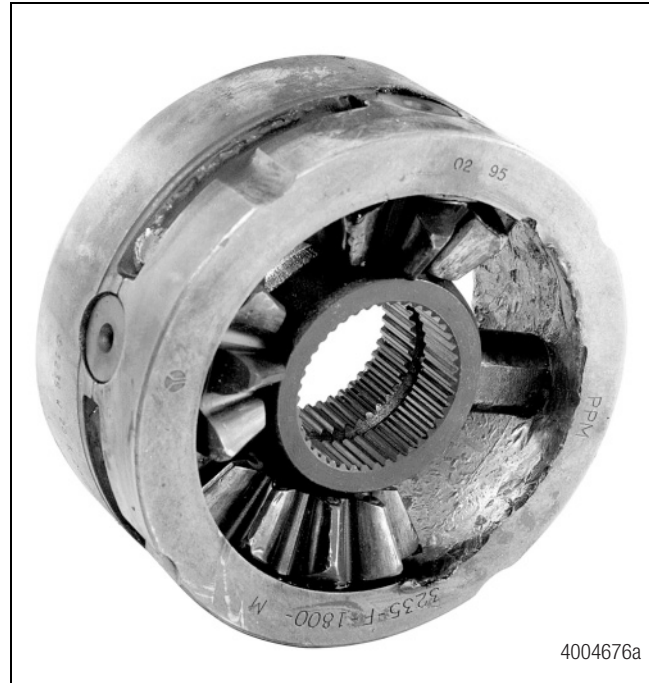
Figure 4.81

One pinion is missing from the IAD assembly. The IAD's inside walls are gouged and scuffed. There's no case separation. Figure 4.81.

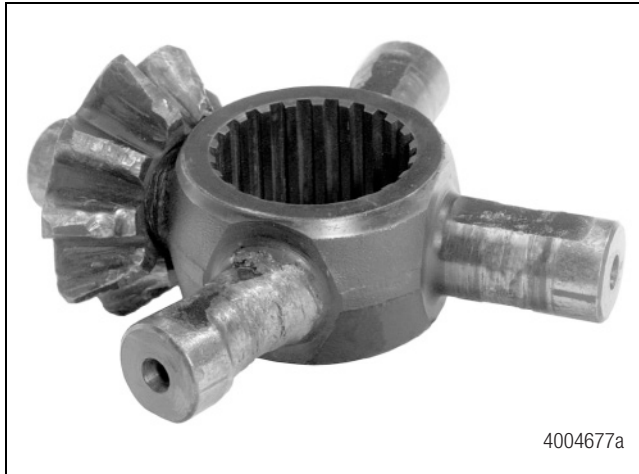
Figure 4.82

**Primary Damage:** You find severe scoring on the spider legs, as well as excessive wear on three non-seized legs. Severe wear damaged one of the spider legs. Figure 4.82.

Teach drivers how to correctly operate a vehicle. Check for mismatched tires or axle ratios.

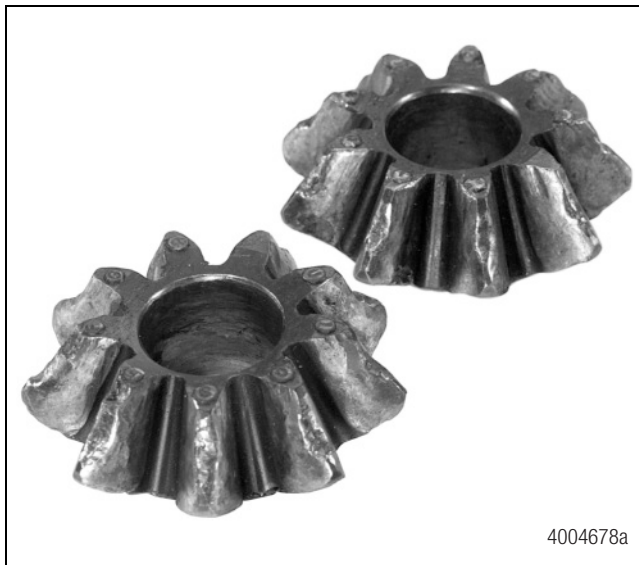
Figure 4.83

**Primary Damage:** You find galling, chipping and excessive wear on the pinions. One pinion spins, but won't slide off its spider leg. Figure 4.83.

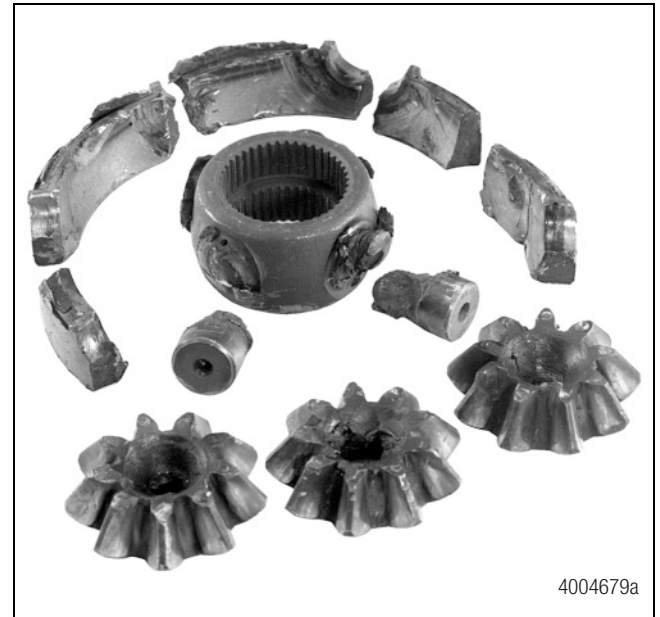
Figure 4.84

**Primary Damage:** You find severe galling on the spider legs. Two loose spider legs have seized inside the pinions. Figure 4.84.

The four spider legs were sheared from the spider at the splined hub area. The differential case halves have separated and are broken. Figure 4.84.

Teach drivers how to correctly operate a vehicle. Check for mismatched tires or axle ratios.

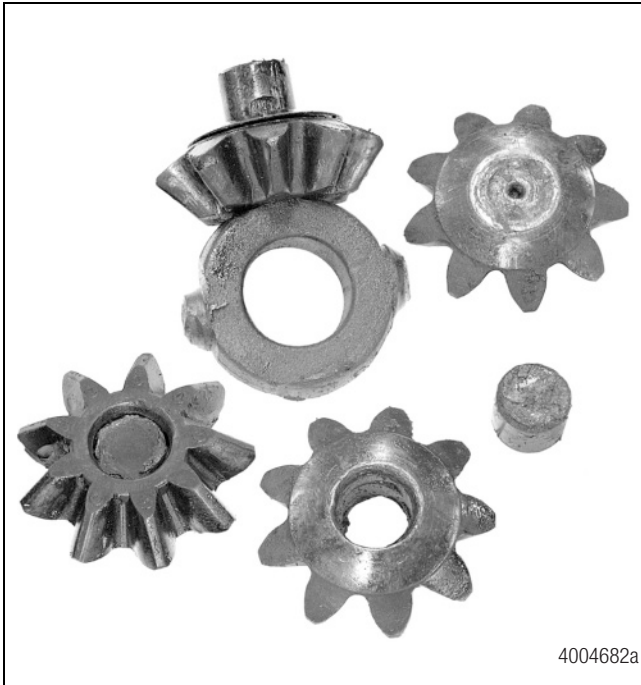
Figure 4.85

**Primary Damage:** Several main differential spider legs have seized gears. Figure 4.85.

**Primary Damage:** Three legs have broken from the spider. Two gears have broken legs seized inside. Figure 4.85.

**Primary Damage:** One thrust washer is distorted and loose inside the main differential case. Figure 4.85. Three washers show excessive abrasive wear. Figure 4.86.

Teach drivers how to correctly operate a vehicle. Check for mismatched tires or axle ratios.

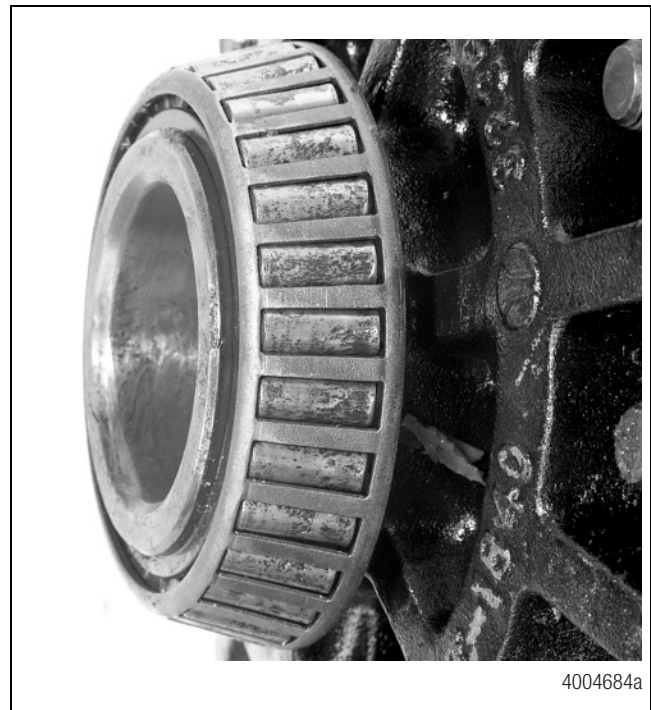
Figure 4.87

**Primary Damage:** The flange-side main differential bearing rollers are pitted and spalled. Figure 4.87.

**Primary Damage:** The bearing cage and rollers are missing from the flange half of the main differential case. Figure 4.87.

Follow Meritor's recommended maintenance practices and service procedures. Operate a vehicle within its approved application and weight limits.

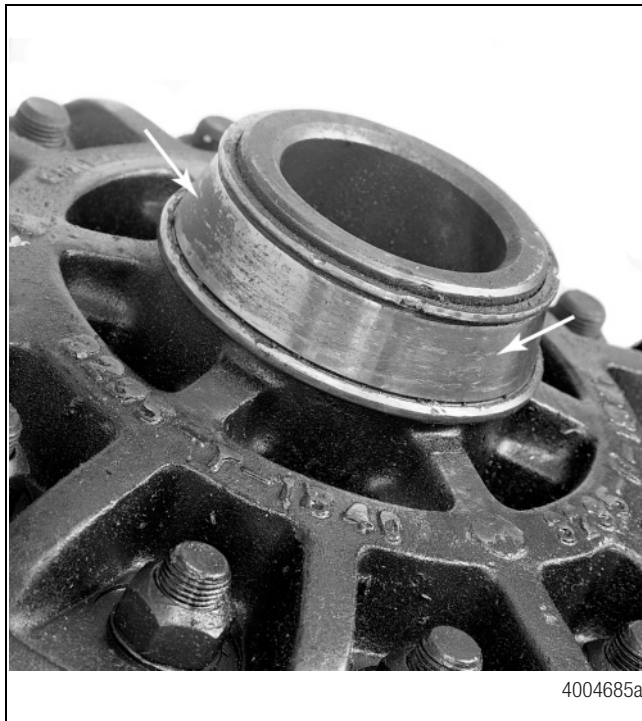
**Figure 4.88**

**Primary Damage:** The flange-side differential bearing inner cone is scuffed and galled. Figure 4.88.

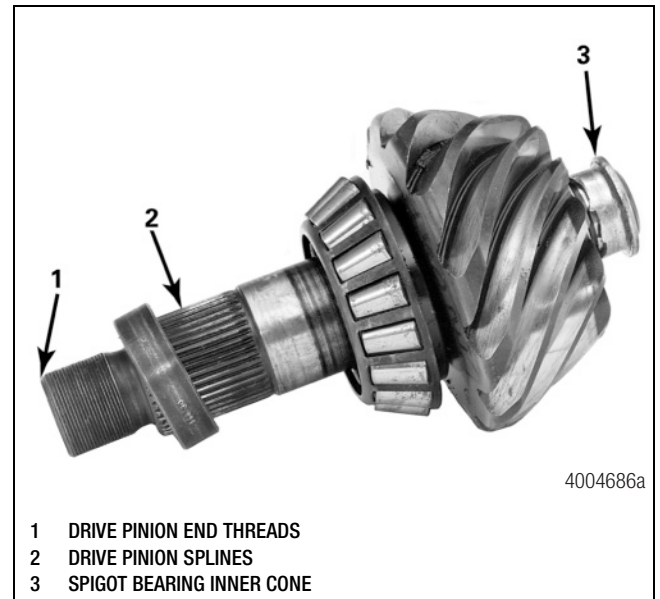
**Figure 4.89**

**Primary Damage:** The threads on the end of the drive pinion show that the pinion nut may have lost its specified preload or was not correctly tightened during assembly procedures. It then slowly backed-off, which enabled the drive pinion shaft to move out-of-position. Figure 4.89.

Follow Meritor's recommended maintenance practices and service procedures to correctly tighten the drive pinion nut to specification.

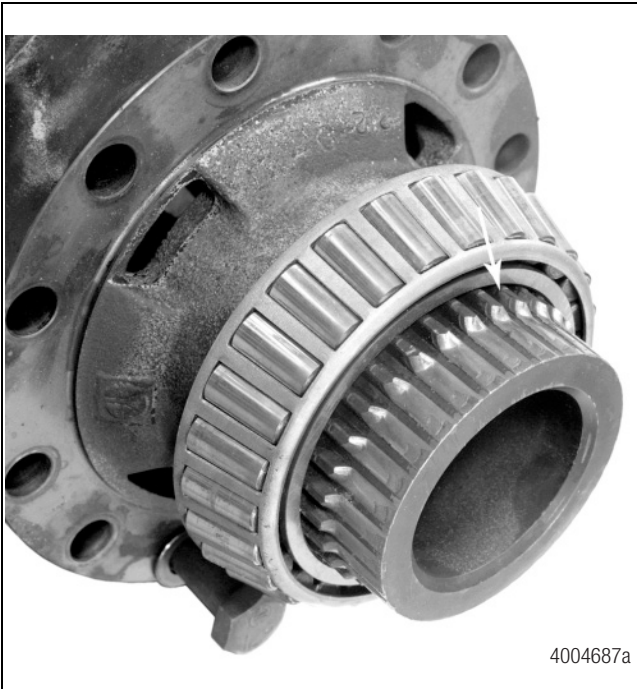
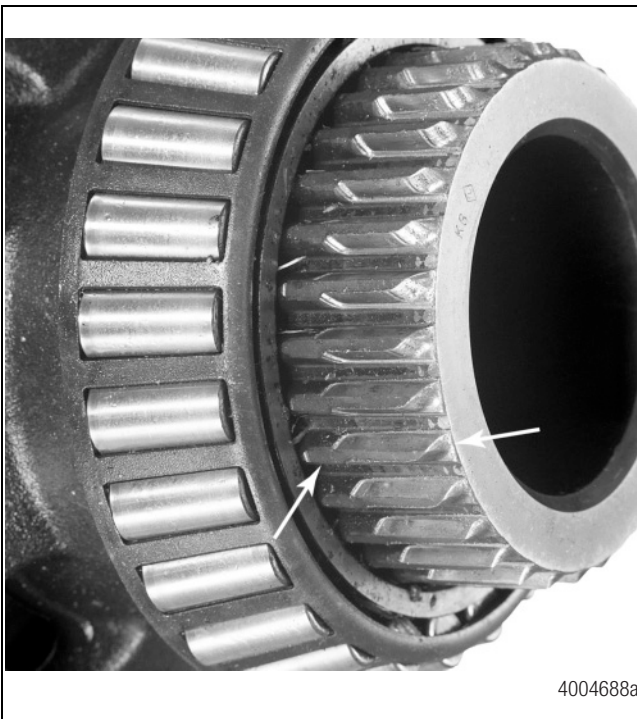
**Primary Damage:** The DCDL splines have worn away. Figure 4.90 and Figure 4.91.

Teach drivers how to correctly operate a vehicle.

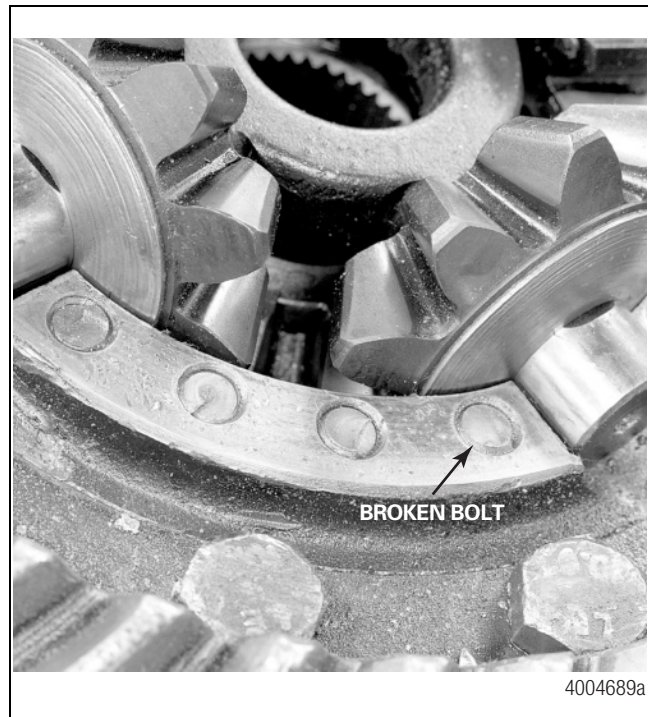
Figure 4.92

**Primary Damage:** The case-to-case bolts were broken by bending fatigue, which was caused by a forward-reverse motion in the driveline related to heavy loading and rough surface applications. Figure 4.92.

Operate a vehicle within its approved application.

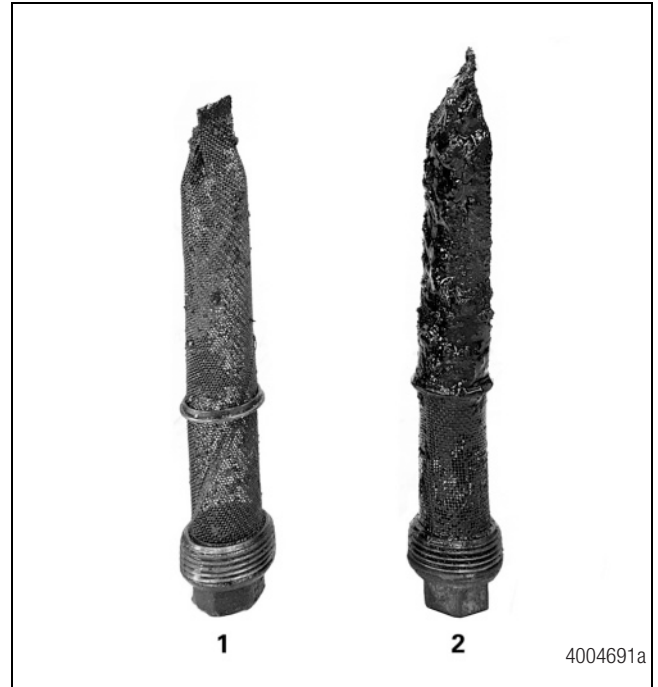
Figure 4.94

Screen 1 is in normal condition. Figure 4.94.

Follow Meritor's recommended maintenance practices and service procedures.

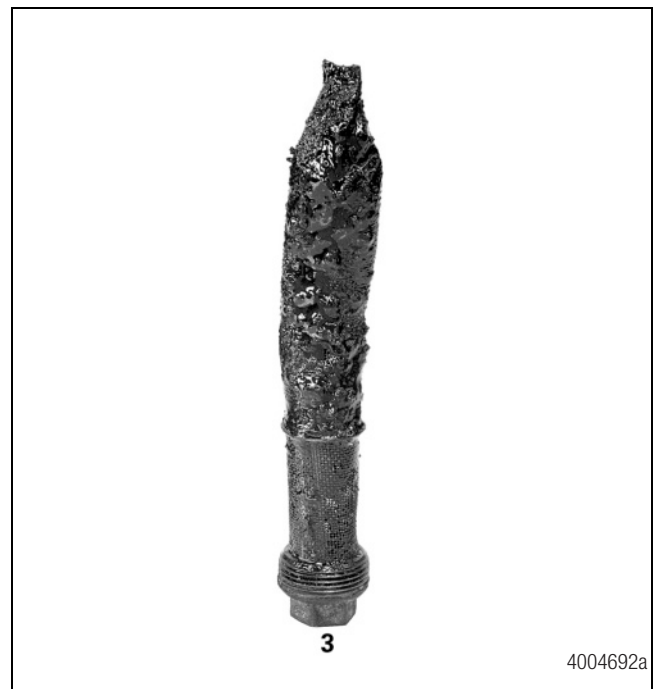
Figure 4.95

Screen 3 is filled with metal chips and particles. Figure 4.95.

It's also important to note that when you apply silicone gasket material, the bead must not exceed 0.125-inch (3 mm), or you can block lubrication passages and damage components.

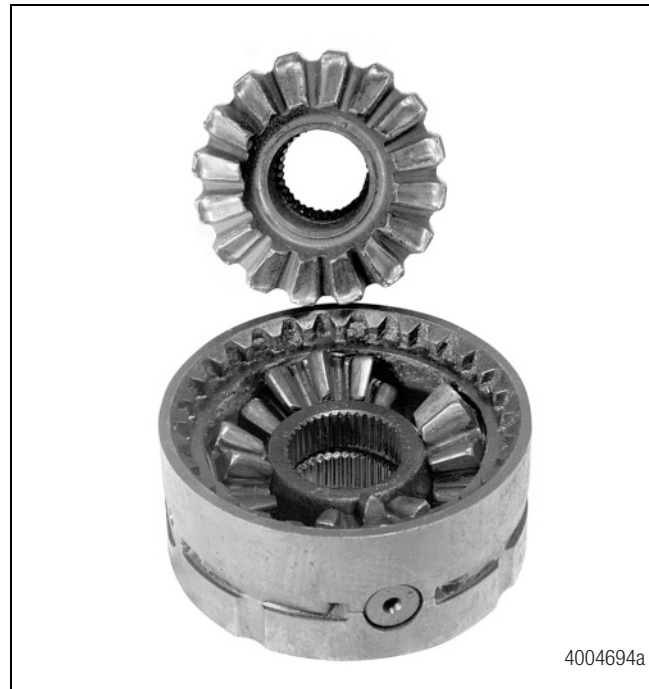
Figure 4.97

The IAD pinion teeth are excessively worn. Figure 4.97.

Inspect the driveline. Check that working angles and phasing are correct. Check that suspension air ride height is correct.

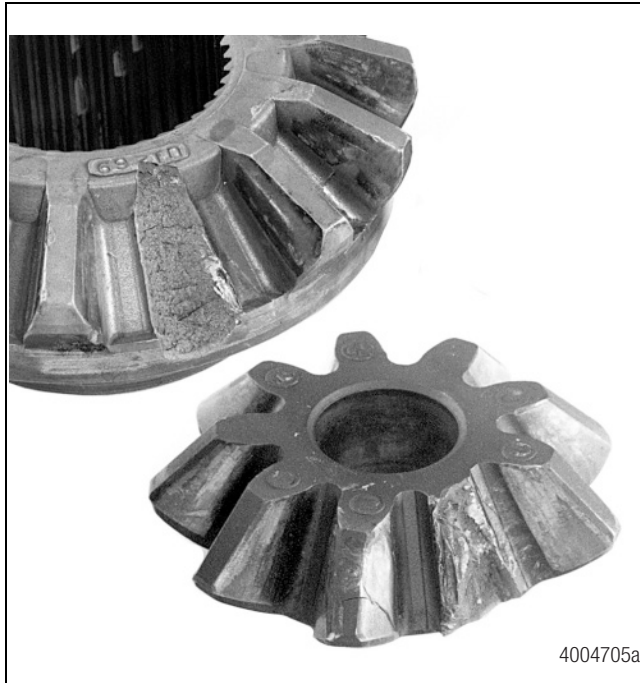
Figure 4.104

**Primary Damage:** The side gear teeth next to the broken tooth are cracked at the base. Figure 4.104.

**Primary Damage:** A rough, crystalline finish formed on both teeth at the fractures. Figure 4.104.

Teach drivers how to correctly operate a vehicle.

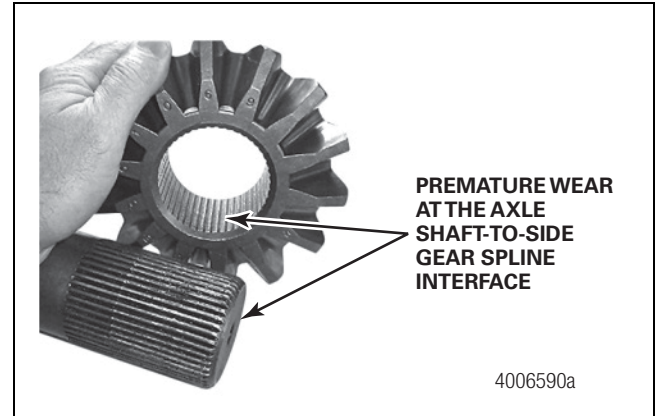
Figure 4.105

Overload conditions cause angular misalignment at the axle shaft-to-side gear spline interface. As the load on the axle housing continues to increase, the angular misalignment becomes more severe, axle deflection occurs, and the increased contact pressure in the differential side gear spline results in rapid wear.

**Primary Damage:** Premature wear at the axle shaft-to-differential side gear interface caused by unusually heavy contact at the spline ends. Figure 4.105.

Operate a vehicle within its approved application and weight limits. Follow recommended maintenance practices.

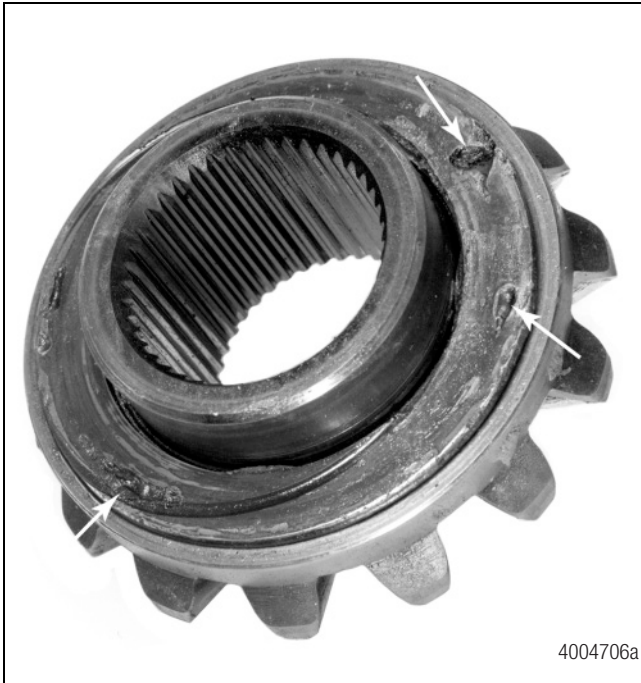
Figure 4.106

Spinout damaged the side gear thrust washer.

**Primary Damage:** The thrust washer seized onto the side gear. Figure 4.106. You find burned lubricant and galling areas on the thrust washer.

Teach drivers how to correctly operate a vehicle.

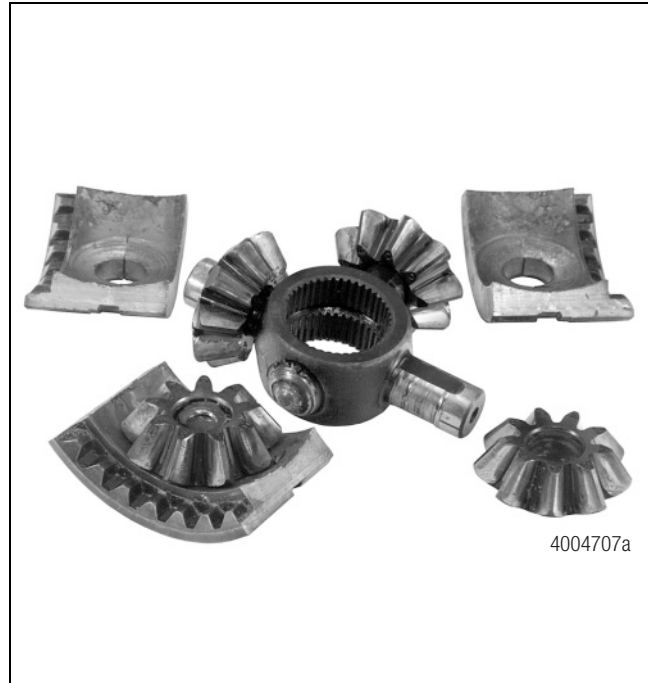
Figure 4.107

**Primary Damage:** One leg broke from the spider and seized within the pinion gear journal. Figure 4.107.

**Primary Damage:** You find excessive wear and galling on all four spider legs. Figure 4.107.

Teach drivers how to correctly operate a vehicle.

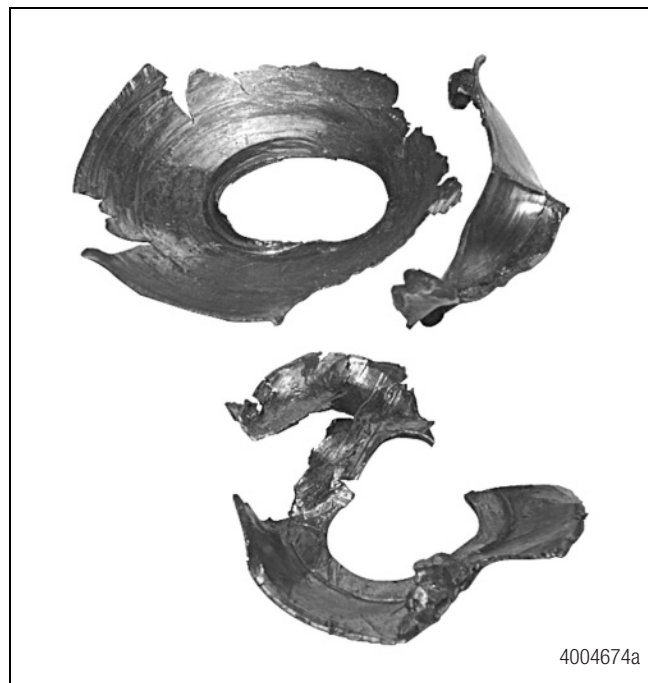
Figure 4.108

The thrust washers are worn. Figure 4.108.

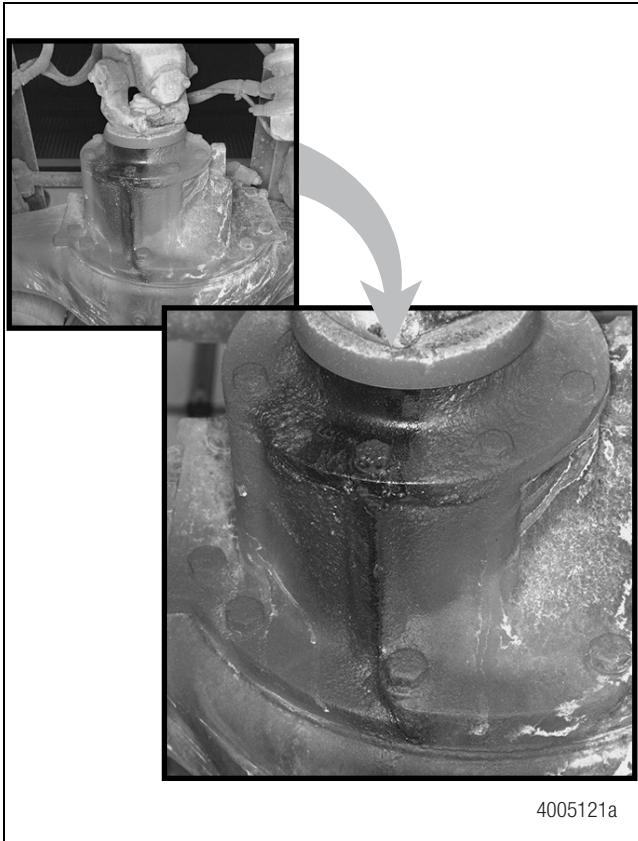
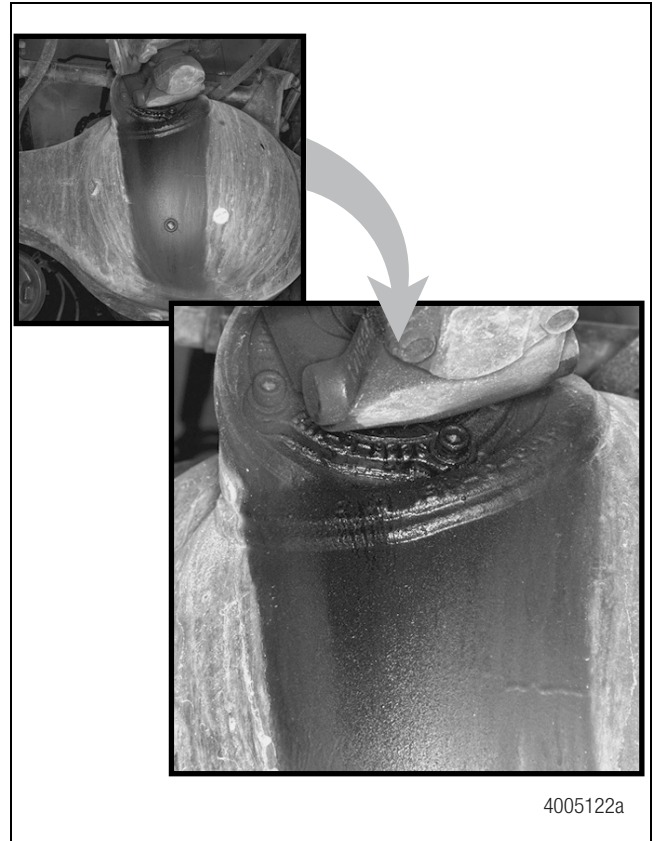
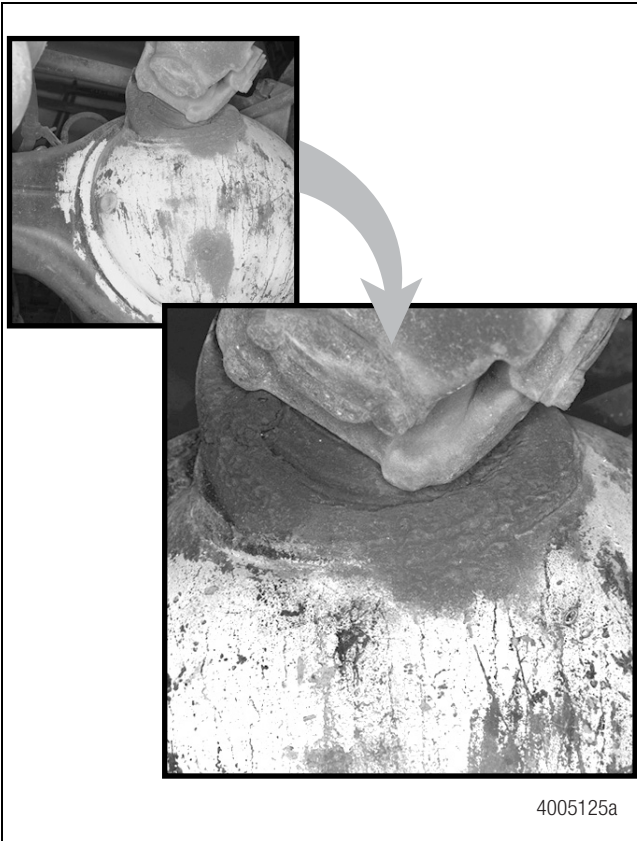
Figure 4.112, Figure 4.113 and Figure 4.114.

Follow Meritor's recommended maintenance practices and service procedures.

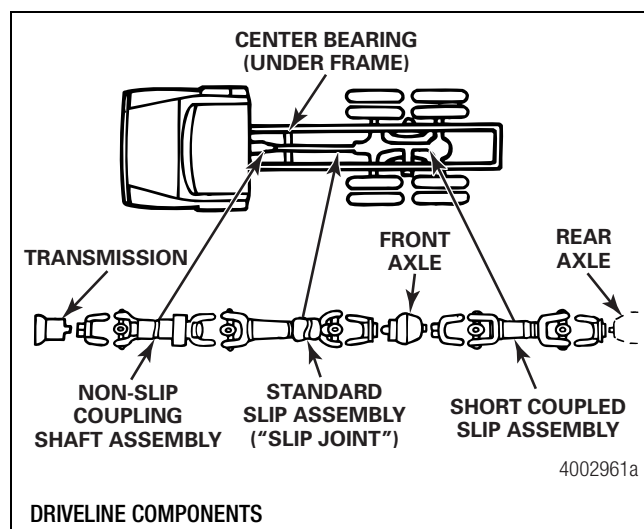
**Figure 5.1**

A typical driveline consists of yokes, tubing, universal joints — and in some cases, a center bearing. Slip yokes enable a driveline to change in length, and u-joints enable it to operate at a variety of angles. Figure 5.1. Tubing transmits turning torque from one u-joint to another, and the center bearing provides support for longer drivelines.

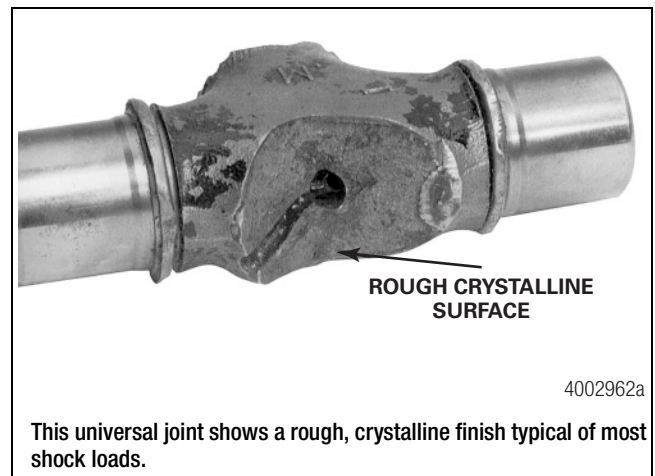
**Figure 5.2**

A rough, crystalline surface has formed on the u-joint at the fracture point. Figure 5.2.

**This universal joint shows a rough, crystalline finish typical of most shock loads.**

Teach drivers how to correctly operate a vehicle.

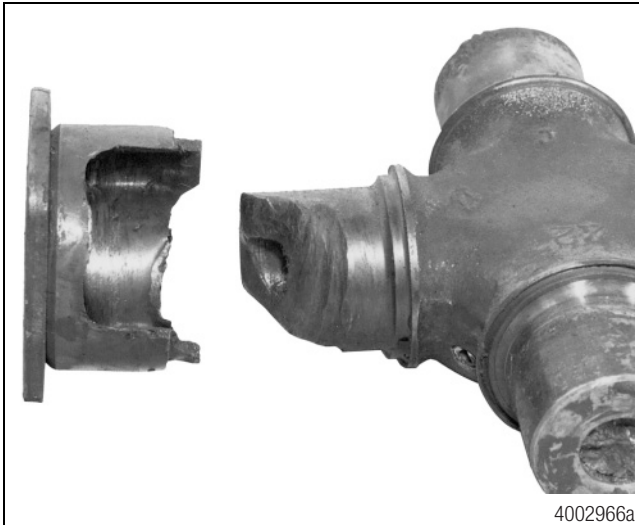
**Figure 5.3**

Heat and friction caused by insufficient lubricant, or installing an incorrect lubricant, caused a u-joint to wear through the side of its bearing cap. A u-joint requires a high-quality extreme pressure (EP) lubricant. Figure 5.3.

This universal joint shows the damage that can happen from lack of lubricant. The friction and heat created by the lack of lubricant caused the universal joint trunnion to wear through the side of its roller bearing cap.

Operate a vehicle within its approved application and weight limits. Follow Meritor's recommended maintenance practices and service procedures.

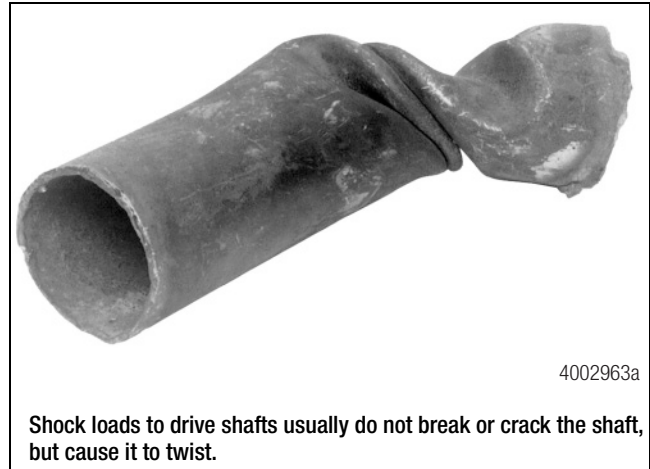
**Figure 5.4**

Figure 5.4 shows that shock load occurred on a drive shaft tube.

Shock loads to drive shafts usually do not break or crack the shaft, but cause it to twist.

Teach drivers how to correctly operate a vehicle.

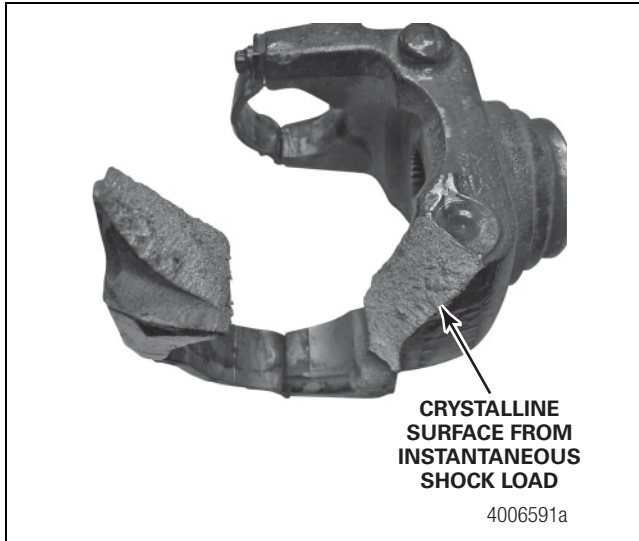
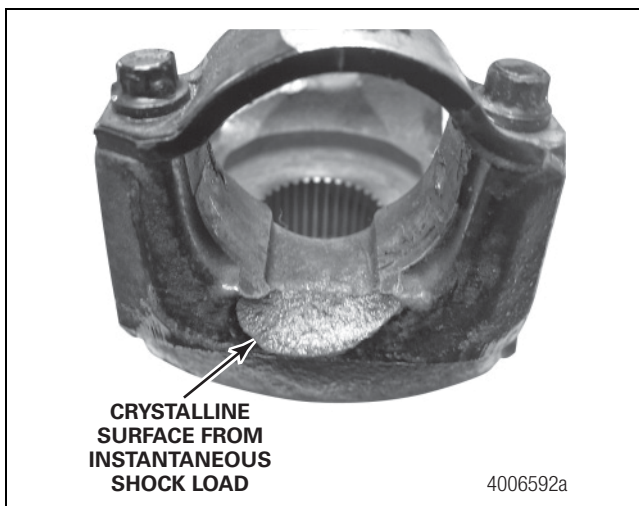
The yoke fracture is a "clean break," and a rough crystalline surface has formed at the fracture point. Figure 5.5 and Figure 5.6.

Teach drivers how to correctly operate a vehicle.

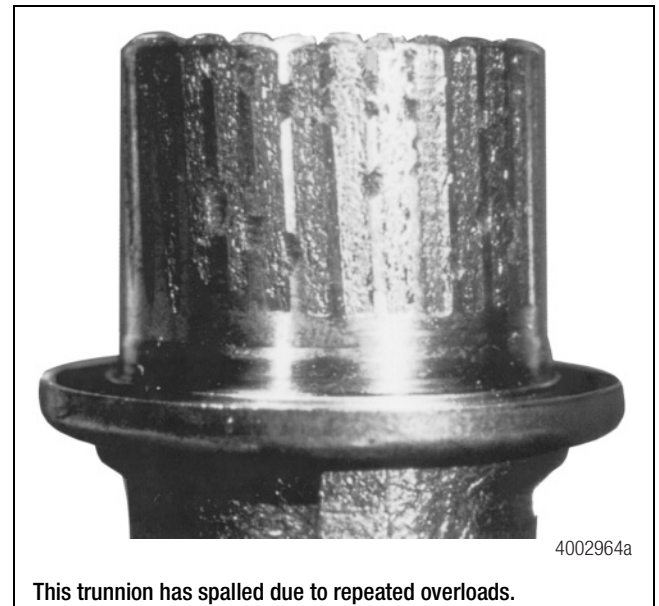
**This trunnion has spalled due to repeated overloads.**

Operate a vehicle within its approved application and weight limits. Follow recommended maintenance practices.

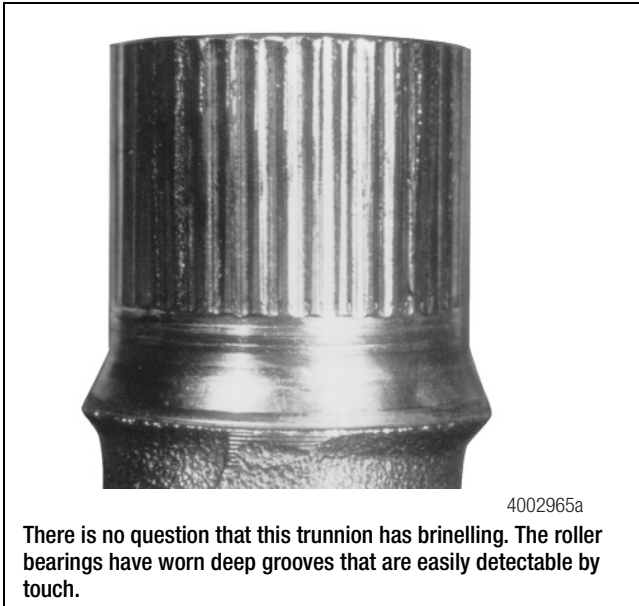
Figure 5.8

This roller bearing shows the effects of brinelling, which causes the needle rollers to wear grooves into the surface of the trunnion. Figure 5.8.

Operate a vehicle within its approved application and weight limits. Follow recommended maintenance practices.

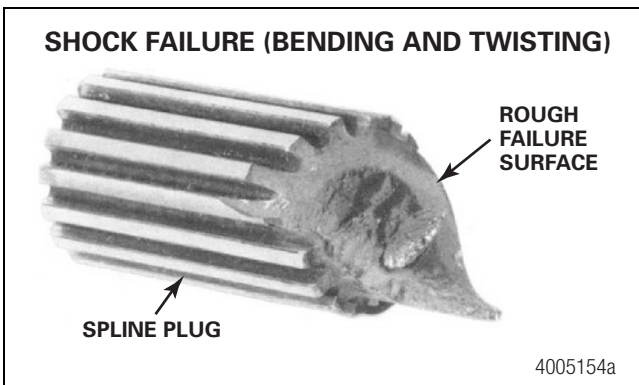
Figure 5.9

Torsional fatigue has damaged the splined shaft in Figure 5.9. The fracture started at the base of each spline. As the splines continued to weaken, the metal formed a star-shaped, radial pattern, which eventually broke the shaft at the center.

Operate a vehicle within its approved application and weight limits. Follow Meritor's recommended maintenance practices and service procedures.

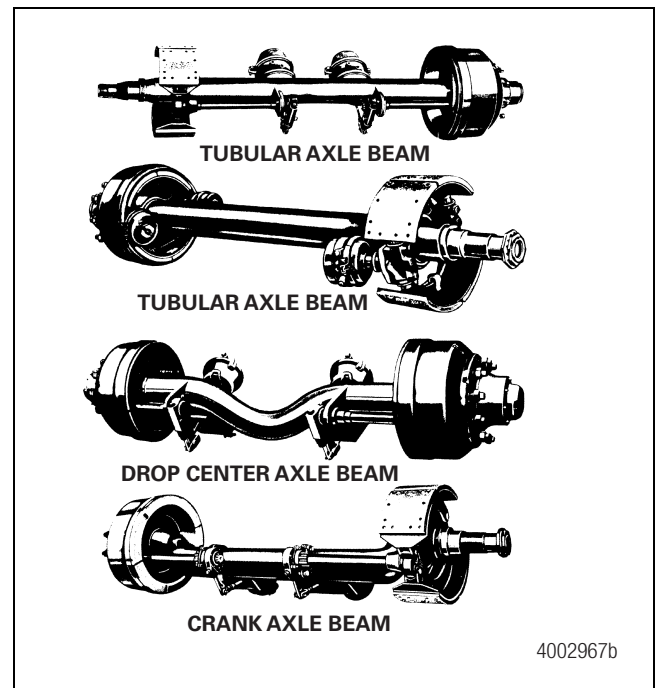
Figure 6.1

Meritor trailer axles are available in a variety of sizes and configurations, and are designed and rated for specific load applications. Figure 6.1. The gross axle weight rating (GAWR) specifies the maximum load limit for a trailer. Trailer axles that are operated above their GAWR can be damaged by torsional fatigue and bending fatigue.

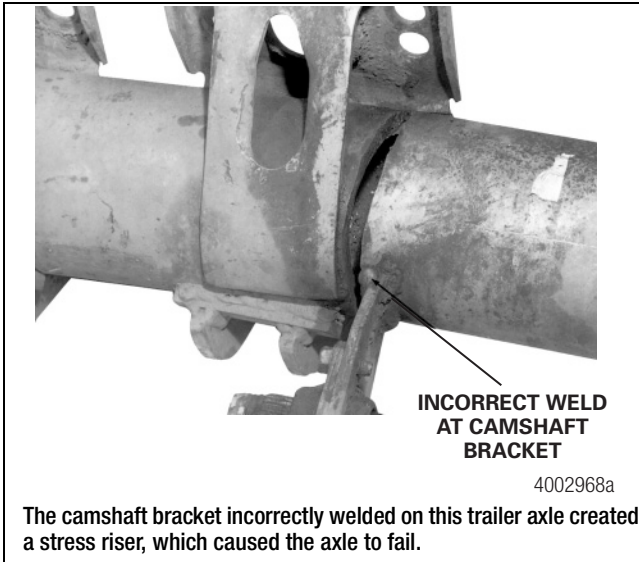
**Figure 6.2**

Welding on an axle creates intense heat that changes the characteristics of the metal that surrounds the weld, and an incorrect weld can cause fatigue to occur. In Figure 6.2, fatigue had created a stress riser, which caused the axle to fail.

Axle weld locations and welding procedures must adhere to Meritor standards and guidelines. Refer to Maintenance Manual 14, Trailer Axles, for complete welding instructions. To obtain this publication, refer to the Service Notes page on the front inside cover of this manual.

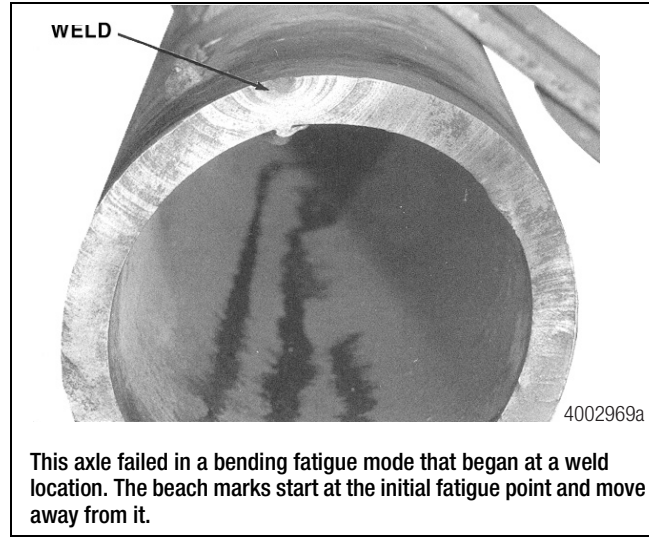
**Figure 6.3**

Usually, bending fatigue failures are toward the outer edges of the trailer axle. Figure 6.3 shows beach marks that begin at the initial fracture point and then move away from it.

Operate the vehicle within its approved application and weight limits.

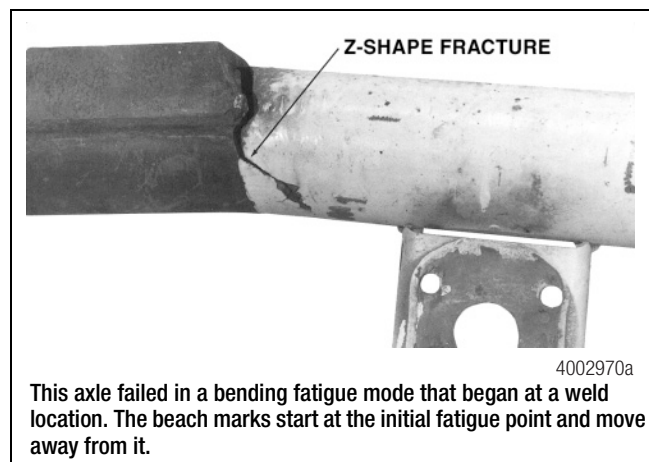
**Figure 6.4**

Beach marks begin at the initial fracture point and then move away from it. When torsional fatigue weakens the axle, the fracture often extends at a 45-degree angle to the axle's centerline. Fractures often form as an "S" or "Z" shape. Figure 6.4.

Operate the vehicle within its approved application and weight limits.

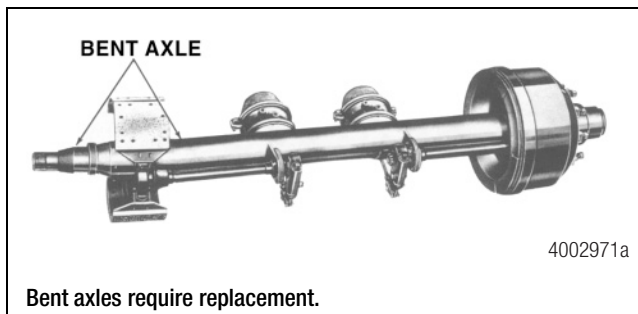
**Figure 6.5**

Figure 6.5 shows a trailer axle that was bent by shock load. The axle didn't fail immediately, but flexed too much and didn't return to its original shape as it continued to operate. When a trailer axle is damaged this way, the bend usually occurs outside the suspension mounts. A bent axle can affect tire wear and how the trailer handles, and must be replaced.

Operate the vehicle within its approved application and weight limits.

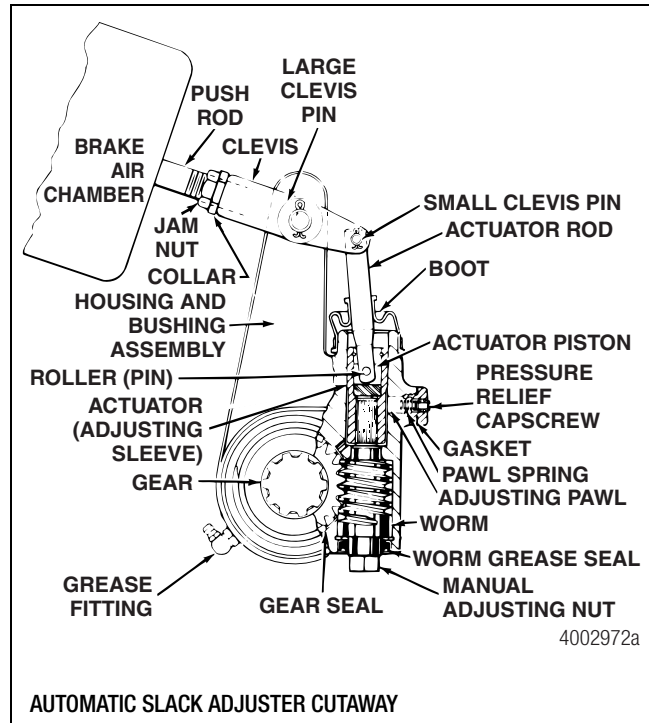
Figure 7.1

A slack adjuster is vital to correct brake operation. As linings wear, Meritor's automatic slack adjusters automatically adjust clearance between the brake lining, and brake drum or rotor on cam and air disc brakes. Figure 7.1.

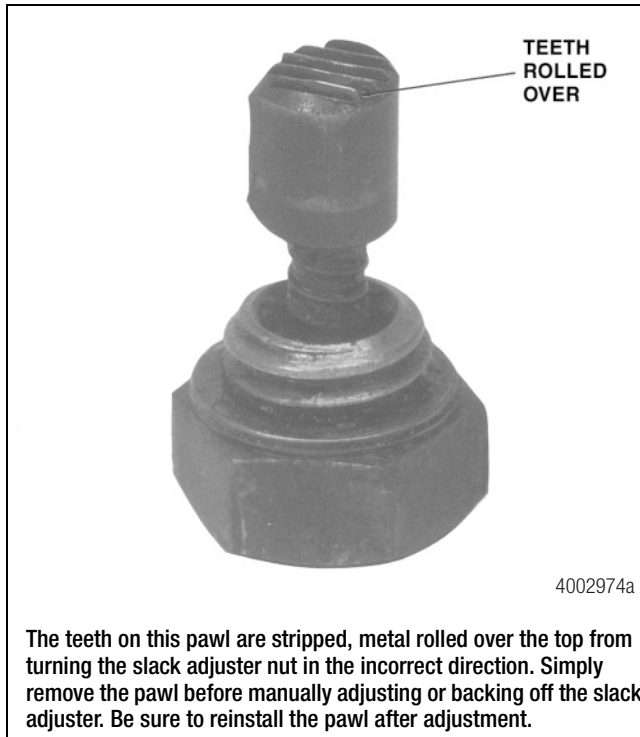
4002974a

The teeth on this pawl are stripped, metal rolled over the top from turning the slack adjuster nut in the incorrect direction. Simply remove the pawl before manually adjusting or backing off the slack adjuster. Be sure to reinstall the pawl after adjustment.

Follow Meritor's recommended maintenance practices and service procedures.

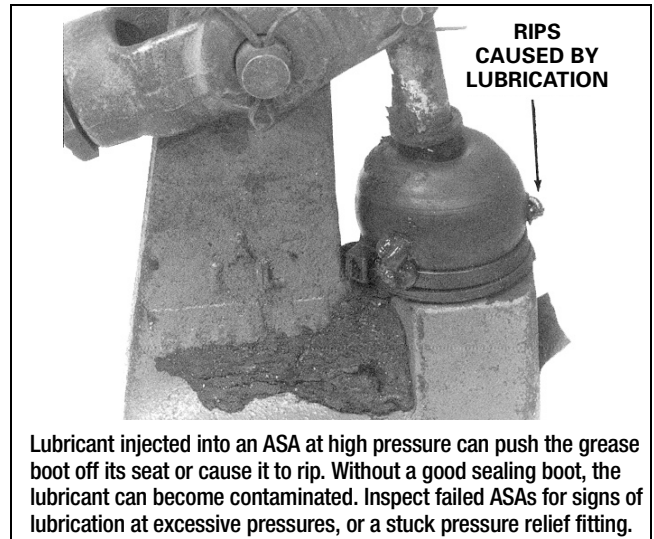
**Figure 7.3**

Insufficient lubrication can cause internal friction, difficulty turning the adjusting nut, and loss of automatic adjustment. If grease is pumped into the fitting at a pressure that's too high, it will push the boot off the slack adjuster or rip the rubber boot. Both of these situations will contaminate the grease. Figure 7.3.

Follow Meritor's recommended maintenance practices and service procedures.

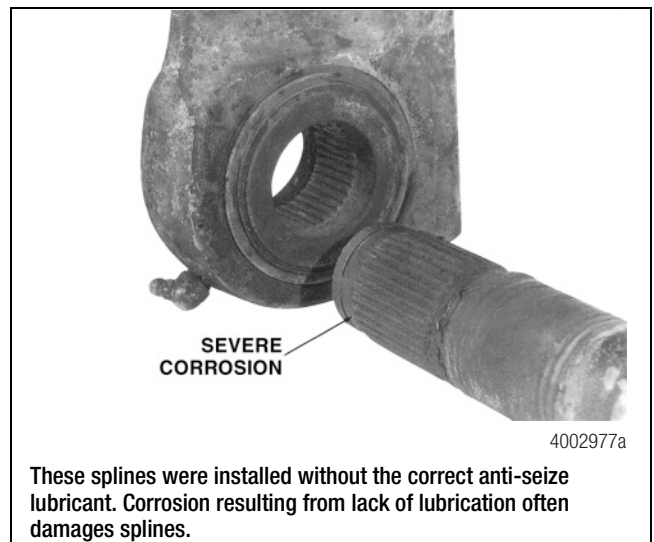
4002977a

These splines were installed without the correct anti-seize lubricant. Corrosion resulting from lack of lubrication often damages splines.

Follow Meritor's recommended maintenance practices and service procedures.

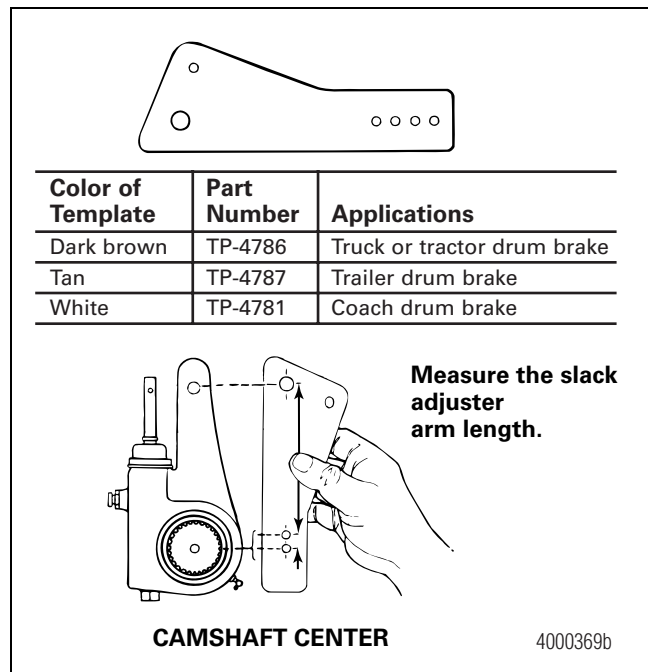
Figure 8.1

If a slack adjuster is installed at an incorrect angle, the brakes will either have too much clearance, or the brakes will drag. Too much clearance will decrease braking efficiency and cause brakes to be out-of-balance. Figure 8.1.

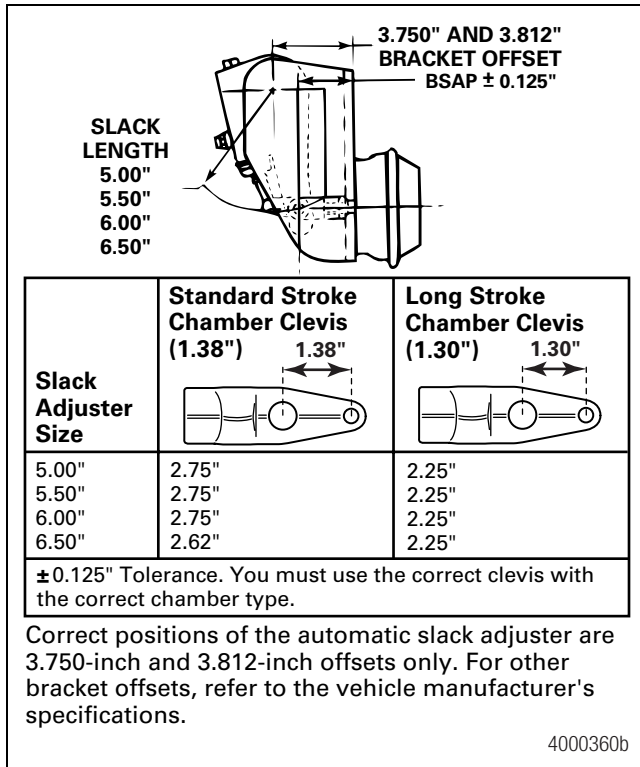
Figure 8.2

Follow service procedures and install the correct slack adjuster for the brake type to prevent over-adjustment and excessive brake clearance. Figure 8.2.

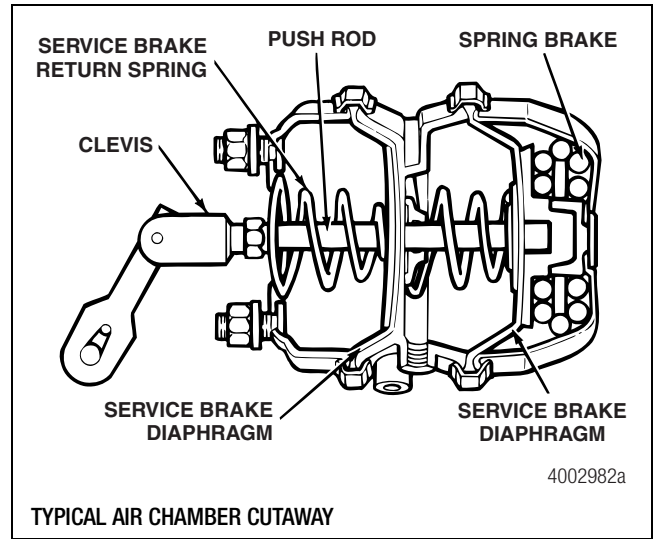
Figure 8.3

The spring brake applies braking force when the air system is drained, and it's also used as a parking brake when the vehicle is stationary. During operation, air pressure releases the spring brake to move the vehicle, and the service brake half of the air chamber controls braking. Figure 8.3.

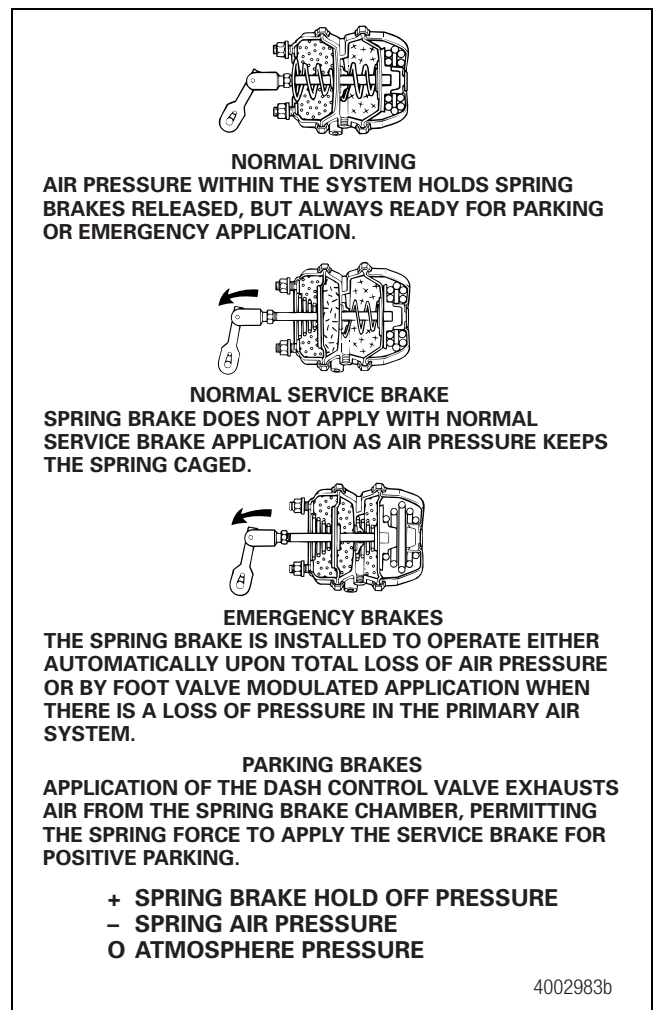
Figure 8.4

If the spring brake fails to fully release, the brakes will drag and the linings will wear prematurely. Look for damage caused by excessive heat buildup. Check for mechanical problems with the spring brake and problems in the air system. Figure 8.4.

The air system supplies the force to apply and release the brakes. Figure 8.4. If air valves stick because they're corroded or plugged with contaminants, the brakes may not apply, or they'll apply with too much force. For example, if a valve malfunctions, the parking brakes and service brakes can apply at the same time and damage components. This is called "compounding."

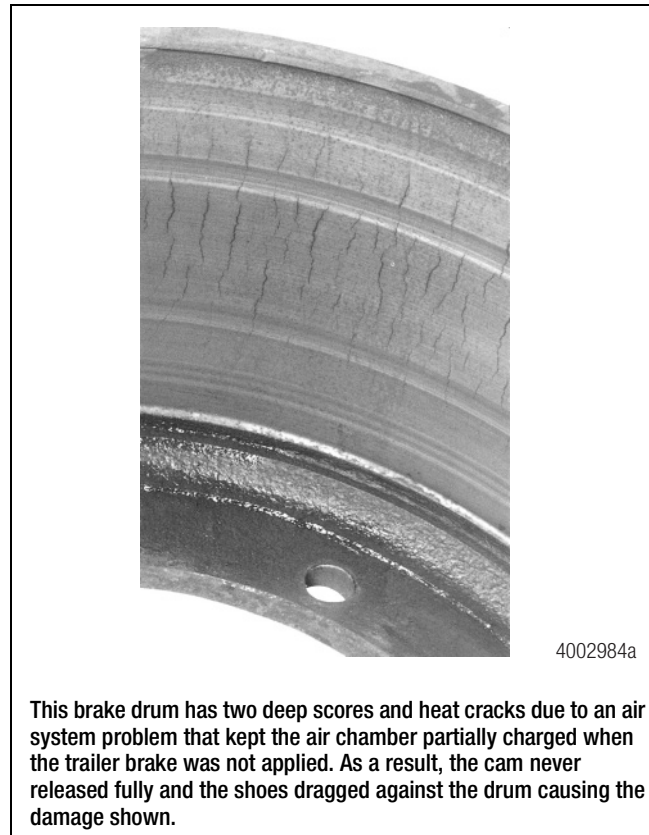
Figure 8.5 shows a brake drum with deep scores and heat checks caused by an air system problem that kept the air chamber partially charged when the trailer brake wasn't applied. As a result, the cam didn't fully release, and brake drag occurred during operation.

Bleed the system's wet tank daily to help prevent moisture buildup that corrodes the air valves. Follow Meritor's recommended maintenance practices and service procedures.

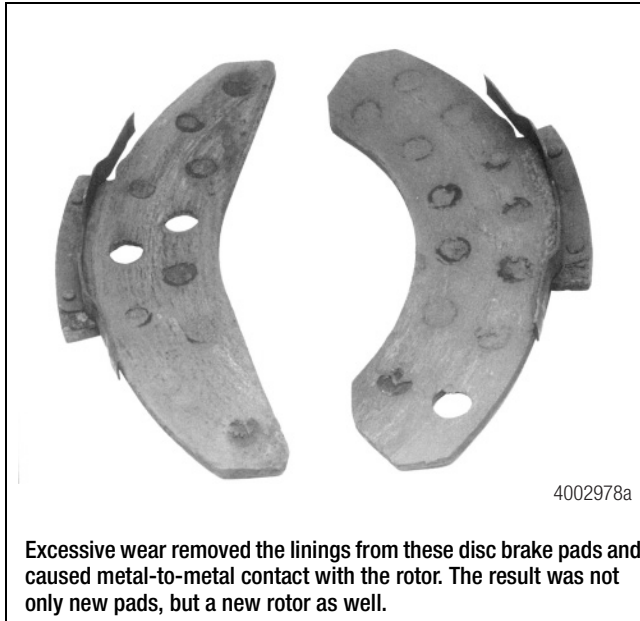
**Figure 8.6**

Figure 8.6 shows metal-to-metal contact damage to the rotor when excessive wear from brake drag removed the linings from the pads.

Operate a vehicle within its approved application and weight limits.
