Manual TP-0445

# Parts Failure Analysis

# Service Notes

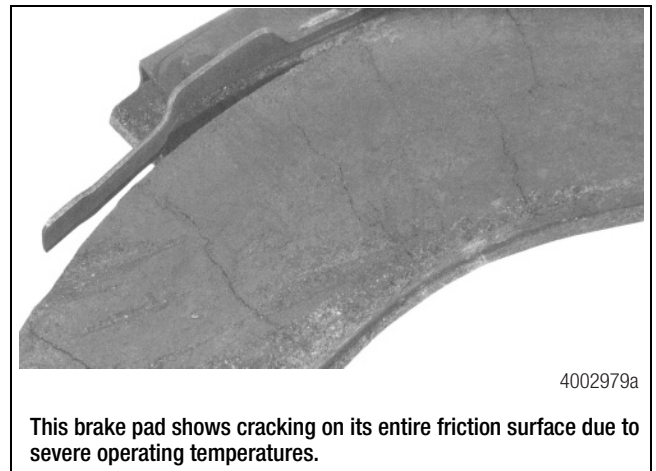
**Figure 8.8**

Figure 8.8 shows a brake pad with heat checks on the entire friction surface that resulted from high operating temperatures.

Operate a vehicle within its approved application and weight limits.

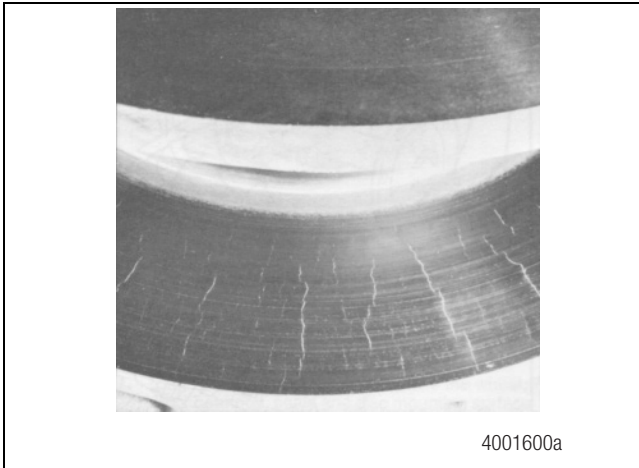
Figure 8.9

There are two types of heat checking: light and heavy. Figure 8.9.

Follow Meritor's recommended maintenance practices and service procedures.

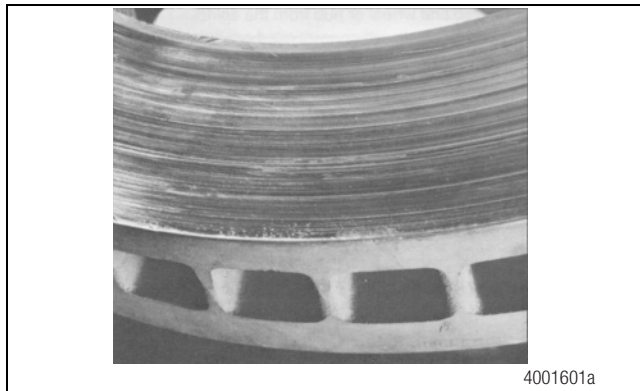
**Figure 8.13**

Inspect both sides of the rotor. If you find grooves or scores of a depth less than 0.02-inch (0.5 mm), continue to use the rotor. If the grooves are greater than 0.02-inch (0.5 mm), you may choose to resurface the rotor. If the rotor thickness measured across any groove is less than 1.46-inches (37 mm), discard and replace the rotor. Figure 8.13.

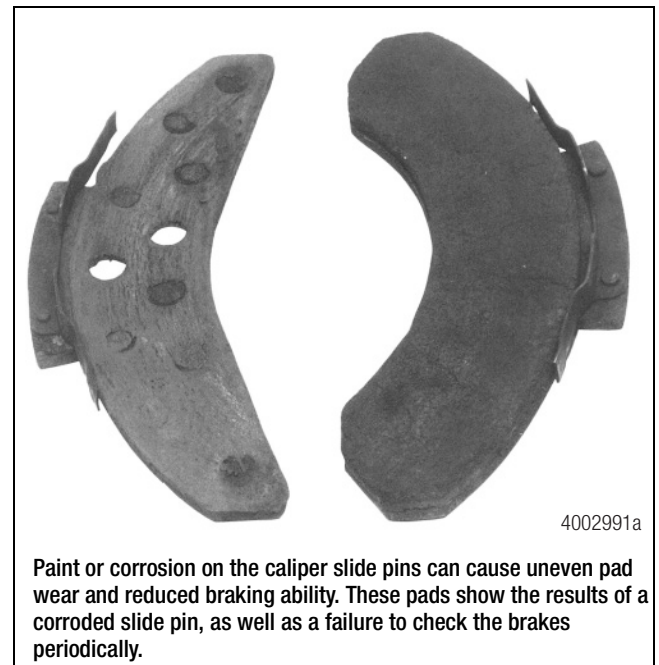
4002991a

Slide pins enable the caliper assembly to apply braking pressure on both sides of the rotor. If the slide pins are painted, the caliper can corrode and seize, and only the inboard pad will apply pressure. As a result, the inboard pad wears prematurely. Figure 8.14.

When a caliper assembly is insufficiently lubricated, the slide pins will corrode and cause the brake pads to drag on the rotor. If a caliper assembly is over-lubricated, pressure will build up and prevent the brake pads from retracting. Figure 8.14.

Paint or corrosion on the caliper slide pins can cause uneven pad wear and reduced braking ability. These pads show the results of a corroded slide pin, as well as a failure to check the brakes periodically.

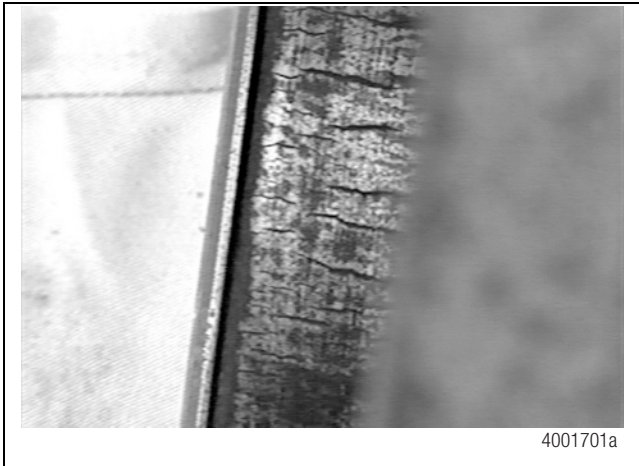
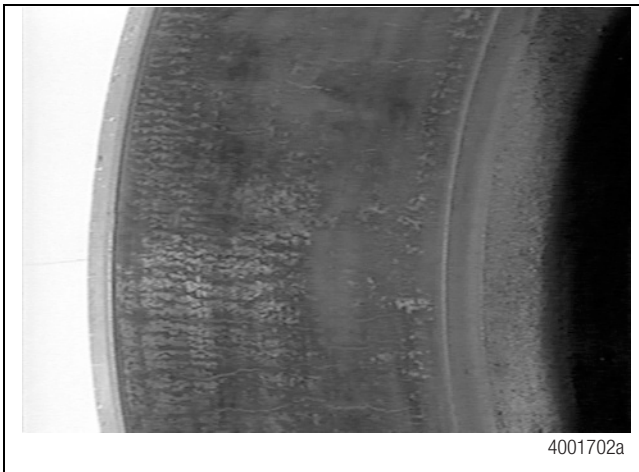
Deep, uniform wear at the edge of the drum where the lining path begins can result from brake drag, imbalance, contaminants embedded in the brake lining, no brake retarder, braking with a hand valve, not downshifting on steep grades, and exceeding a vehicle's braking capacity. Figure 8.15 and Figure 8.16.

Replace the drum. Install dust shields; or if they're installed, remove the shields and operate the vehicle.

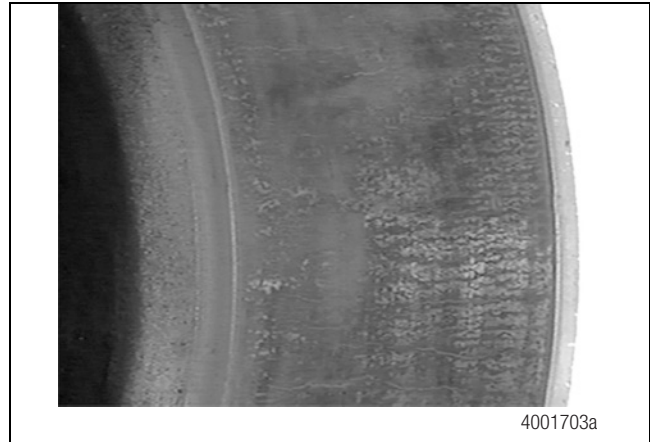
**Figure 8.17**

Deep wear on only one side of the drum indicates the drum is machined out-of-round, or the drum was dropped or bent. No evidence of hot spotting may be evident. Replace the drum. Figure 8.17.

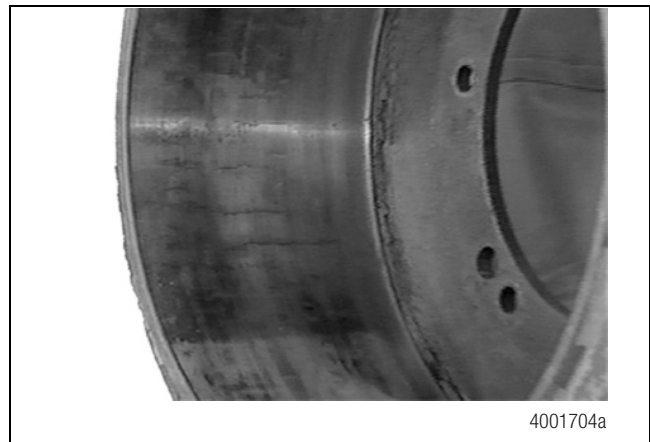
**Figure 8.18**

Heat checking is fine lines or cracks that uniformly cover the drum's surface. Heat checking is a normal condition that results when the drum's friction surface continually heats and cools. However, if the drum operates under high temperatures or overloaded conditions or if the vehicle operates under heavy braking, larger cracks can develop and extend below the surface.

Fine lines and cracks over the entire drum surface that are less than one-inch (25.4 mm) in length.

Replace the drum.

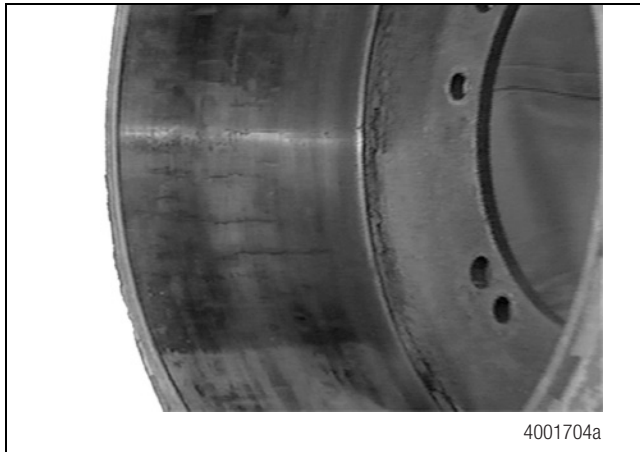
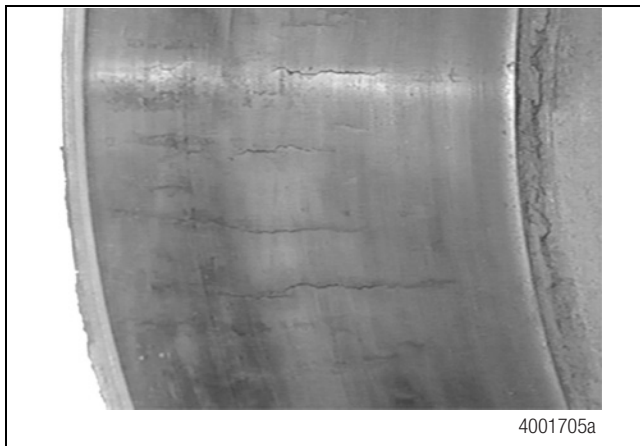
Look for fine cracks on only one side of the drum surface. However, cracks that are one-inch (25.4 mm) or more are usually deep and require drum replacement. Hot spotting may or may not be evident, and you also may find deep wear on the same side of the drum.

Heat checking on only one side of the drum can indicate that the drum is machined out-of-round, it was dropped or bent, or the drum-to-pilot fit has too much end play. Figure 8.19 and Figure 8.20.

Replace the drum.

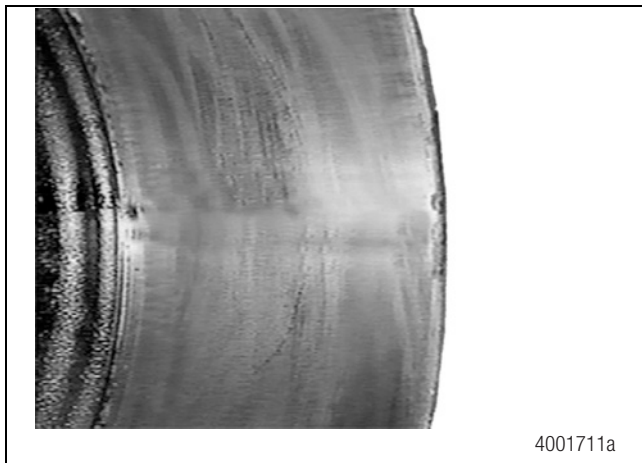
**Figure 8.26**

Very high operating temperatures can cause the brake drum to turn a blue color, and components are damaged.

Replace the drum or rotor.

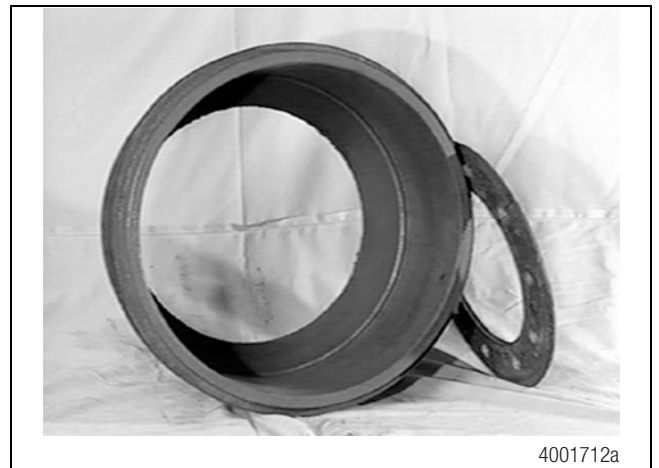
**Figure 8.27**

The bolt flange is broken, but the drum surface isn't cracked. This situation usually results when an incorrect drum was assembled onto a hub or spoke wheel. When the fasteners were tightened, the clamping load cracked the flange. Flanges can also break if both brake shoes don't contact the drum at the same time. Figure 8.27.

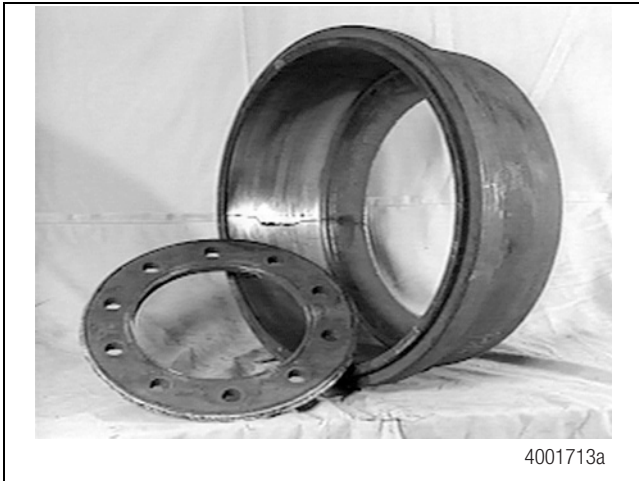
Figure 8.28

High temperatures caused the expanding brake shoes to separate the bolt flange from the drum with enough force to crack the drum, but the flange remained intact. A cracked drum surface occurs from excessive wear, heat checking or hot spotting, or a combination of these conditions. Figure 8.28.

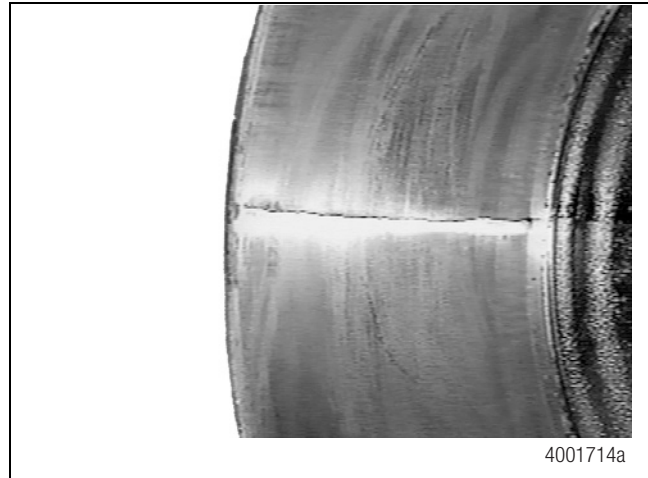
Figure 8.29

Brake drum pilot interference with the hub or wheel pilot also can cause the entire cross section of the drum to crack, if the drum was forced onto the pilot. Figure 8.29.

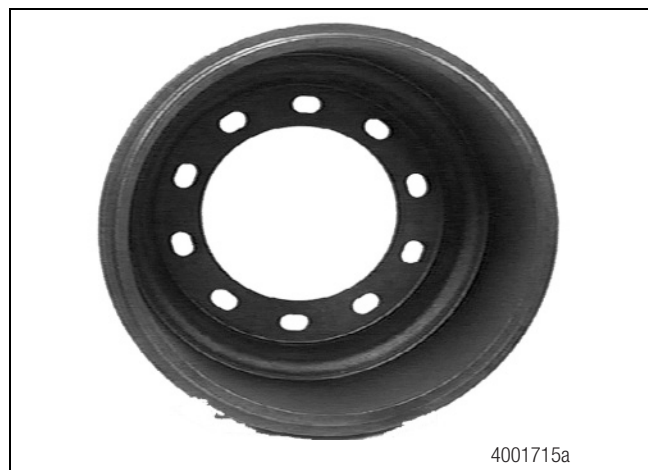
Figure 8.30

Worn bolt holes result because the bolts weren't tightened to the correct torque specification. Drum pilots also can be worn and damaged, and runout in the brake drum could have occurred. Figure 8.30.

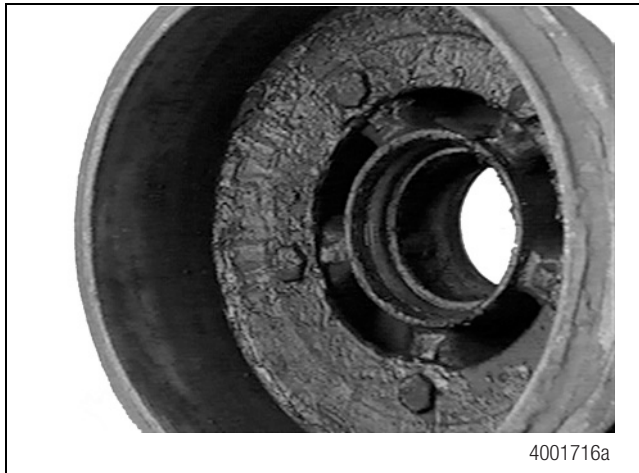
Figure 8.31

The brake system has been contaminated with lubricant when the following conditions are evident: oil or grease has penetrated the drum's surface; the brake drum is discolored; and lubricant is evident on the components, which resulted from wheel or hub oil seals that leaked. All of these conditions require drum replacement. Figure 8.31.

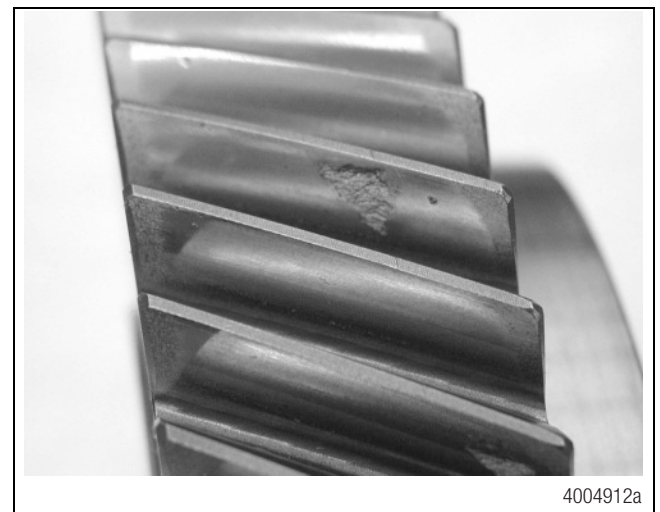
Figure 9.1

Spalling on spur gear teeth looks similar to heavy pitting, but the cavities are usually larger in diameter and shallower in depth. Figure 9.1. Was the gear overloaded?

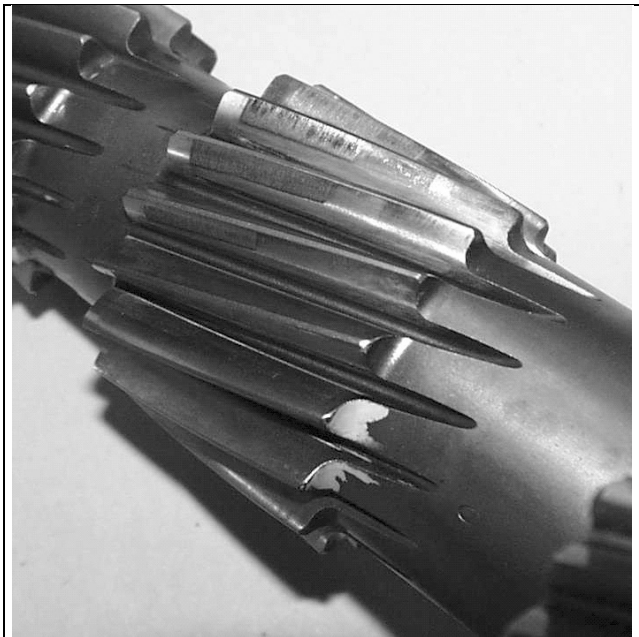
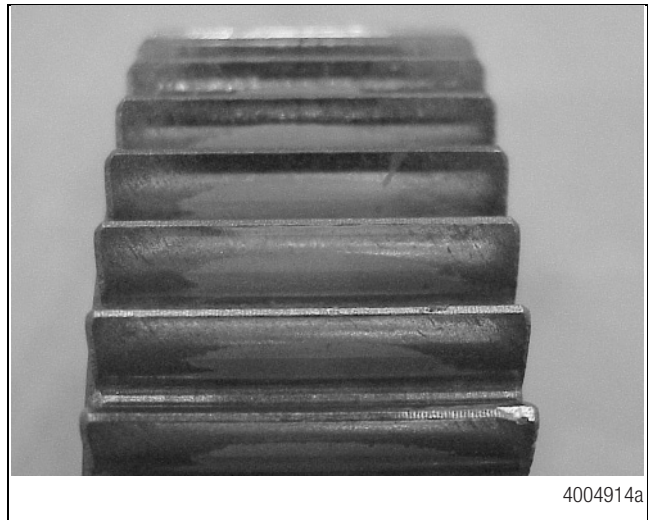
Figure 9.2 and Figure 9.3 show how metal separated from the gear teeth and welded to the mating gear teeth. Spur gears damaged by galling require replacement.

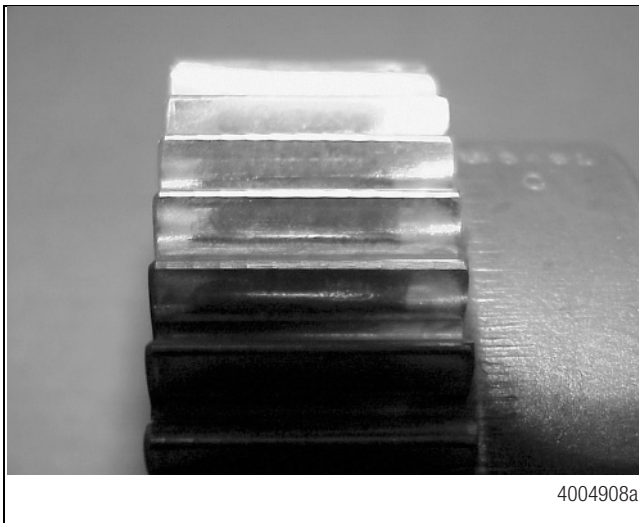
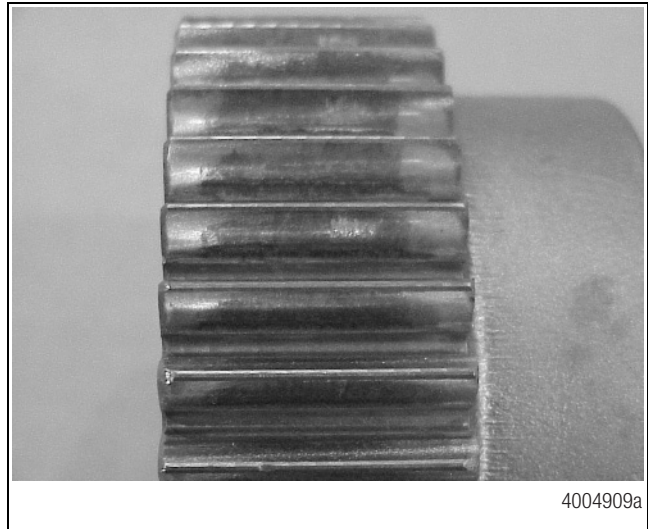
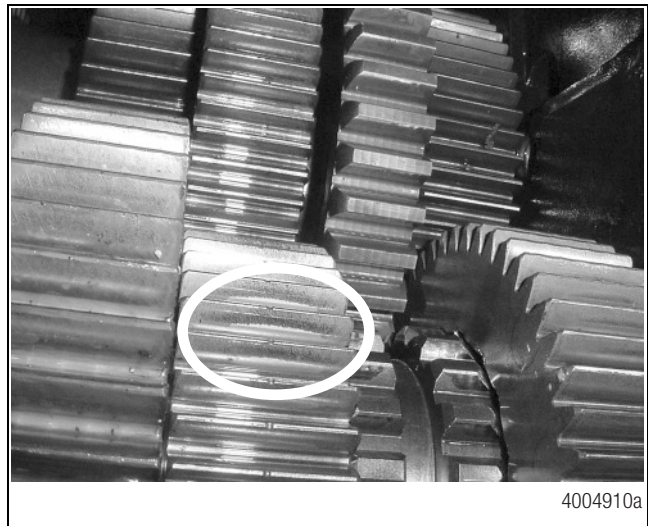
Frosting is a grayish or yellowish white color usually found at the center of the teeth at the mating gear contact position. Light pitting on the gear teeth also may accompany frosting. Figure 9.8, Figure 9.9 and Figure 9.10.

No action is required. Frosting is a normal wear condition on spur gear teeth that does not affect performance or gear life. As the gear continues to operate, sliding friction eventually removes frosting. If frosting is the only wear you see on spur gears, do not replace the gears.

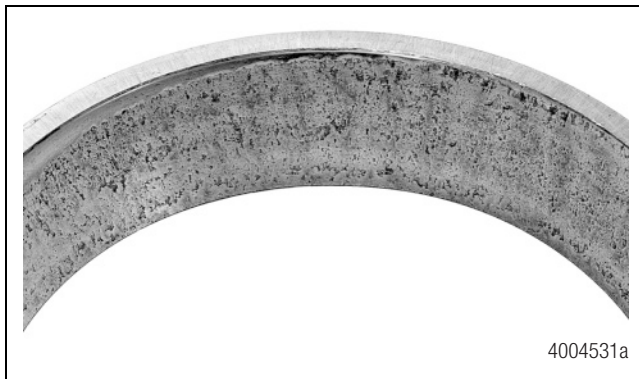
Figure 9.11

Pitting is a type of surface fatigue that forms pits, or cavities, on metal surfaces. Figure 9.11. If pitting is heavy, it can progress until pieces of surface metal break, or spall, from a component.

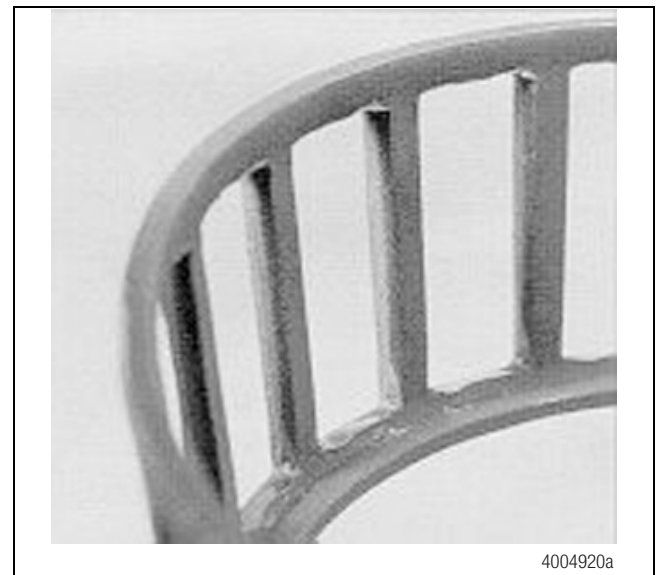
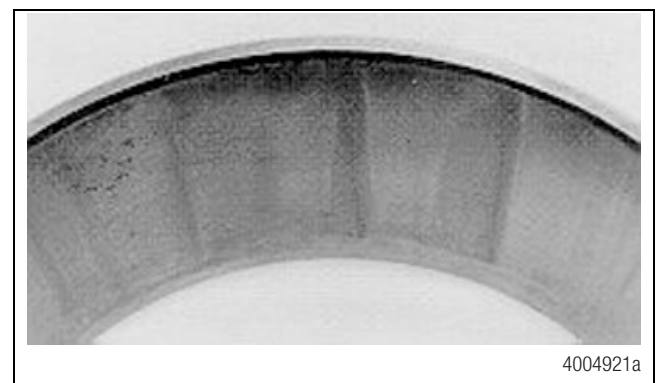
Look for wider bearing pockets and "skidding" wear on the cup and cone surface. Figure 9.12 and Figure 9.13. "Skidding" wear occurs when the wider bearing pockets enable the rollers to turn at an angle in the pocket, and then snap back into place. A bearing damaged by excessive end play requires replacement.

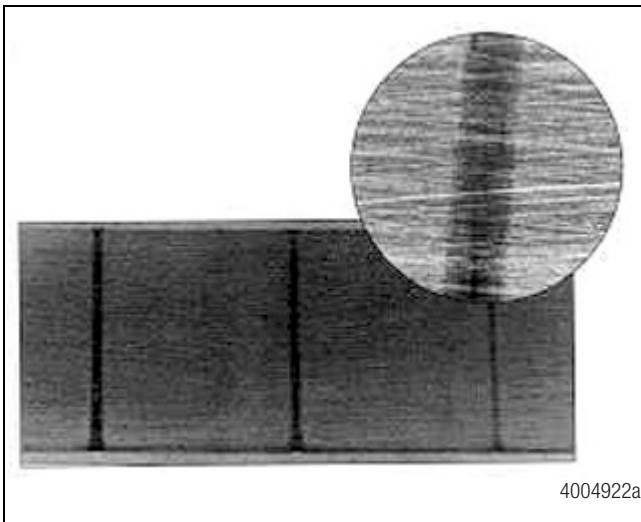
Figure 9.14

Look for machined marks and displaced metal on the bearing cup and cone. Figure 9.14. A bearing damaged by brinelling requires replacement.

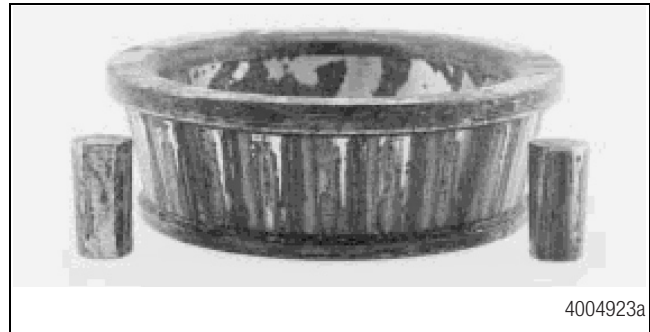
Figure 9.15

Etching is a dark surface stain on the roller bearing. Figure 9.15. A bearing damaged by etching requires replacement.

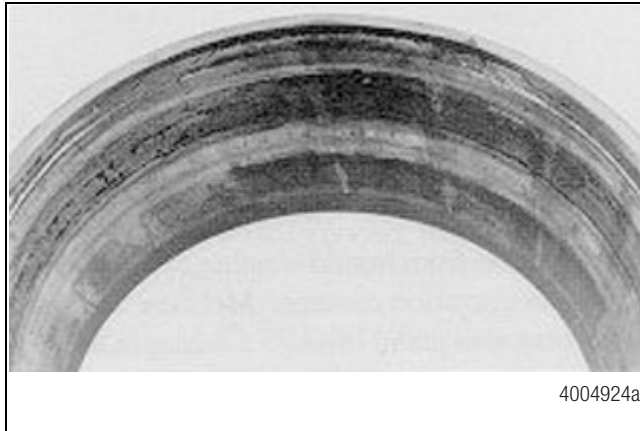
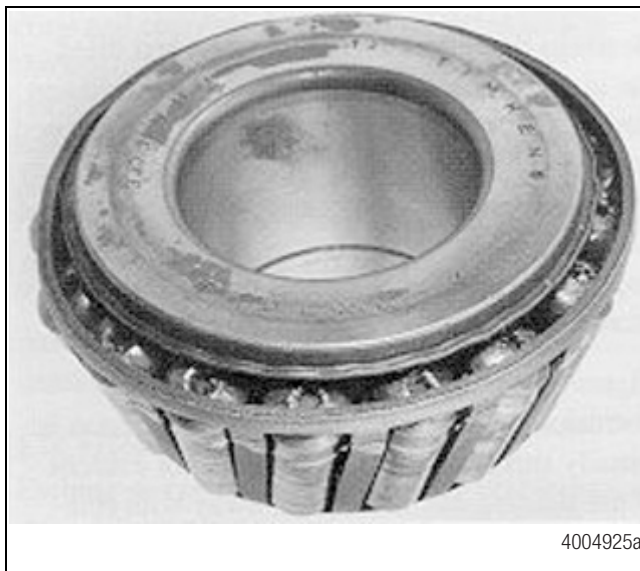
A bearing damaged by insufficient lubricant will overheat, and you’ll see that its color has changed from silver to deep blue. If the bearing is black, it is an indication that it seized and caused metal to separate from the bearing and weld to other mating components. Figure 9.16 and Figure 9.17. Bearings damaged by insufficient lubricant require replacement.

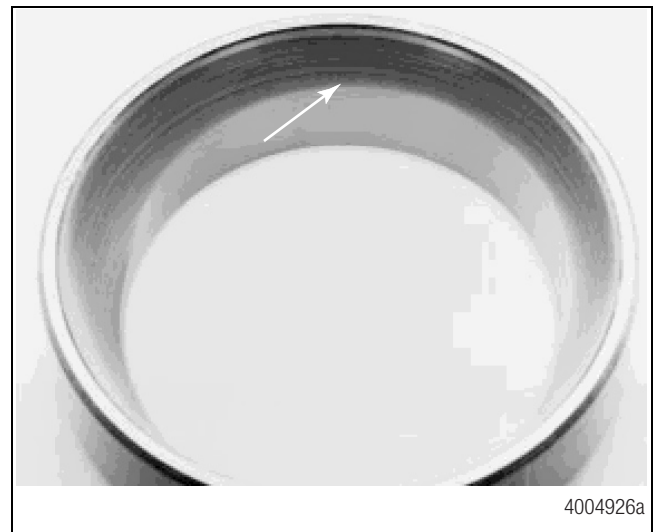
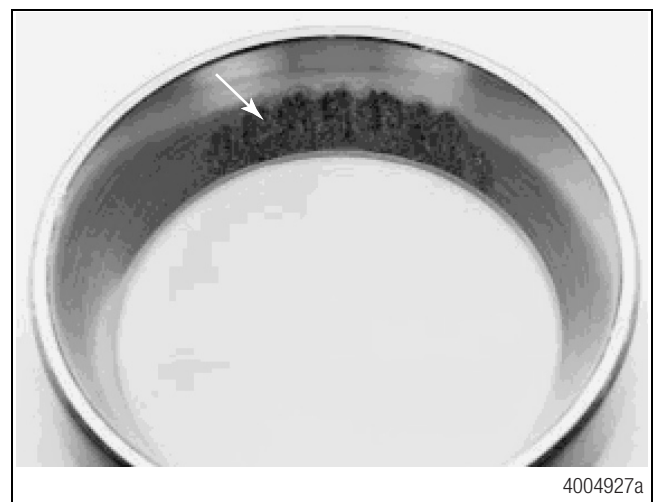
Look for uneven wear damage on the bearing, as well as spalling on the cup and cone. Both conditions require bearing replacement. Figure 9.18 and Figure 9.19.

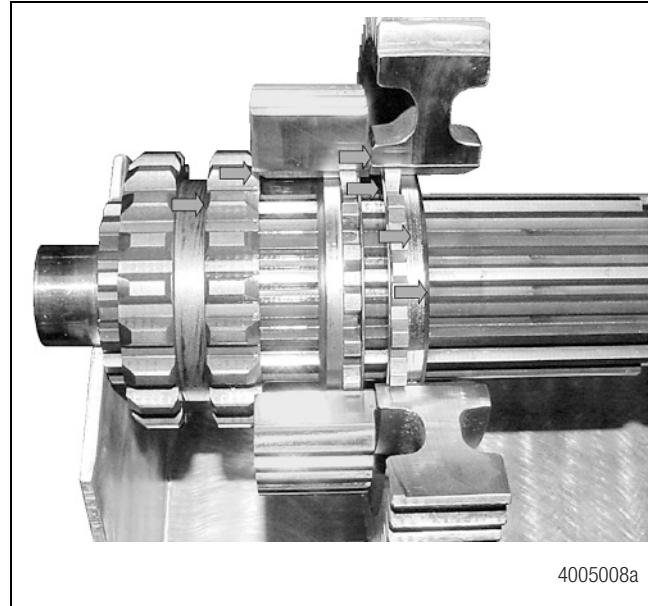
Figure 9.20

**Insufficient lubricant caused high operating temperatures that damaged the washer. The driver operated the vehicle incorrectly. Figure 9.20. Shock load occurred, which damaged the transmission. Figure 9.21.**

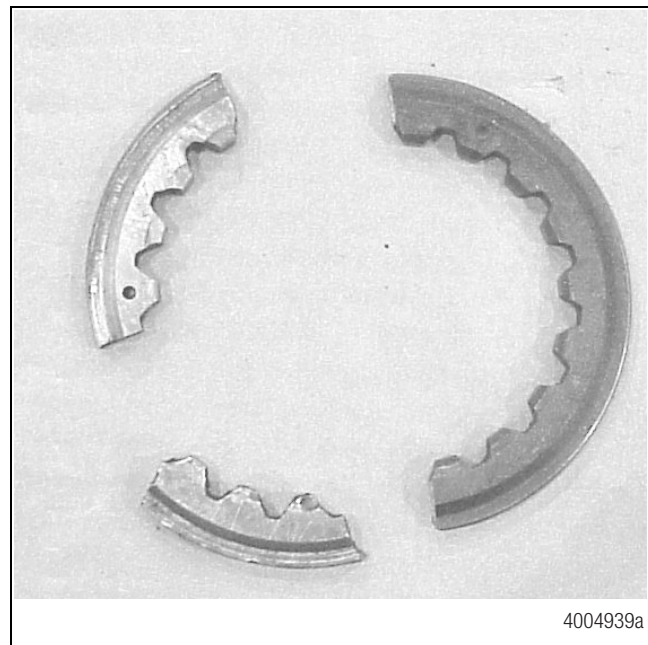
Figure 9.21

Figure 9.21. The fracture didn't occur on the entire surface of the teeth, and the gear will be out-of-position. Check the sliding shift collars and the teeth on the clutch collar for fractures and excessive wear, which are signs of grinding gears. Figure 9.23.

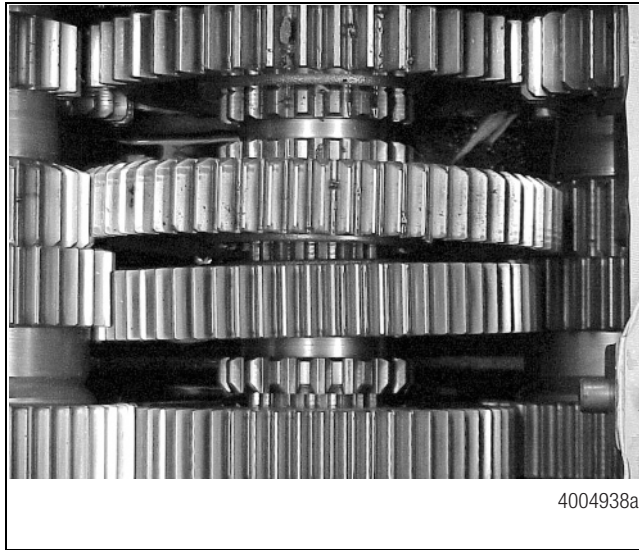
**Figure 9.22**

Check the main shaft spacing. If it is too tight, metal-to-metal contact occurs, which results in high operating temperatures that damaged the main shaft. Figure 9.22.

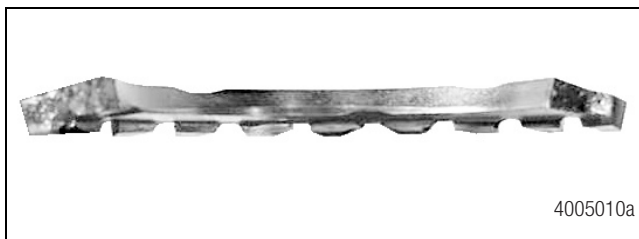
**Figure 9.24**

If the main shaft washer is fractured, was it dropped during assembly? Figure 9.24. Is there evidence of heat checking? Did shift lever slip out (not jump out) occur? Is the snap ring damaged?

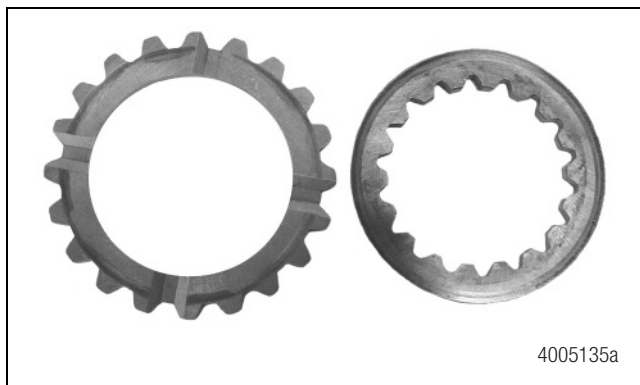
Figure 9.25

It’s normal to find wear on washers and spacers in high-mileage units. Figure 9.25. However, inspect parts for excessive wear or a “burned” look that occurs from insufficient lubricant and high operating temperatures. Figure 9.26.

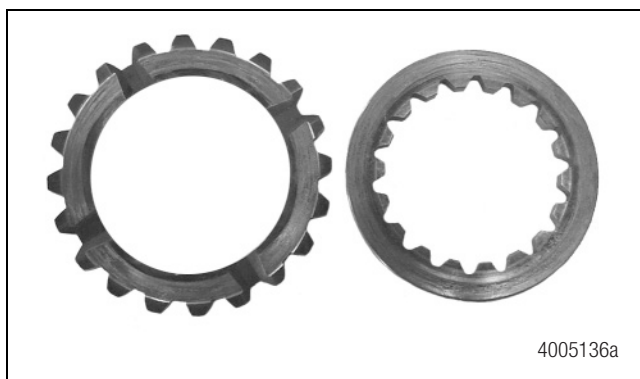
Figure 9.26

The main shaft gear float clearance is not within the correct specification. The washers and spacers were damaged by insufficient lubricant; or the operator used “float shifting,” which loaded the washers and spacers. Float shifting forces lubricant from between the washer and spacer, which damages these parts.

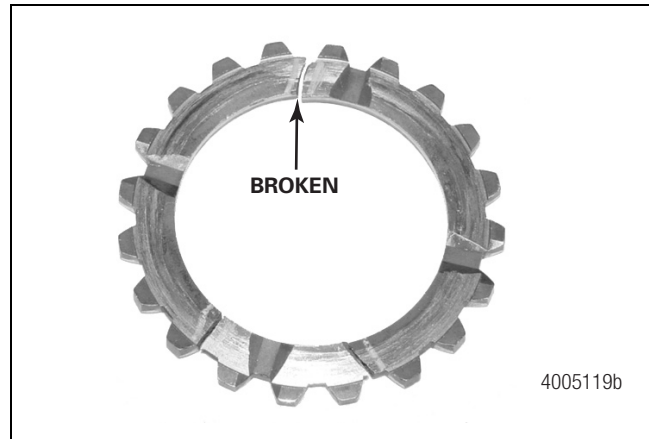
Figure 9.27

Try to determine if the driver shifted the transmission correctly and didn’t use “float shifting.” During float shifting, the driver doesn’t use the clutch, but “floats” the shift collar into gear. Look for scoring, galling, burning and fractures on the washers and spacers. Figure 9.27.

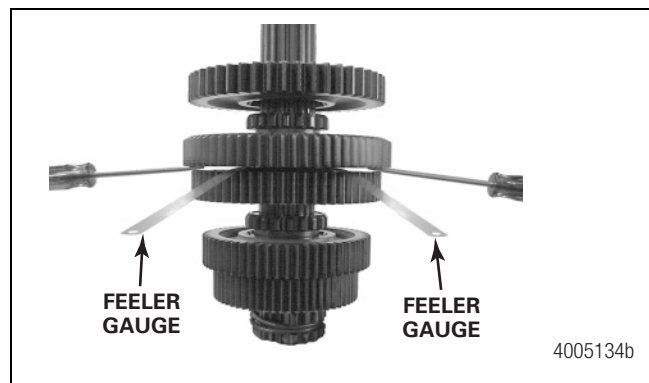
Gear float is important, because when it’s correctly set, it enables lubricant to pass between the mating gears to lubricate the gear hubs, washers and spacers. If clearance is too tight, the gear hubs, washers and spacers will score, gall and burn.

Check that gear float clearance is correct. In-service float clearance must not exceed 0.024-inch (0.068 mm), or two times the maximum factory-set clearance of 0.006-0.012-inch (0.152-0.304 mm). Figure 9.28 and Figure 9.29.

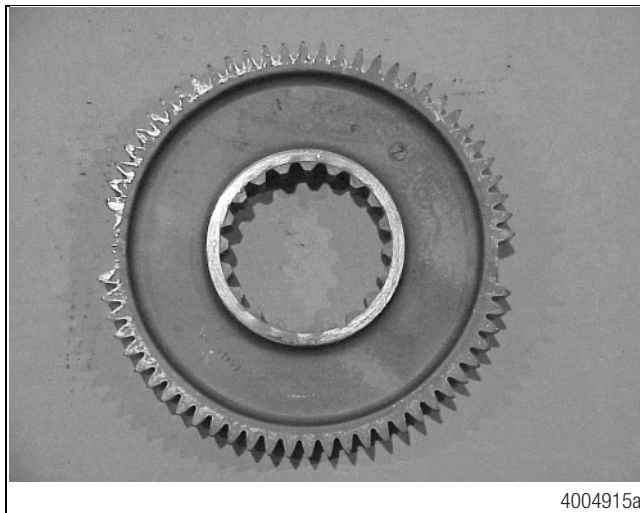
Figure 9.30

**Shock load occurred that damaged the gear teeth.**

Look for fractures on gear teeth at 180-degree intervals. Figure 9.30. If the shock load is severe, damage can extend to the main shaft and bearing, as well as other transmission components. Try to determine if the driver shifted the transmission incorrectly. Figure 9.31, Figure 9.32, Figure 9.33, Figure 9.34 and Figure 9.35.

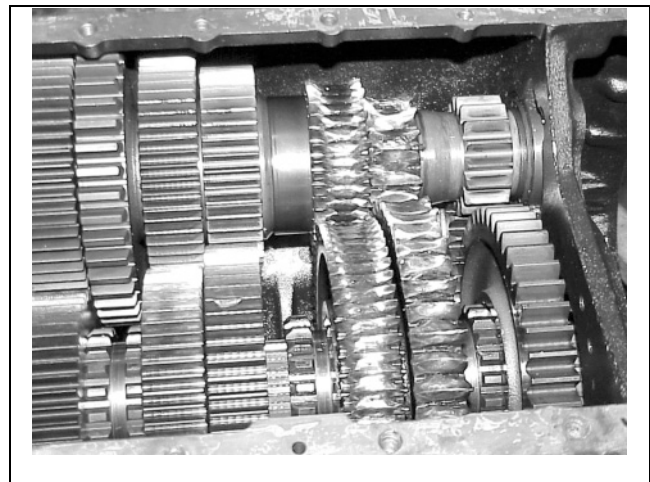
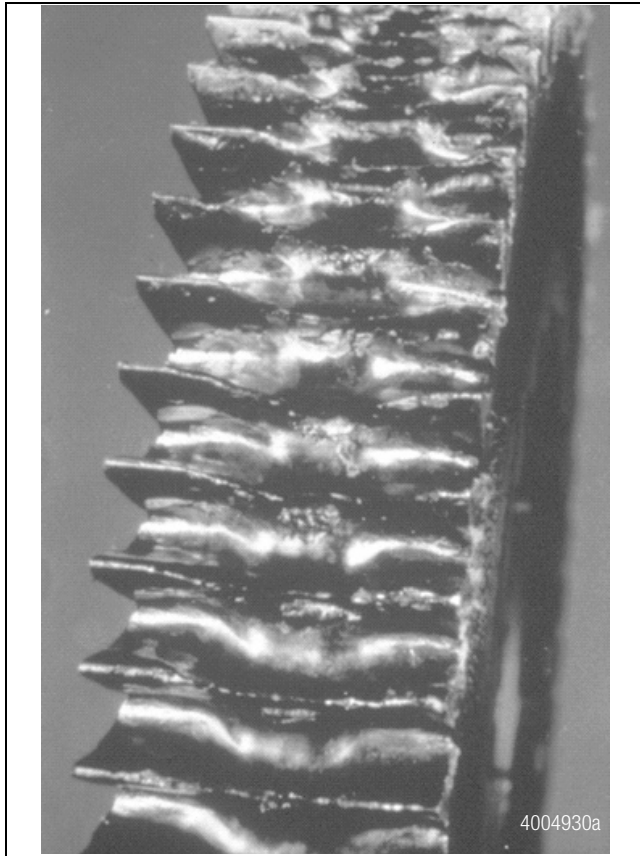
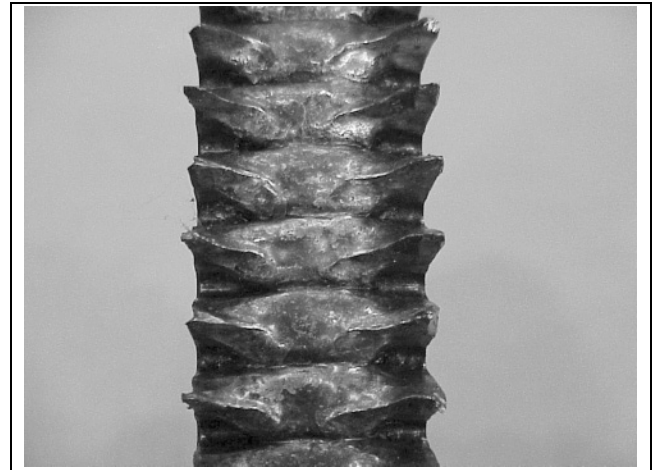
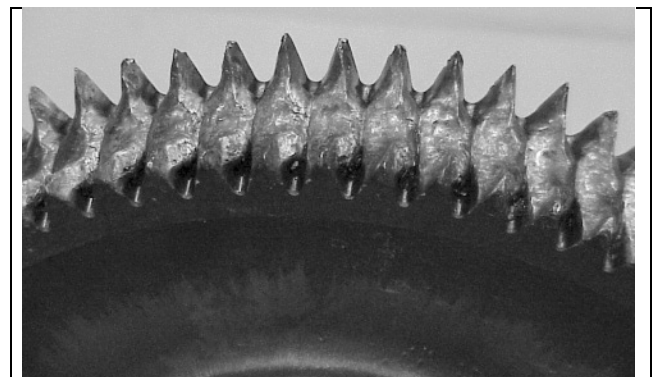
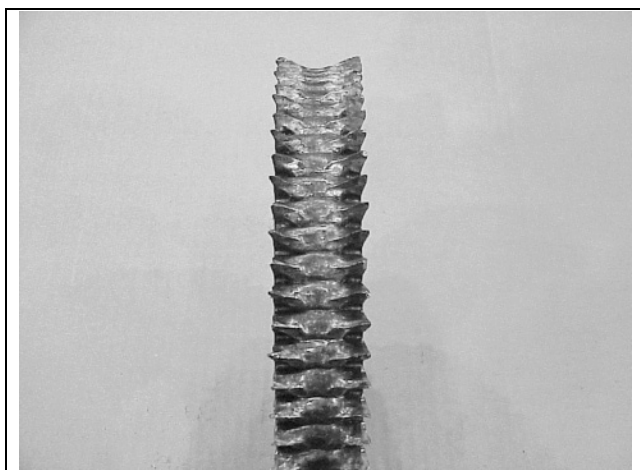
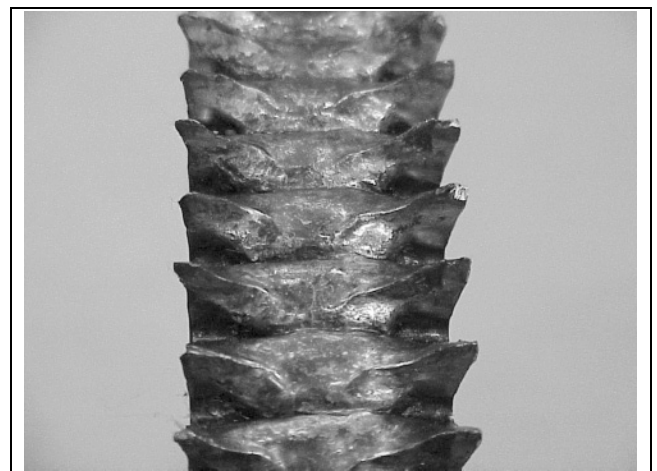
Look for leaking transmission seals. Look for a common wear pattern on the gear teeth called "apple coring," which occurs when metal melts at high temperatures and leaves a central, concave depression in the gear teeth. Figure 9.36, Figure 9.37, Figure 9.38, Figure 9.39, Figure 9.40 and Figure 9.41.

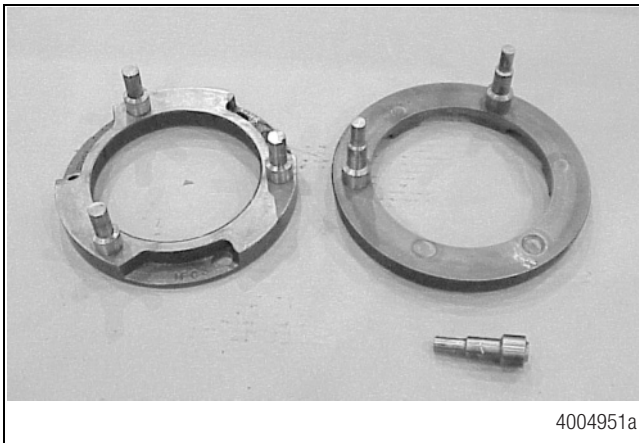
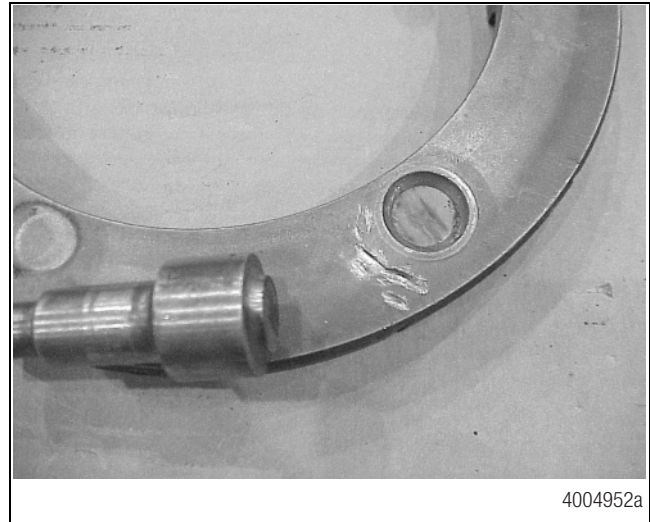
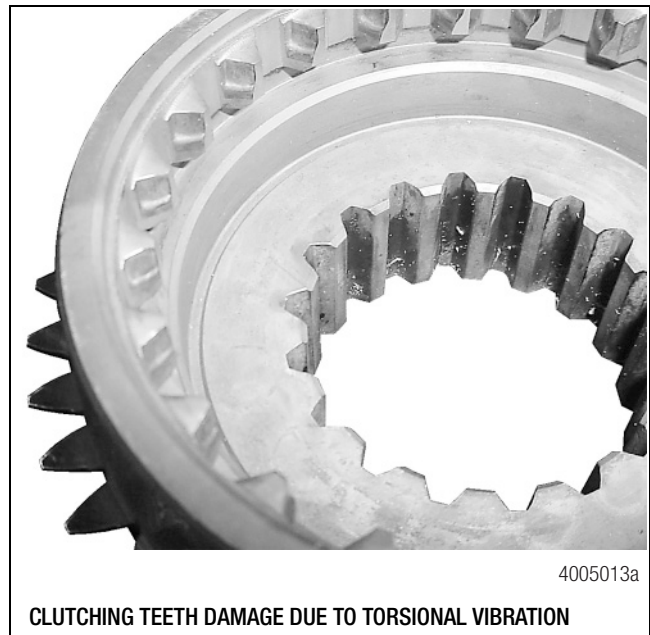
Check the synchronizer assembly and pins. When torsional vibration occurs, pins can be fractured. Figure 9.42, Figure 9.43 and Figure 9.44. A synchronizer damaged by torsional vibration require replacement.

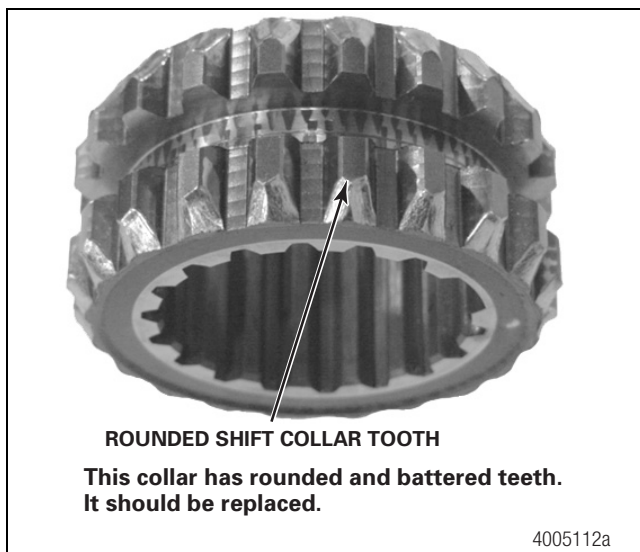
Figure 9.45

Shift collar teeth surfaces are worn and rounded instead of flat and trapezoid shape. Figure 9.45. Are the sides of the teeth surfaces polished? This indicates that the collar is fully engaged into the mating gear. If wear doesn't extend to the end of the tooth, the collar isn't engaging fully into the gear.

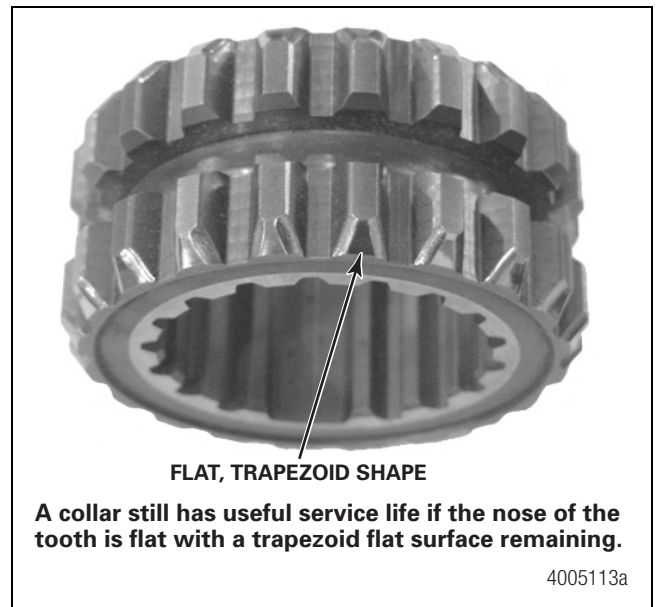
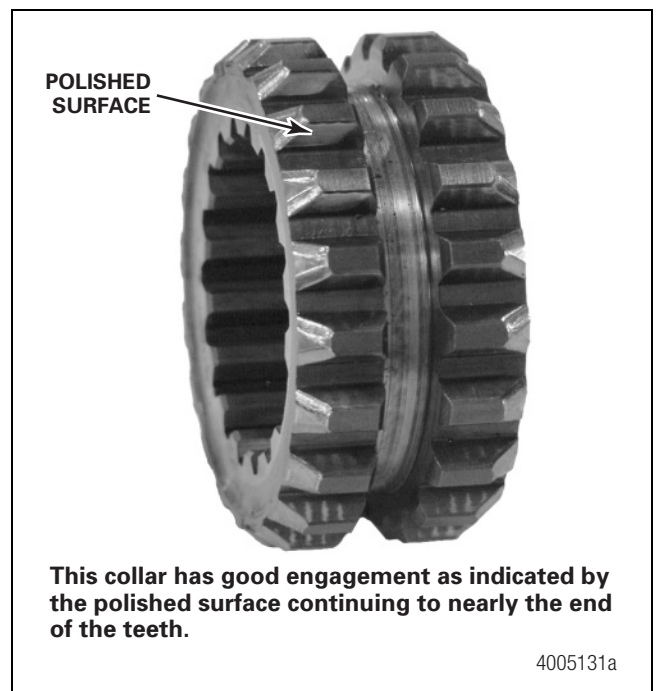
Can you still see a trapezoid shape on the ends of the teeth? Are teeth surfaces polished? If so, the shift collar is fully engaging and doesn't require replacement. Figure 9.46 and Figure 9.47.

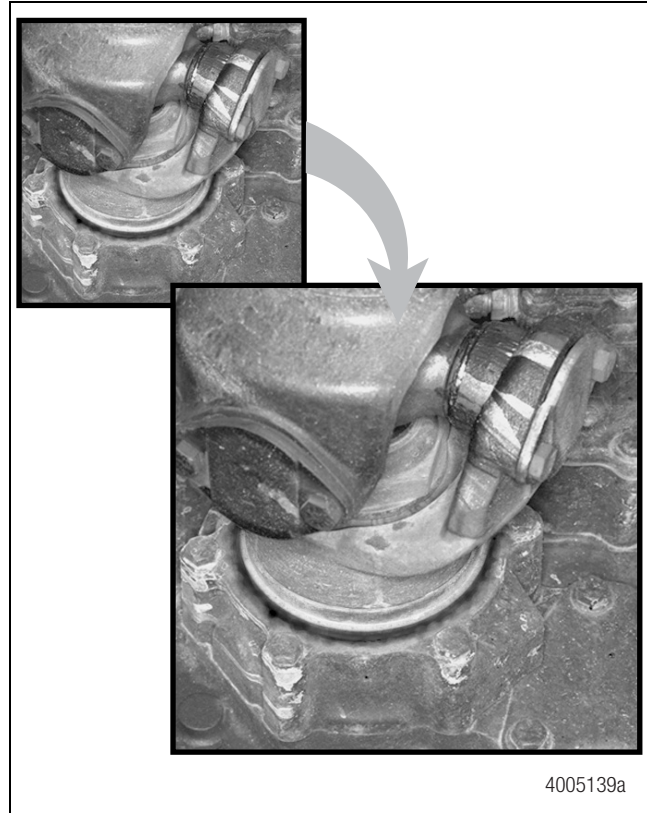
**Figure 9.48**

There's slight moisture from packing grease at assembly, but the area around the seal is dry. Figure 9.48.

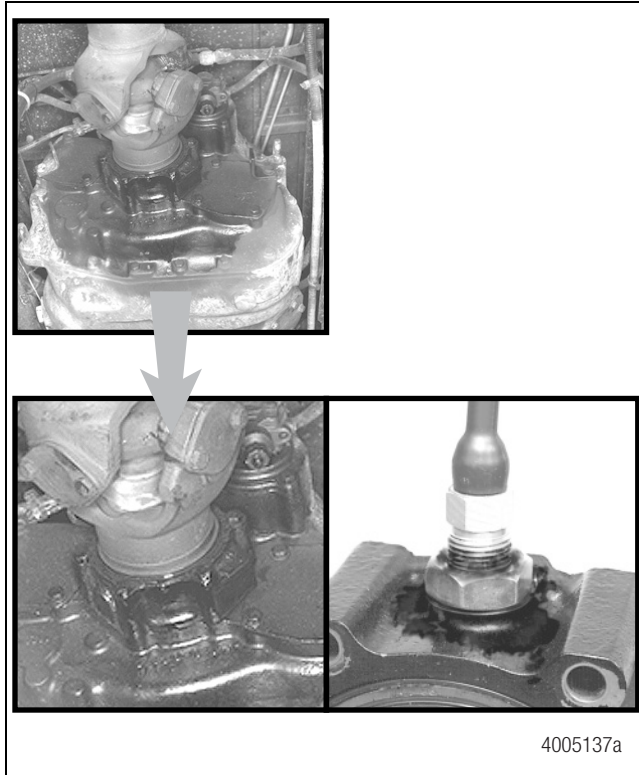
**Figure 9.49**

Check for an oil path from the speedometer sensor to the yoke area. If you see a path, the seal is leaking. If you don't see an oil path, but there's oil around the seal, the seal requires replacement. Both of these conditions can occur at the same time. Figure 9.49.

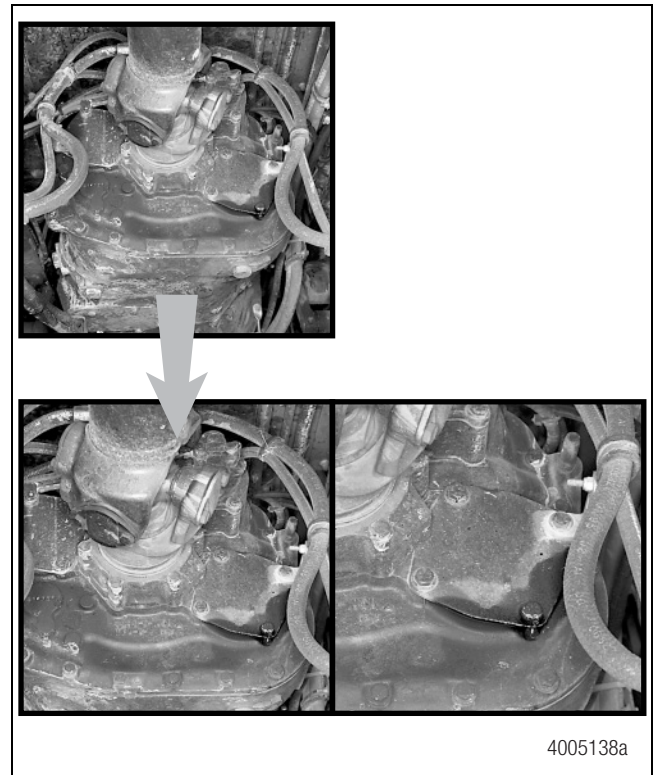
**Figure 9.50**

Check for an oil path from the cover bolts to the yoke area. If you see a path, the seal is leaking. If you don't see an oil path, but there's oil around the seal, the seal requires replacement. Both of these conditions can occur at the same time. Figure 9.50.

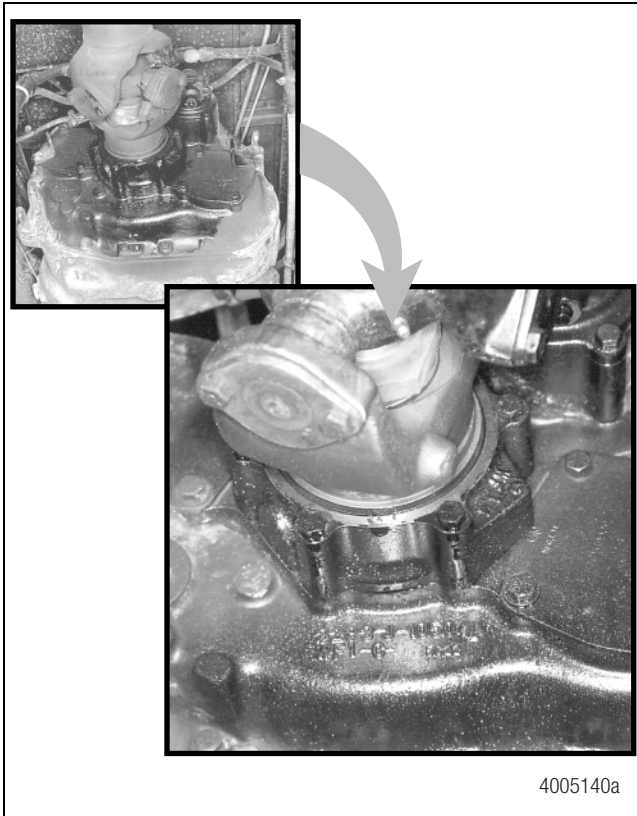
Figure 9.51

The seal requires replacement, even if you don't find an oil path from the speed sensor, shift tower and retainer bolts. Figure 9.51.
