Manual TP-0445

# Parts Failure Analysis

# Service Notes

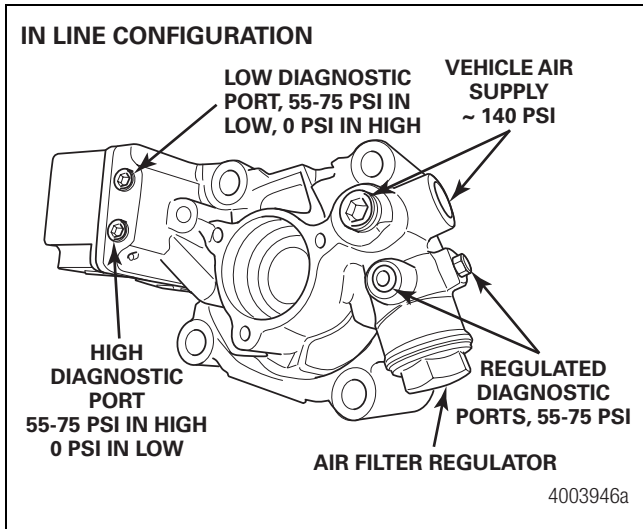
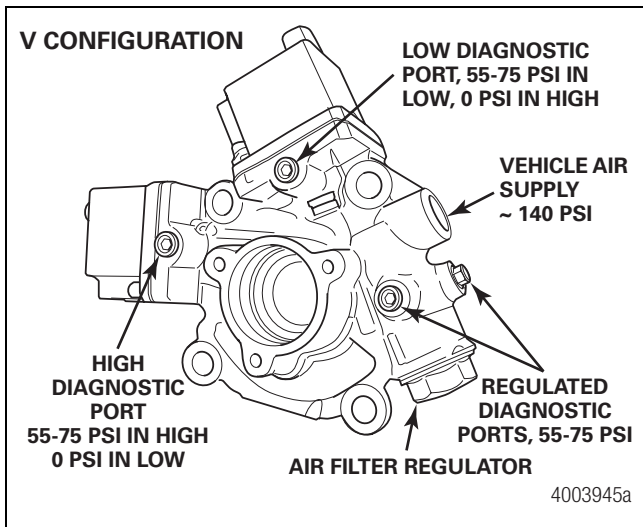
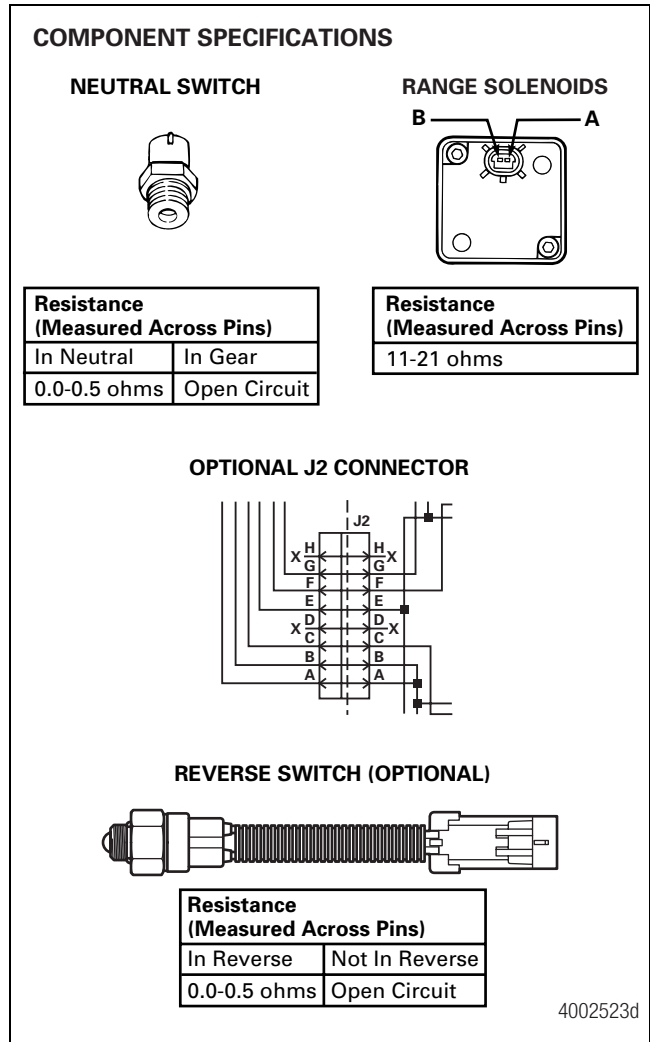
These flowcharts provide diagnostic information for ZF-FreedomLine Platform G transmission range shift systems. When using diagnostics to troubleshoot system faults, it's important to follow these flowcharts step-by-step and use the diagnostic procedures in the sequence outlined below. Figure 9.52, Figure 9.53 and Figure 9.54.

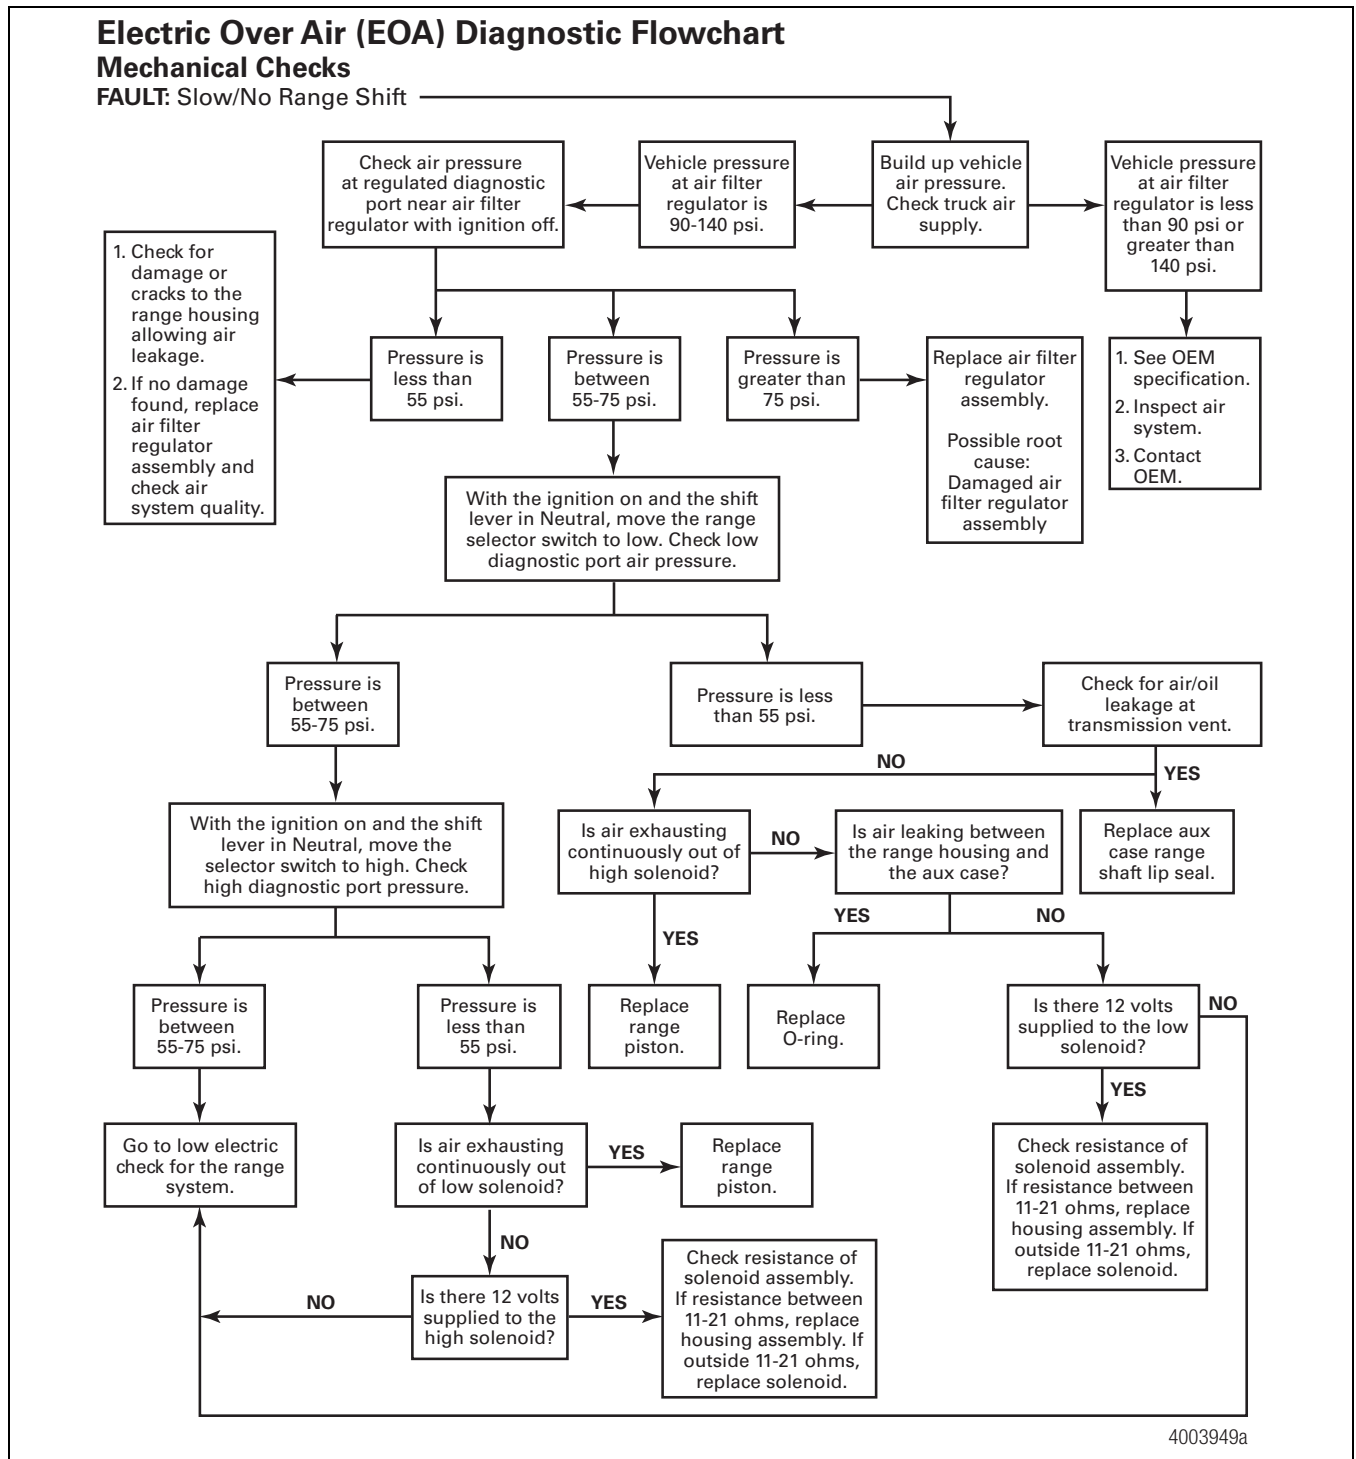
Figure 9.55

1. Mechanical Checks — Follow the mechanical checks flowchart to verify that all mechanical systems function correctly. Repair all mechanical issues BEFORE you perform electrical checks. Figure 9.55.

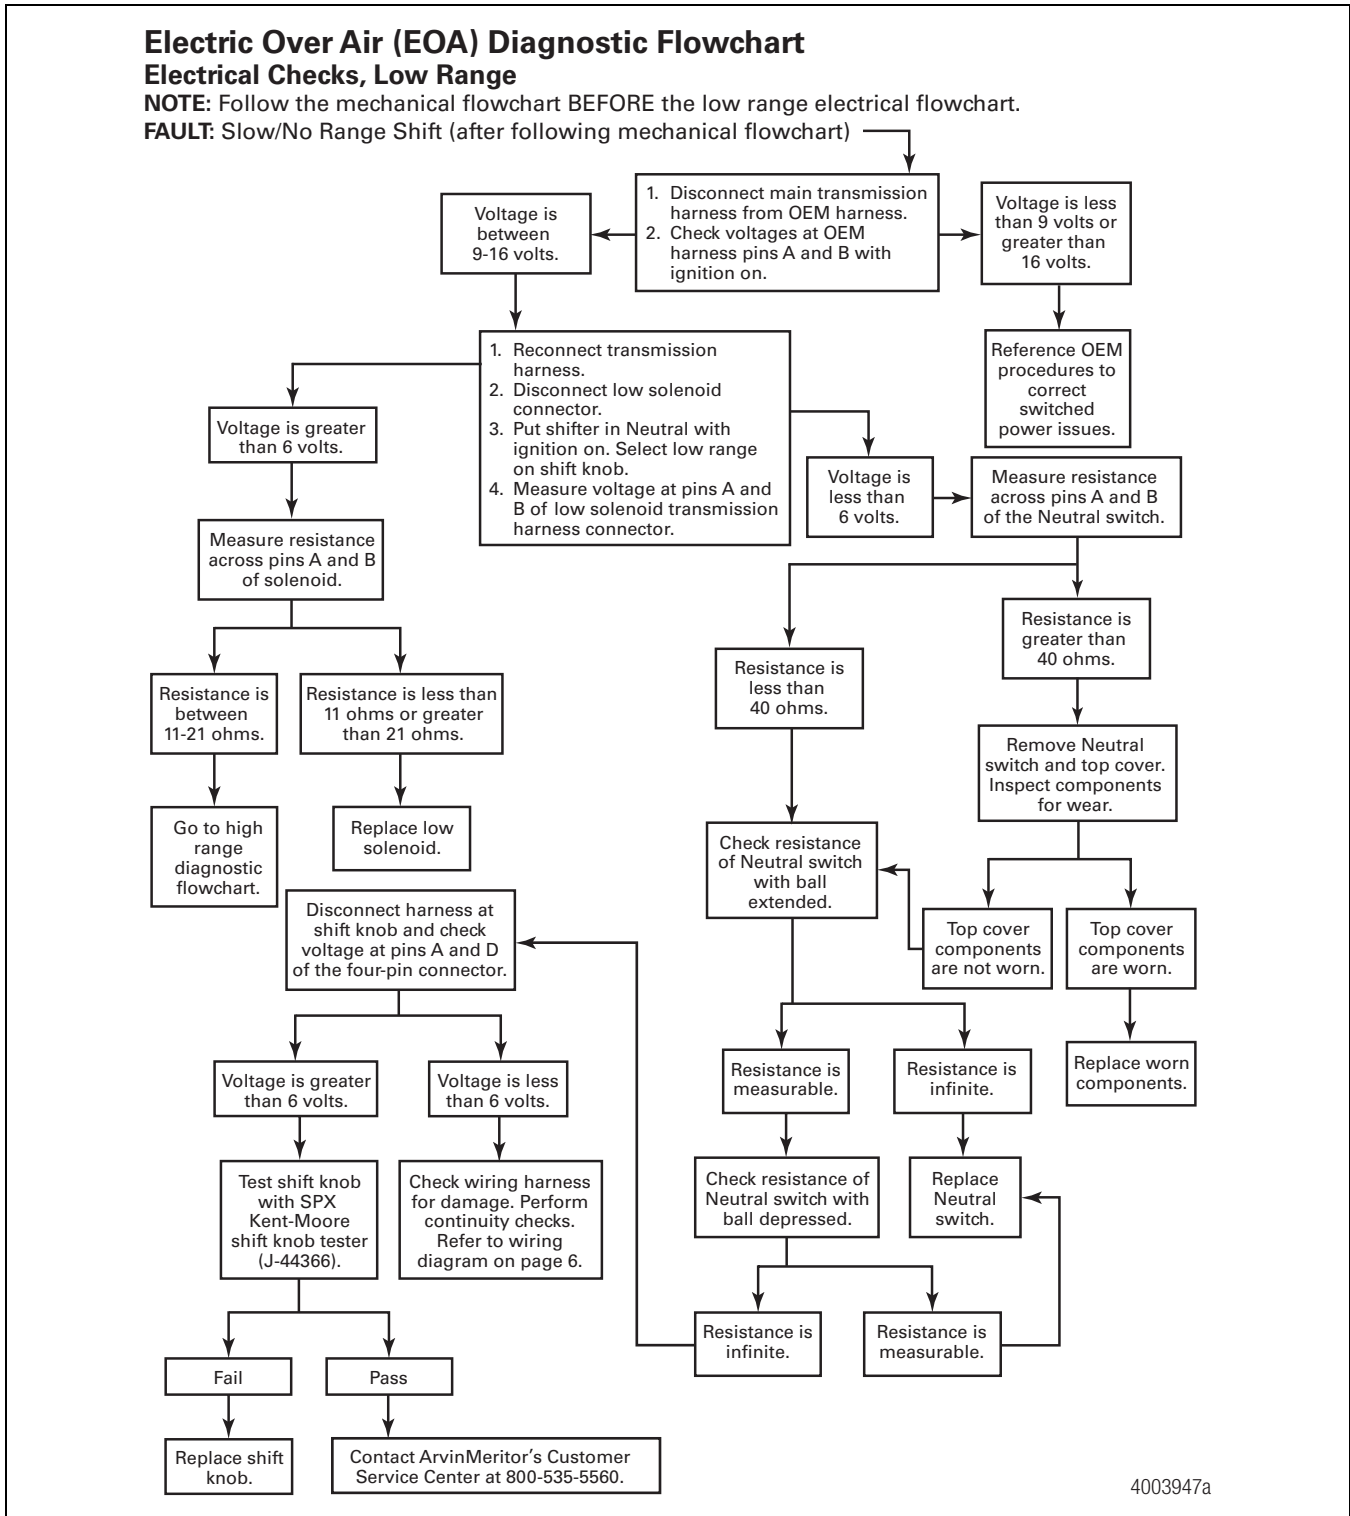
Figure 9.56

2. Low Range Electrical Checks — Follow the low range electrical checks flowchart to verify that the low electrical system functions correctly. Perform low range electrical checks AFTER mechanical checks and BEFORE high range electrical checks. Figure 9.56.

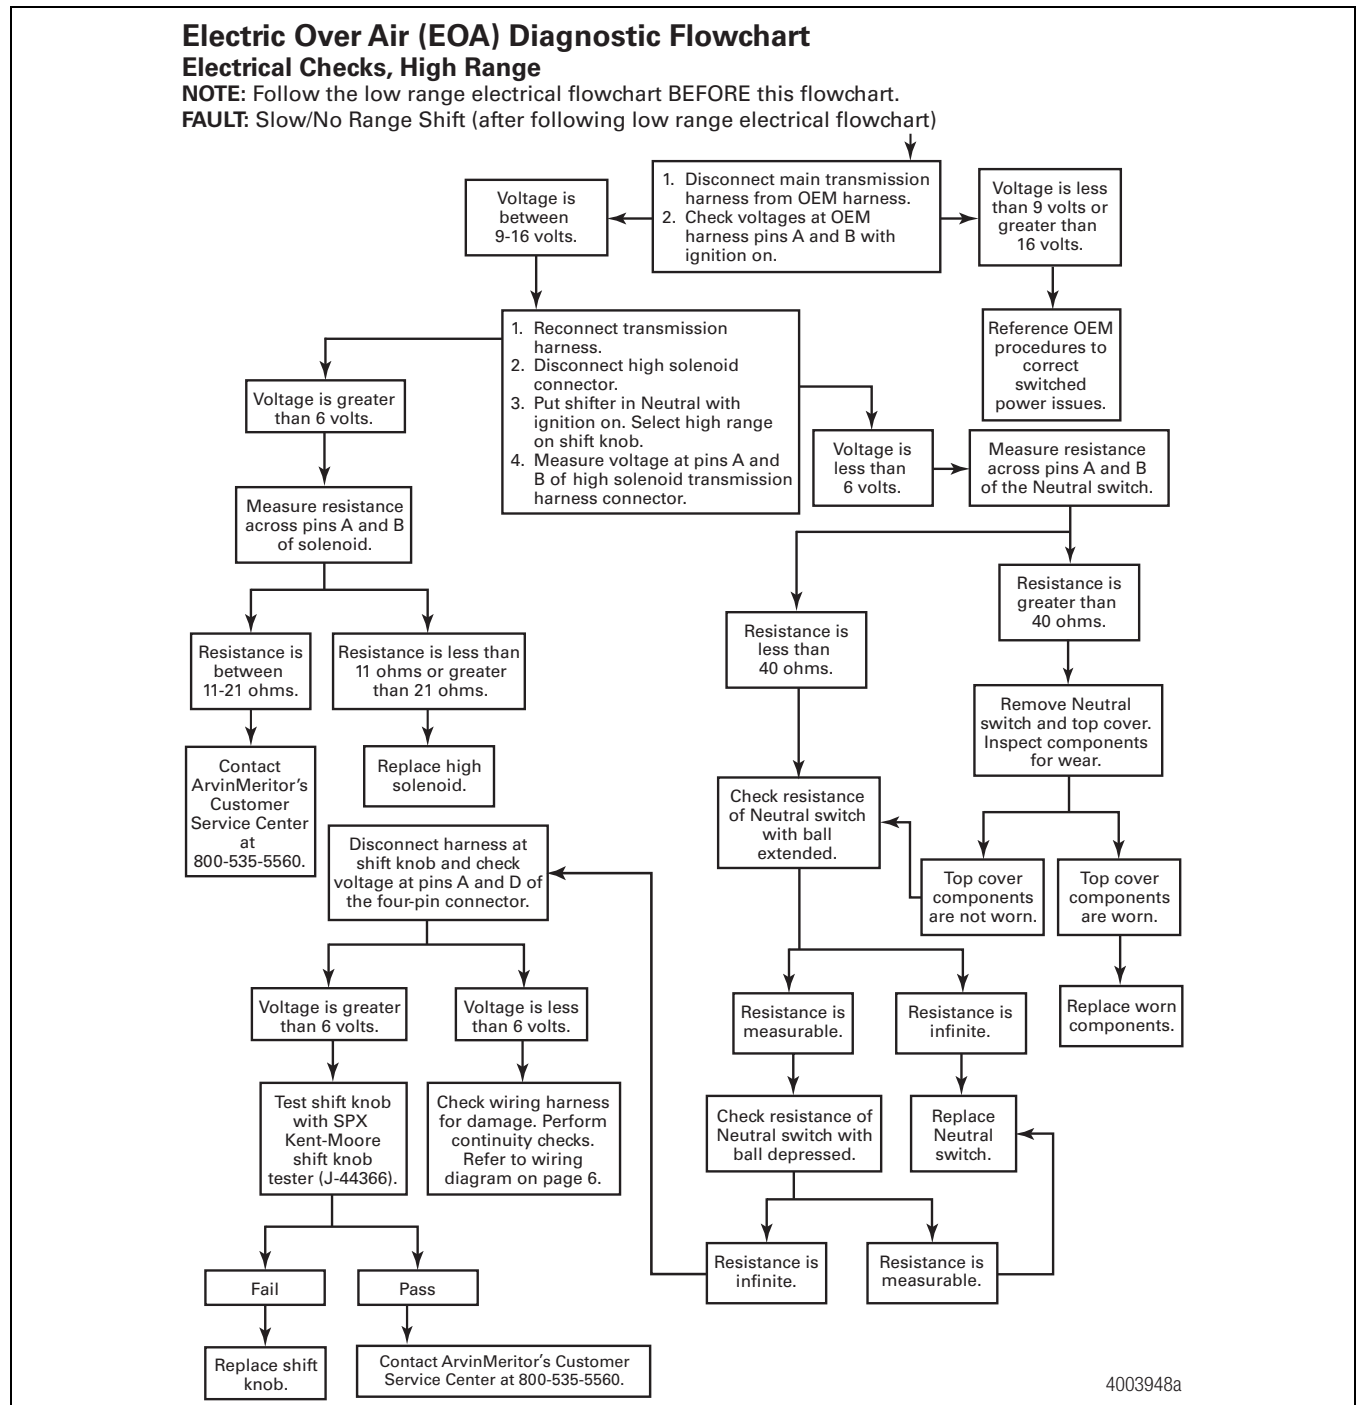
Figure 9.57

3. High Range Electrical Checks — Follow the high range electrical checks flowchart to verify that the high range electrical system functions correctly. Perform high range electrical checks AFTER mechanical checks and low range electrical checks. Figure 9.57.

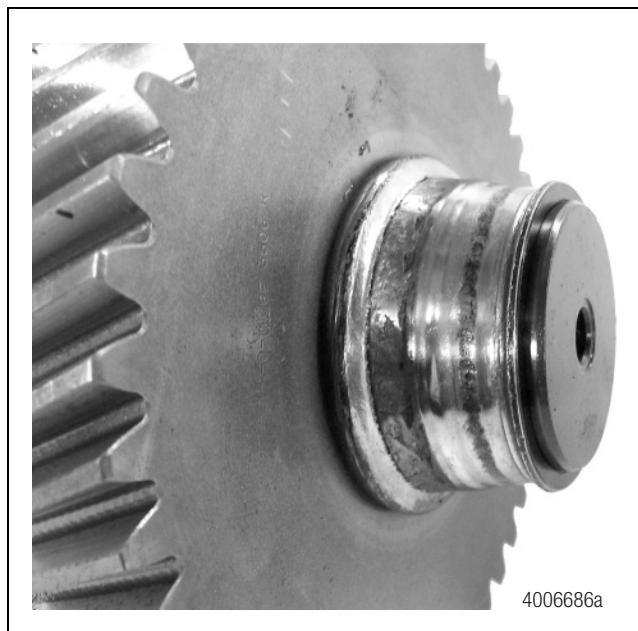
You find damage to the front idler bearing caused by lack of lubrication. Figure 10.1.

You find damage to the front idler bearing cone and/or rollers caused by heat and/or lack of lubrication. Figure 10.1 and Figure 10.3.

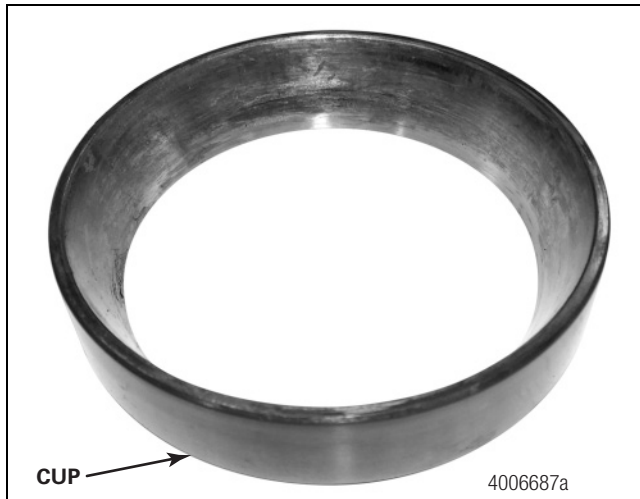
Figure 10.2

You find damage to the front idler cup caused by heat and/or lack of lubrication. Figure 10.2.

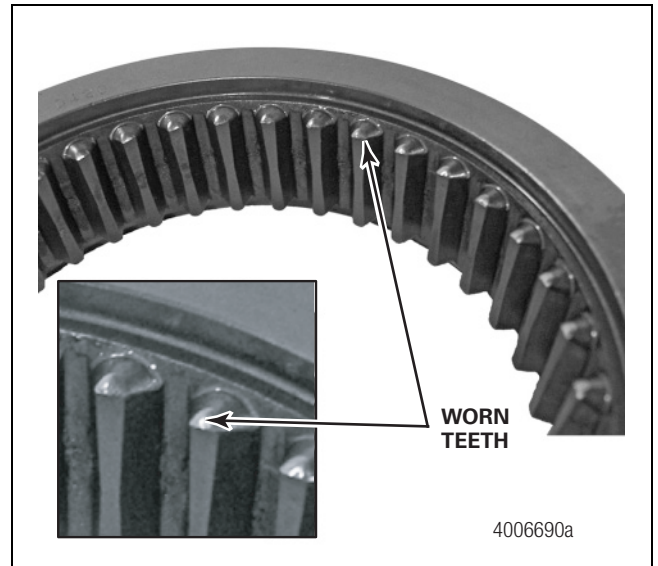
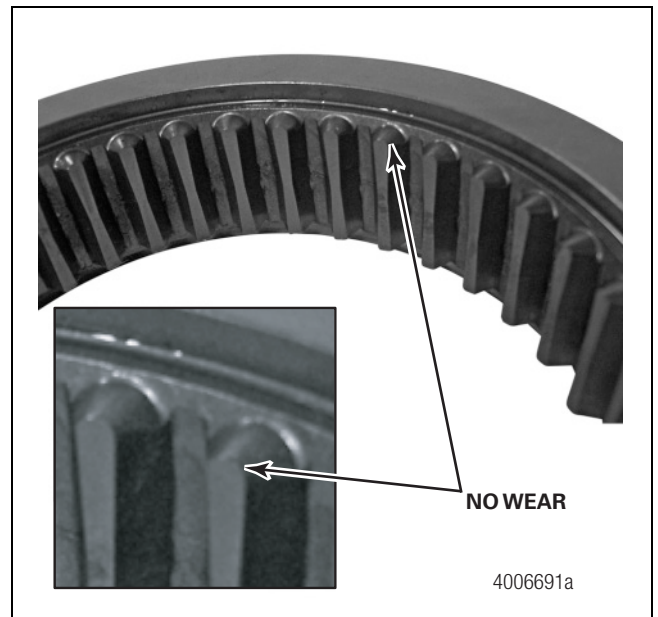
There could be signs of gear clash wear at the end of the high/low clutch collar teeth on the high gear side. This is caused by the inclination of the vehicle as it loses air during towing. Figure 10.5 and Figure 10.6.

Follow the vehicle towing instructions in Maintenance Manual MM-0146, Transfer Cases MTC-4208, -4210 and -4213, for the MTC-4208 and MTC-4210 transfer case product models.

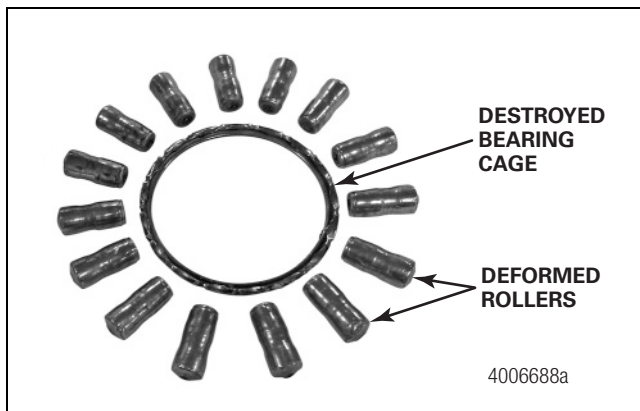
Figure 10.3

The bearing cage is destroyed. Figure 10.3.

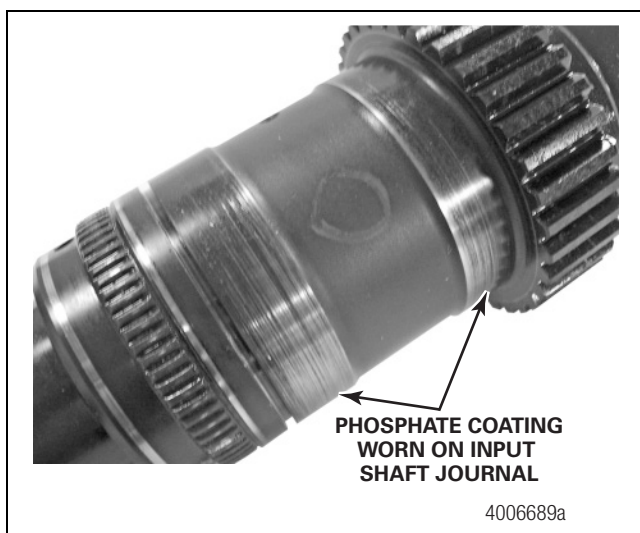
Figure 10.4

The input shaft surface and phosphate coating for the low gear bearing journal show eccentric wear, which means wear shows on approximately 180 degrees of the bearing journal, but not on the 180 degrees of the opposite side of the input shaft journal. This condition indicates the low gear is rotating, but the input shaft is not rotating; or the input shaft is rotating at a slower speed during towing. Figure 10.4.

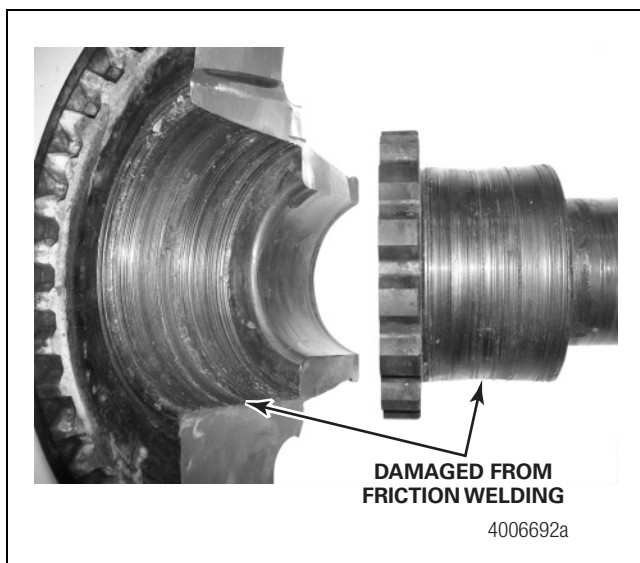
Figure 10.7

Front output shaft and gear spinout damage caused from friction welding. Figure 10.7.

Spinout between the front output shaft journal and the front output shaft gear caused a friction welding of the two components as well as damage to the front output shaft bearing.

Follow the vehicle towing instructions in Maintenance Manual MM-0146, Transfer Cases MTC-4208, -4210 and -4213, for the MTC-4208 and MTC-4210 transfer case product models.

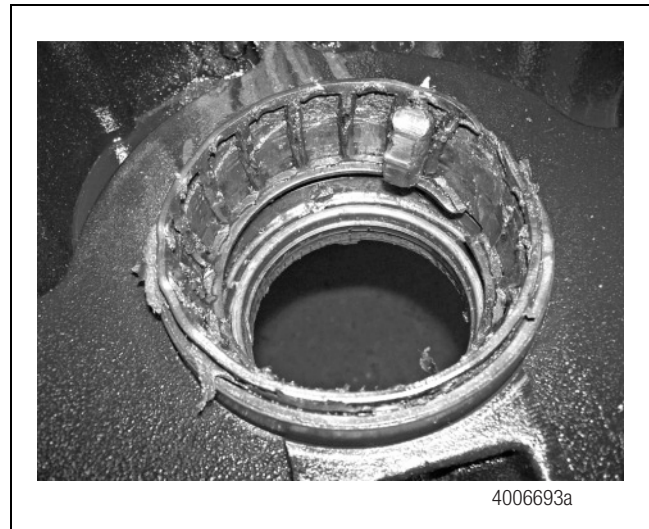
Figure 10.8

Front output shaft rear bearing cup is damaged from heat. Figure 10.8.

Front output shaft bearing cup and cage is completely destroyed from heat. Figure 10.8.

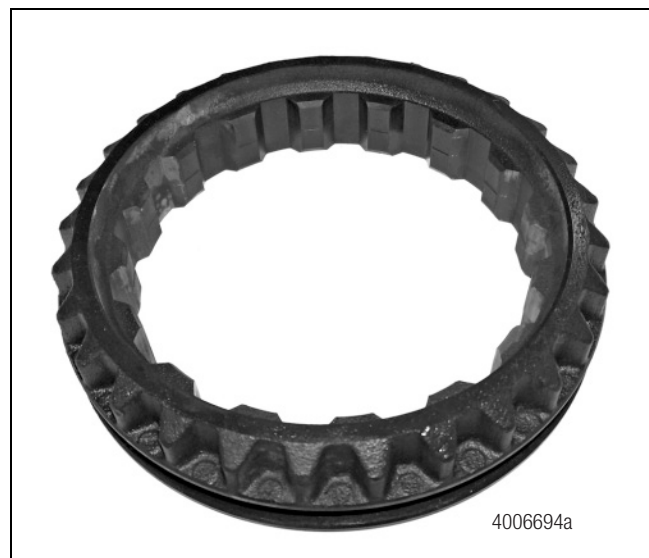
Figure 10.9

There is no damage to the part-time 4x4 or 6x6 clutch collar because it was not engaged. Heat from the other parts caused slight discoloration of the clutch collar. Figure 10.9.

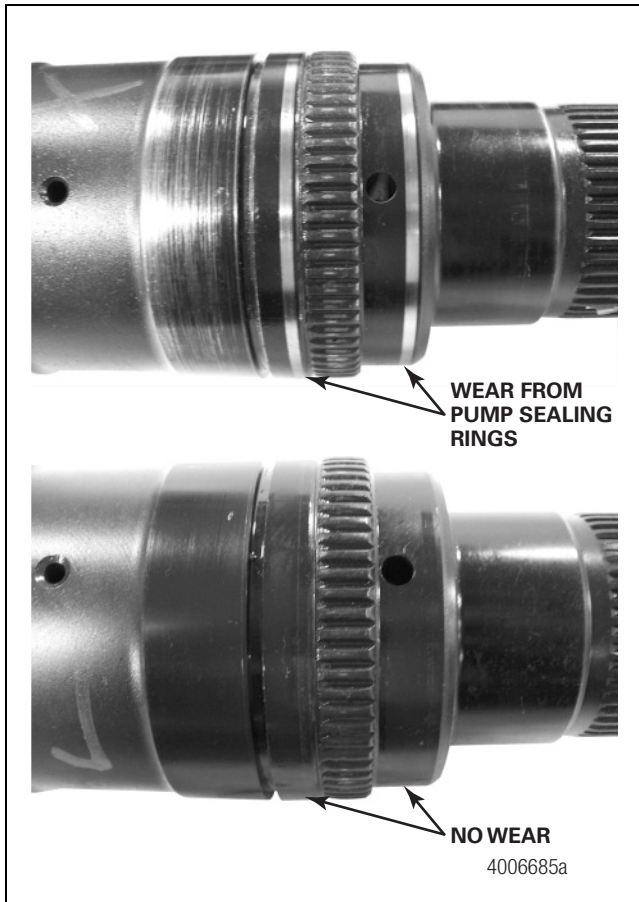
Figure 10.10

No signs of wear on the front input shaft from the oil pump sealing rings indicate the input shaft was not turning during towing. Figure 10.10.

This damage is caused by the transfer case turning during towing. The transfer case may fail during towing or while driving the vehicle after it has been incorrectly towed.
